PRELIMINARY ADVICE OF VEHICLE NO. XB 9515C

Please be informed that we had conducted the inspection of the above mentioned vehicle on 14/05/2018 at the premises of M/s Woon Meng Motor Pte Ltd and have the following to report:-

ADJUSTMENT ON REPAIR COST FOR VEHICLE NO. XB 9515C

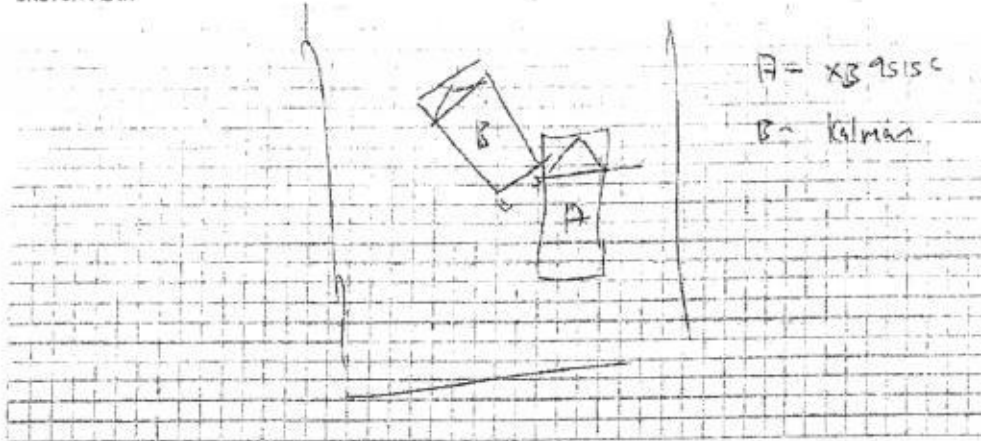
SKETCH PLAN

stationary and waiting

On the 30.04.18 at about 830am, I was waiting for loading and unloading at 25 Pasir lane. When suddenly vehicle B (Kalman) made an reverse without an ift his rear and had hit onto my vehicle front left side parking. I pressed my horn to warn but still reverse to hit my vehicle.
