REF: CS/SMO18008572 / Atbn2

4. Description of Damages

THE VEHICLE SUSTAINED DAMAGES AT THE FRONT N/S PORTION. DAMAGES SEE DETAILS.

ADJUSTMENT ON REPAIR COST FOR VEHICLE NO. SLM 5590U

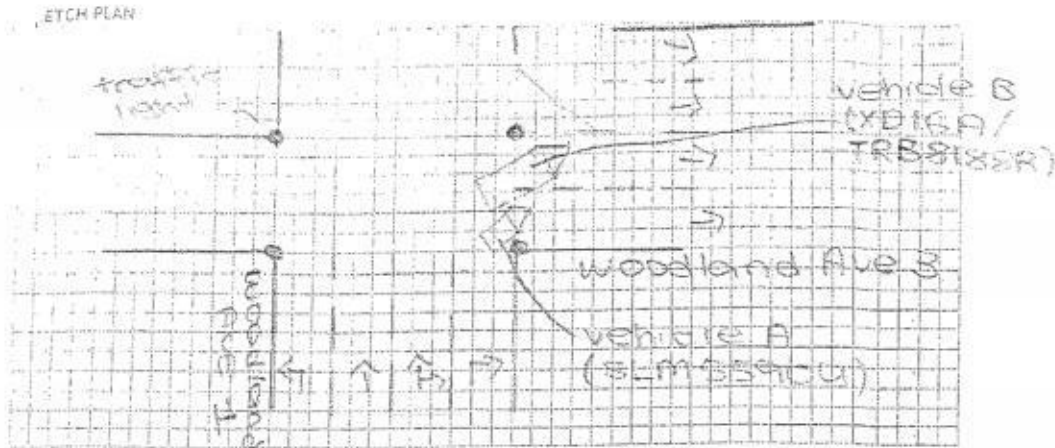
Sketch Plan #2 Pg. 1

DESCRIBE CIRCUMSTANCES OF THE ACCIDENT

I was turning into Woodland Ave 3 when the traffic light turn green. Vehicle B was turning too. Suddenly, vehicle B's rear trailer cut into my lane resulting in hitting onto the front left-hand portion of my vehicle.
