NTUC INCOME INSURANCE CO-OPERATIVE LTD Ref: NS/INC18008615/Ss3b

4. Description of Damages

THE VEHICLE SUSTAINED DAMAGES AT THE REAR N/S PORTION.
DAMAGES SEE DETAILS.

ADJUSTMENT ON REPAIR COST FOR VEHICLE NO. SMB 1473Y

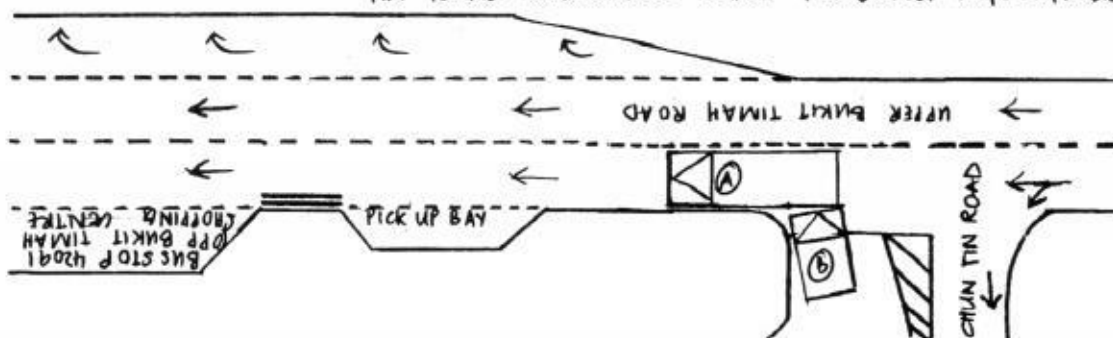
SKETCH PLAN

① CMB1473K

⑥ SJK5147b

JUNCTION OF UPPER BUKIT TIMAH ROAD WITH CHUN TIN ROAD (TOWARDS BUKIT PANJANG INTERCHANGE)
