**PRELIMINARY ADVICE OF VEHICLE NO. XD 6502Z.**

**Accident involving XD 6502 Z & Wheel Loaded WC 7271 H (policy no: B29071170PLY) at Ford Road Island Plant on 22.04.2018.**

## ADJUSTMENT ON REPAIR COST FOR VEHICLE NO. XD 6502Z

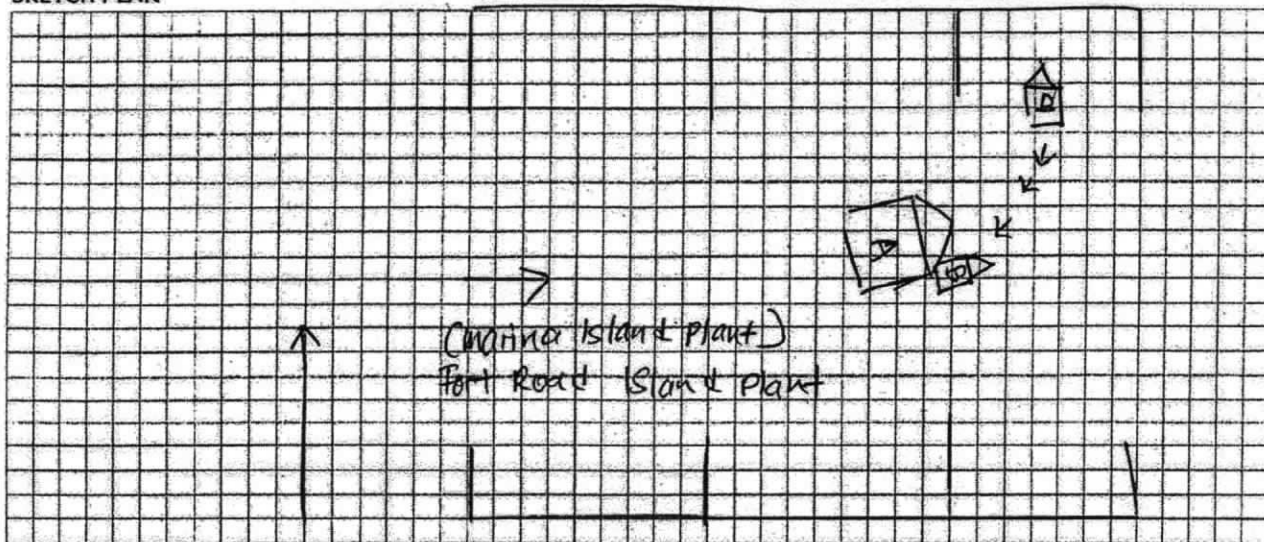
# SKETCH PLAN

A = XD6502Z

B = WC7217H

On 22.04.18 around 12pm I was  
(Maha Island plant)  
driving my company truck XD6502Z at Fort Road Island plant.  
At that time, I want to unloading but there is a wheel loader  
WC 7217H inside there, so I stop and wait. Unfortunately,  
when the wheel loader reverse he didn't saw me and hit my truck.  
Our truck front right bumper, front right foot step damage.
