Veh No: SLR 6800G Yr Regn: 2017, July

Make: Audi A6 c.c 1798

VEHICLE DAMAGE INSPECTION REPORT

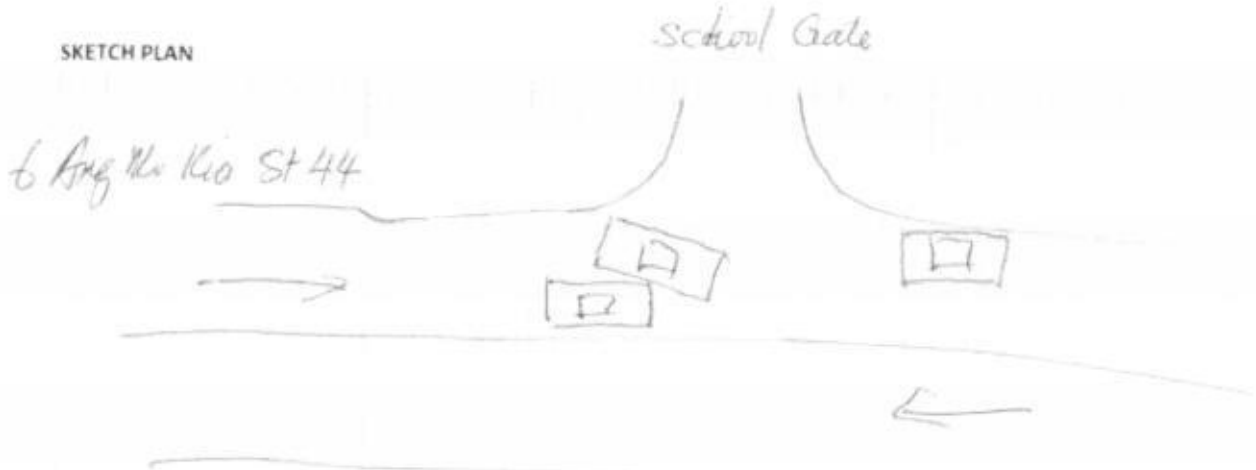
SKETCH PLAN

I have stopped by the side of the road to pick up my son from Pathlight School. I signalled right after he gotten in and having seen clear, I was slowly moving out when I was hit on my right side by vehicle SG45766B which is going straight.

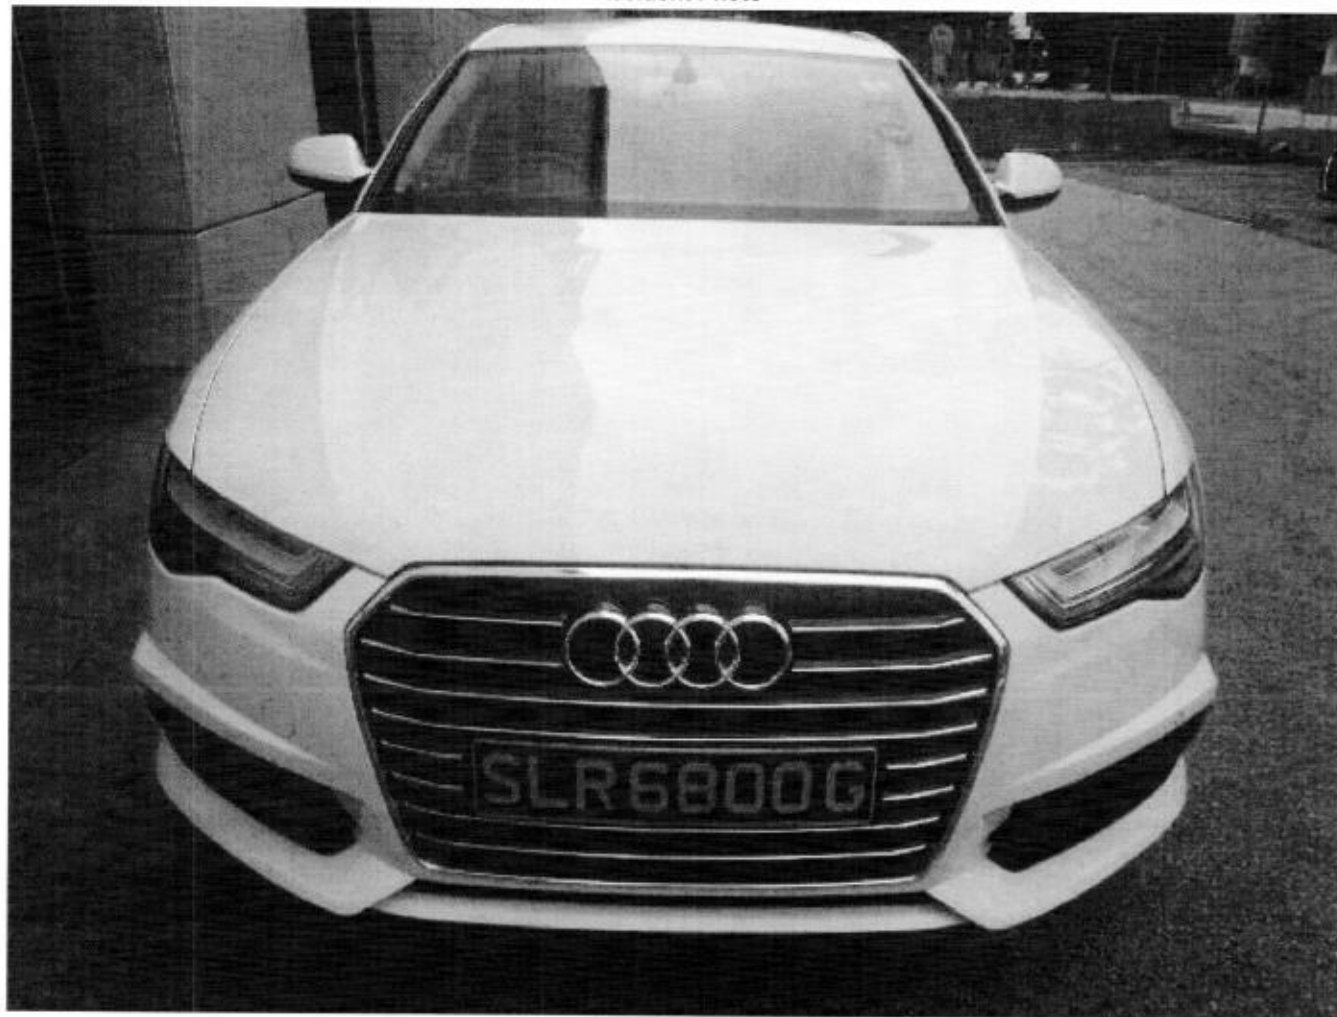
Accident Photo

Des. of Damages: Frt / Rear / O/S / N/S / U/C / Rooftop or

The U/C / Chassis frame / Body Structure affected due to collision.
