**ACCIDENT INVOLVING SHB8983E & GW7642Y ALONG SLIP ROAD OF CTE  
- PIE/CHANGI ON 15.05.2018**

**Preliminary Advice**

Insured Vehicle No	: GW7642Y	Accident Date	: 15/05/2018
TP Vehicle No	: SHB8983E	Assignment Date	: 16/05/2018
Make	: KIA OPTIMA	Est. Duration of Repair	: 4 days
Date of Inspection	: 16/05/2018		
Inspection At	: Premier Automotive Services Pte Ltd (HQ) 23 Changi South Ave 2, #01-02 Singapore 486443

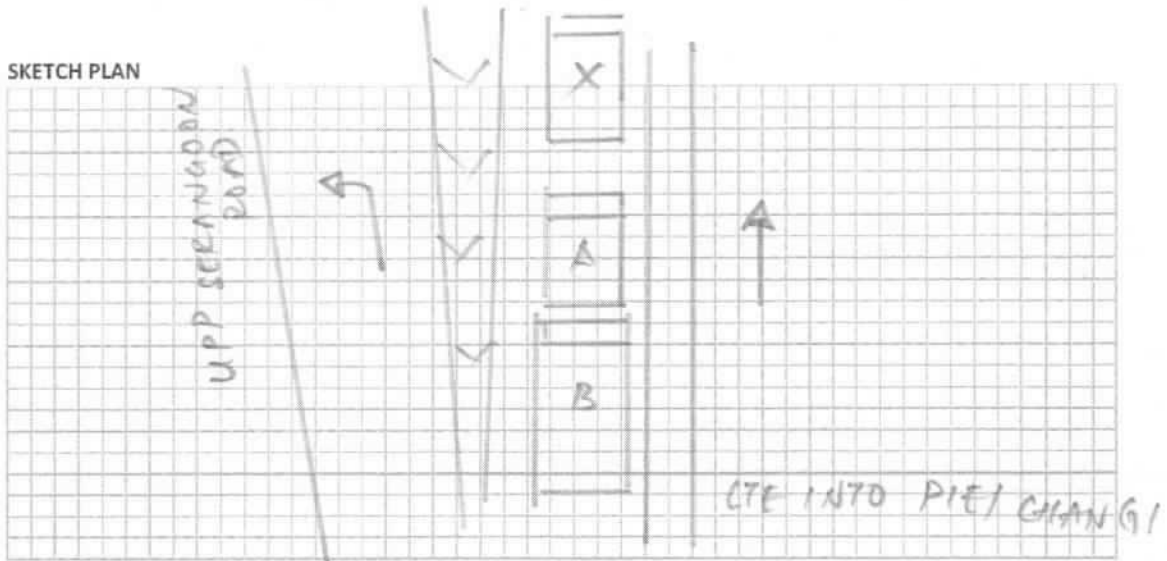
### SKETCH PLAN

ON 15/05/2018 @ 1540 HRS, I WAS DRIVING MY TAXI ( SHB8983E )  
TRAVELLING ALONG THE SLIP ROAD OF CTE INTO PIE/CHANGI AIRPORT WITH 3  
PASSENGER ONBOARD.

I STOPPED MY TAXI AS VEHICLES AHEAD OF ME STOPPED.

WHILE STATIONARY FOR A FEW SECONDS, SUDDENLY I FELT AN IMPACT FROM THE  
REAR.

WHEN INSPECTED, I DISCOVERED THAT VEHICLE B ( GW 7642 Y – LORRY )  
WHICH WAS BEHIND ME – HAD COLLIDED ONTO THE REAR OF MY TAXI.

DUE TO THE IMPACT, MY TAXI HAD DAMAGES ON THE REAR PORTION AND VEHICLE  
B HAD DAMAGES ON THE FRONT PORTION.

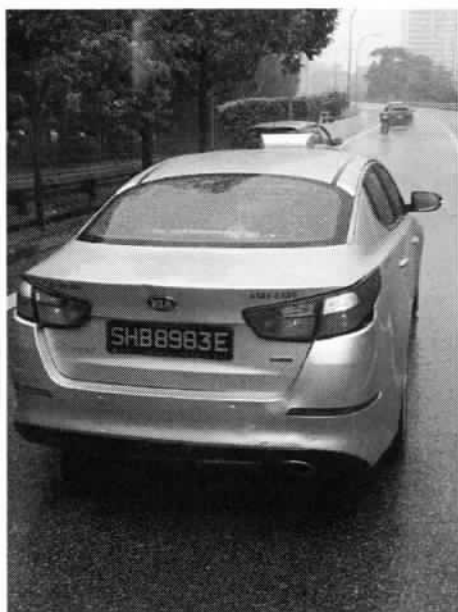
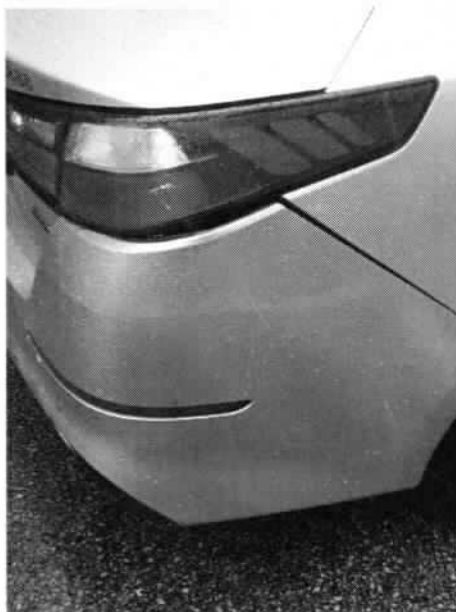
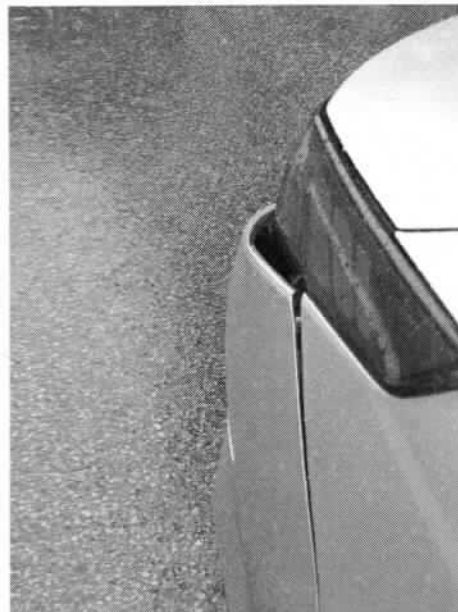
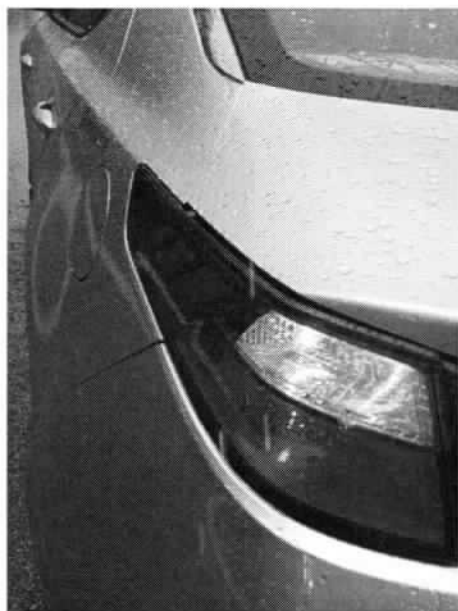
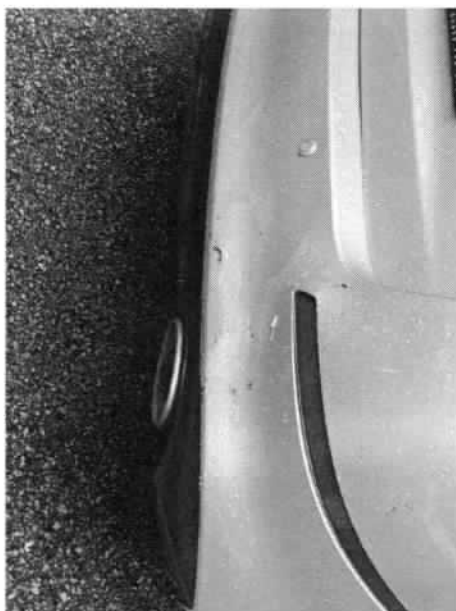
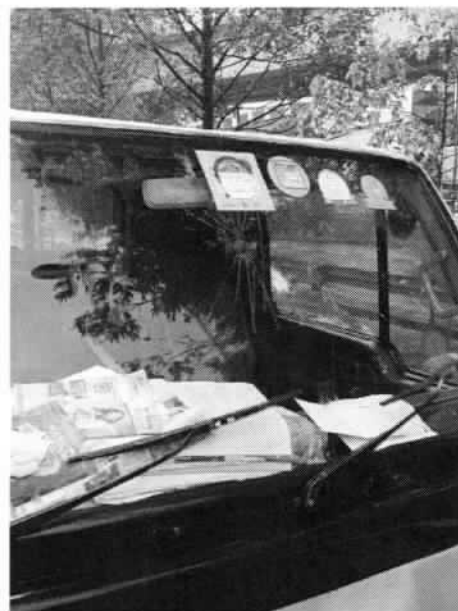
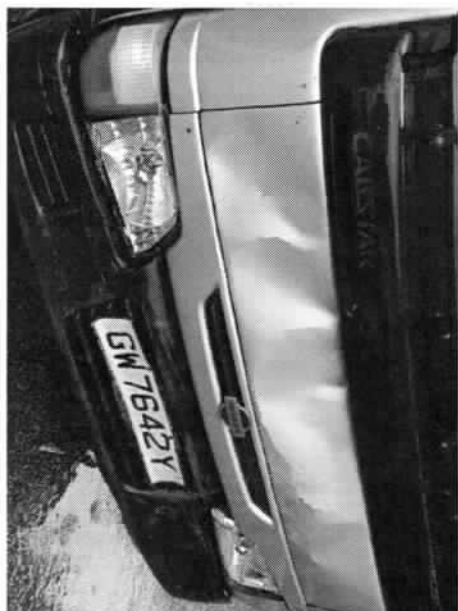
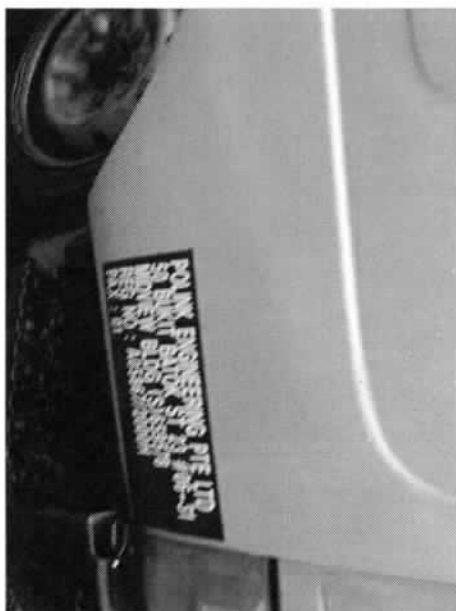
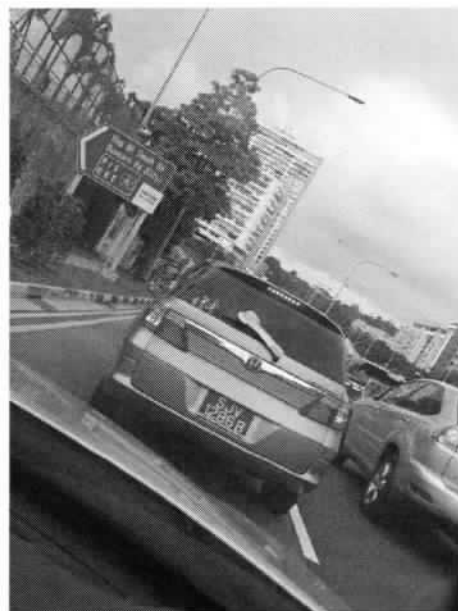
The U/C / Chassis frame / Body Structure affected due to collision.

The vehicle sustained impact / damages rear portion and parts claimed are consistent to the accident.

No.	Qty	Part No.	Particulars	Condition	Repairer's	Amount
1	1		*BOOTLID	Dented	1,119.00 FL	*1,119.00 FL
2	1		*BOOTLID OUT PANEL	Repair	290.00 FL	*- FL
3	1		*L/R BUMPER BRACKET	Serviceable	29.00 FL	*- FL
4	1		*R/R BUMPER BRACKET	Serviceable	29.00 FL	*- FL
5	1		*R/R C-MEMBER BRACKET	Bent	56.00 FL	*56.00 FL
6	1		*R/R INNER LAMP	Serviceable	350.00 FL	*- FL
7	1		*R/R OUTER LAMP	Cracked	421.00 FL	*421.00 FL
8	1		*REAR BADGE	Necessary	47.60 FL	*47.60 FL
9	1		*REAR BUMPER	Deformed	696.00 FL	*696.00 FL
10	1		*REAR BUMPER DAMPER	Cracked	116.00 FL	*116.00 FL
11	1		*RERA BUMPER SPOILER	Cracked	206.00 FL	*206.00 FL
12	1		*REAR BUMPER SUPPORT	Cracked	607.00 FL	*607.00 FL
13	1		*REAR MOUNTING	Serviceable	14.00 FL	*- FL
14	1		*RR EXHAUST SILENCER	Serviceable	1,009.00 FL	*- FL
15	1		*REVERSE SENSOR	Shorted	280.00 FS	*200.00 FS
16	1		*REAR BUMPER CLIPS	Necessary	48.00 FS	*48.00 FS
17	1		*BOOTLID STICKERS	Necessary	100.00 FS	*100.00 FS
