Veh No: **RD6149G** Yr Regn: _____
 Type: M/Car / M/Cycle / Bus / Van / Lorry / ☒ Prime Mover /
 Truck / Trailer of: _____
 Make: **BYD**
 Colour: **White/Green** A/C: Insured / Std / NI / NA
 Sp/Reading: **152712** T/Radio: Insured / Std / NI / NA
 Eng/No: _____
 C/No: **LC0CE4DB8G1071054**
 Gen. Cond: ☒ Good / Fair / Poor / Burnt
 Steering: ☒ In order / Jammed / Leaked / Burnt or
 Brake: ☒ In order / Jammed / Leaked / Burnt or
 Modi: ☒ Nil / ☒ R/Rim / STD A/Rim or
 Tyre Size: F: **225/65 R17**
 R: **— " —**
 BS / DUN / EXNOVA / GY / FS / LIZA / MIC / OHTSU / PIR / SUMI /
 TOYO / YOKO or **Pirelli**
 Front: _____ Rear: _____
 R/Bal: **S** mm R/Bal: **S** mm
 L/Bal: **S** mm L/Bal: **S** mm
 D.O.A: **13/05/2018** D.O.I: **18/05/2018**
 Survey held at **Soon Hock AMK**
 Des. of Damages: Frt / Rear / O/S / N/S / U/C / Rooftop or:
Front
 The U/C / Chassis frame / Body Structure affected due to collision

PRELIMINARY ADVICE OF VEHICLE NO. RD 6149G

ADJUSTMENT ON REPAIR COST FOR VEHICLE NO. RD 6149G

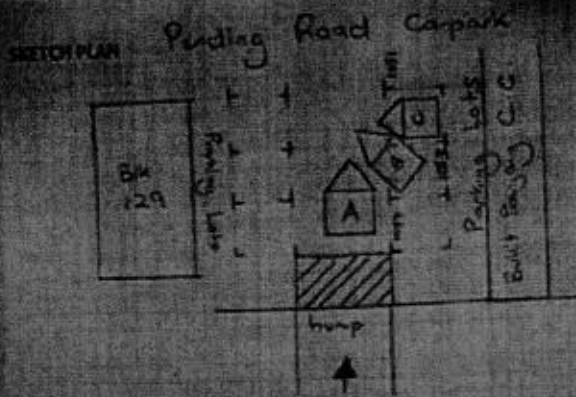
Sketch Plan

A - RDG 476
B - SKK 9299H
C - SKK 4454X

DESCRIBE CIRCUMSTANCES OF THE ACCIDENT

On the 17th May 2018 Sunday afternoon, I was driving my taxi RDG 476 as an employee of HDT Singapore with a lady Chinese passenger to the carpark of Bk 129 Pending Rd.

While entering the carpark over the hump on a one-way street, I saw a pedestrian crossing from left to right just before my entry into the said carpark. After the entry over the hump, I saw the street in front of me was clear while there were cars parked on both sides of the parking lots.

As I moved further at a very low speed, suddenly, a car came out from the second lot (1053) from the right side and I applied brake immediately but it was too late to stop after crossing the hump and as a result, I hit the car rode out from the parking lot 1053 causing damages to both cars (SKK 9299H and SKK 4454X, which was unattended).
