NTUC INCOME INSURANCE CO-OPERATIVE LTD Ref: NS/INC18008969/Sqb			
73 BRAS BASAH ROAD		 	
#05-01 NTUC TRADE UNION HOUSESINGAPORE 189556			
		Date: 17-05-2018	
Code: INC4			
<b>1. Policy Particulars :- THIRD PARTY CLAIM</b>			
Insured Veh.	GBD 5726L	Veh. Inspected	SHC 4536J
Policy No.	5093337337	Coverage (\$)	0.00
Claim No.		Excess (\$)	0.00
Assign From		Assign Date	15/05/2018
<b>2. Vehicle Particulars &amp; Condition</b>			
Make & Model		c.c	0
Engine No.	HIDDEN	Year of Reg.	
Chassis No.		Colour	
Odometer	-	Steering	
Brakes		Modification	
General			
<b>3. Conditions of Tyres</b>			
	Size	Make	Balance
R/H Front Tyre			mm
L/H Front Tyre			mm
R/H Rear Tyre			mm
L/H Rear Tyre			mm
<b>4. Description of Damages</b>			
<b>5. General Information</b>			
Accident Date	14/05/2018	Inspection Date	15/05/2018
Survey held at	SMRT AUTOMOTIVE SERVICES PTE LTD 60 WOODLANDS INDUSTRIAL PARK E4 SINGAPORE 757705		
<b>5a. Remarks</b>			
A)THE INSPECTION WAS CONDUCTED ON A"WITHOUT PREJUDICE" BASIS. B)IN ACCORDANCE TO YOUR INSTRUCTIONS, WE HAVE NOT AUTHORISED REPAIRS.

**1. Policy Particulars :- THIRD PARTY CLAIM**

THE VEHICLE SUSTAINED DAMAGES AT THE REAR PORTION. DAMAGES SEE DETAILS.
--

**ADJUSTMENT ON R

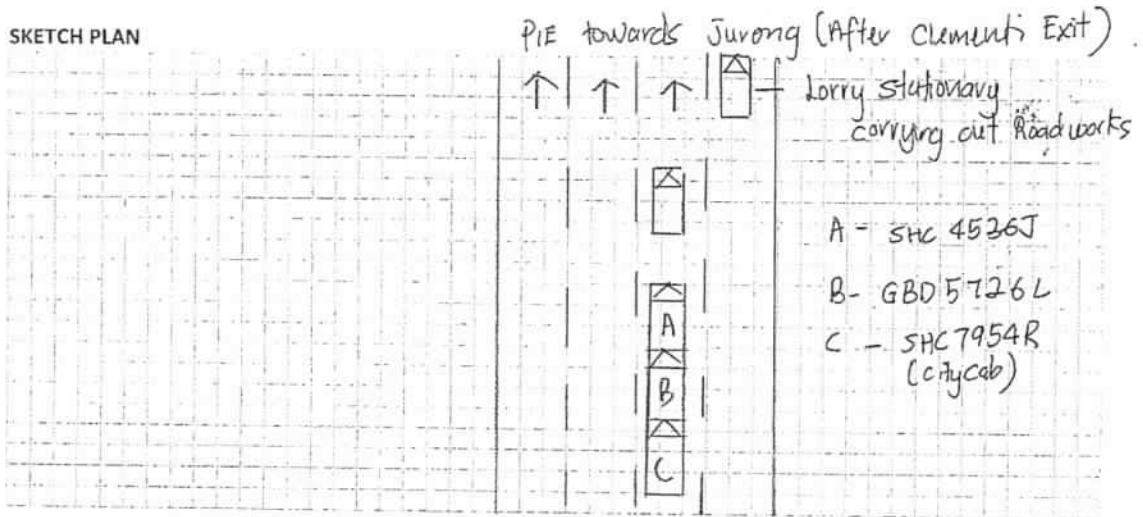
### SKETCH PLAN

I WAS TRAVELLING ALONG PIE TOWARDS JURONG (AFTER CLEMENTI EXIT) WITH ONE PASSENGER (MALE CHINESE) ON BOARD) TRAFFIC WAS HEAVY AND ROAD WAS WET DUE TO DRIZZLE. THERE WAS A STATIONARY LORRY ON THE EXTREME RIGHT LANE CARRYING OUT ROAD WORKS. A VEHICLE INFRONT OF MY TAXI CAME TO A HALT. I SLOWED DOWN AND STOPPED AS WELL. AFTER WHICH I FELT AN IMPACT AT THE REAR OF MY TAXI. A VEHICLE GBD5726L HAD COLLIDED ONTO THE REAR OF MY TAXI. WHEN I ALIGHTED I REALISED THAT IT WAS A CHAIN COLLISION INVOLVING THREE VEHICLES INCLUDING MINE.
