VEHICLE DAMAGE INSPECTION REPORT

Our File No: CS/CT118009164/KSBQ2

Claimant Vehicle
No : SJH7405JInsured Vehicle
No : SLC3399Y

Make & Model: TOYOTA VIOS, 1.5 E (A)

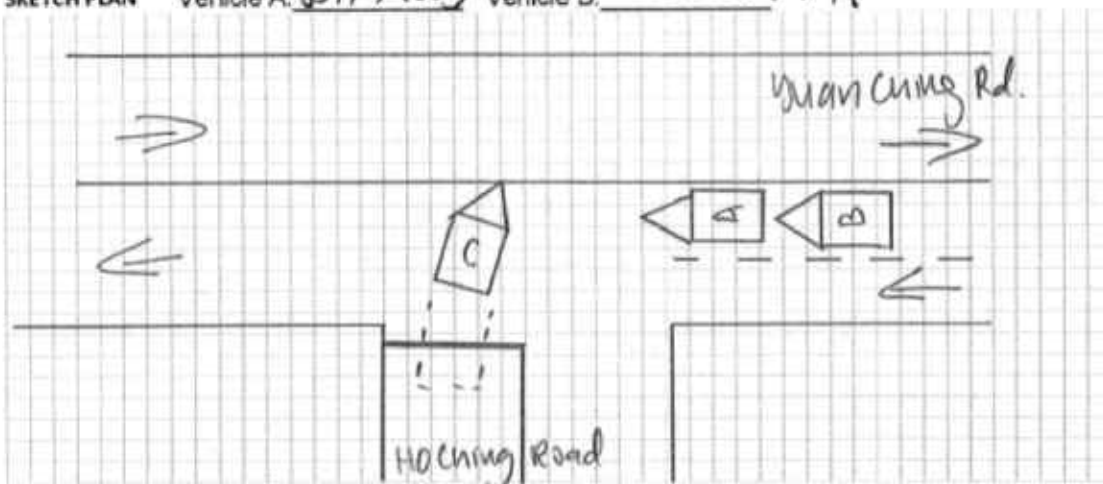
Sketch Plan #2

SKETCH PLAN Vehicle A: JH 7405J Vehicle B: SLC 3399Y.

While I driving along Yuan Ching Road, suddenly vehicle C turning out from Ho Chi Ching Road and I make the emergency brake to complete stop. However vehicle B behind me could not stop in time and hit onto my rear vehicle.
