# LKK Auto Consultants Pte Ltd

| Affiliated to Federation Internationale Des Experts En Automobile | | | | |
|---|---|---|---|--|
| Insured Veh. | SHA 1072K | Veh. Inspected | SKE 9981C | |

**Subject:** RE: TP CLAIMS\_PROGRESSIVE\_SKE 9981 C & SHA 1072 K\_DOA:12/05/2018

## VEHICLE DAMAGE INSPECTION REPORT

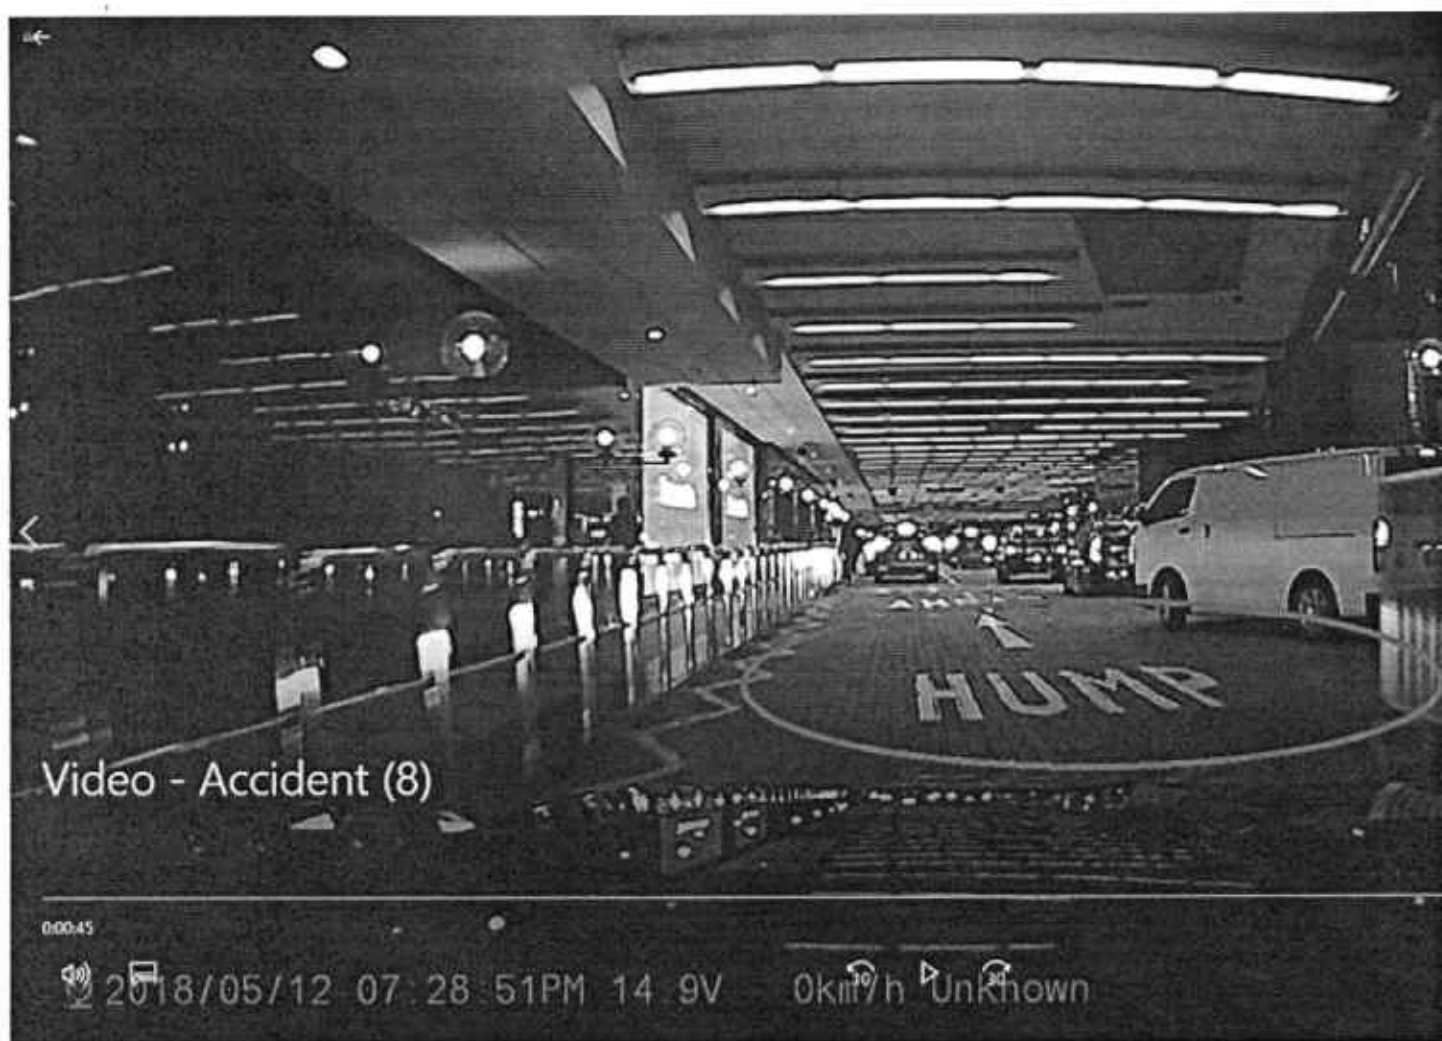
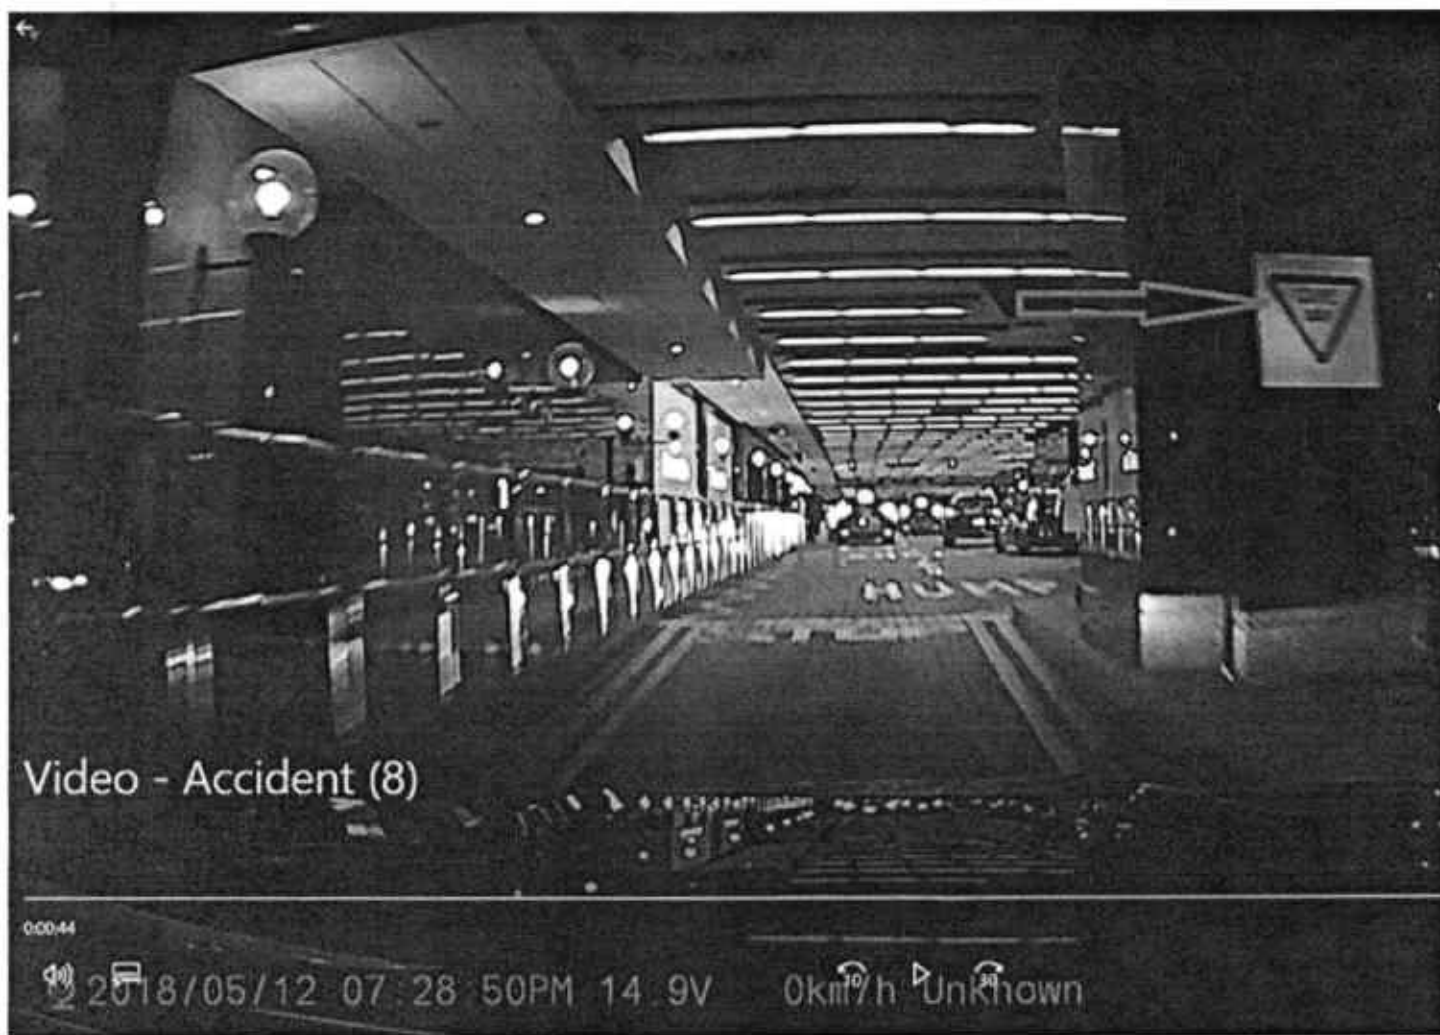
Please noted that our insured vehicle is not U-turn, so that BOLA 11 is no apply.

Also there is no lane marking, so that BOLA 15 is also not apply.

And also take noted that our insured vehicle is not turning from side road, our insured vehicle is from main road turning into the Takashimaya gateway. BOLA 2 is not apply for this case.

Please noted that your client side got STOP LINE and GIVE WAY SIGN.

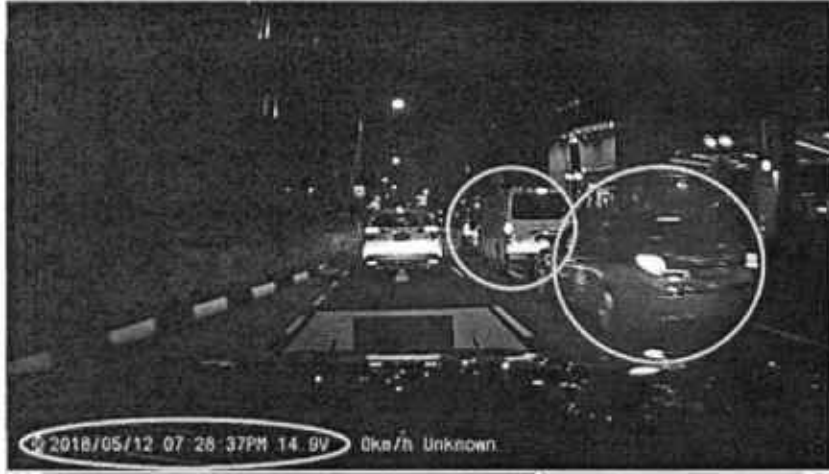
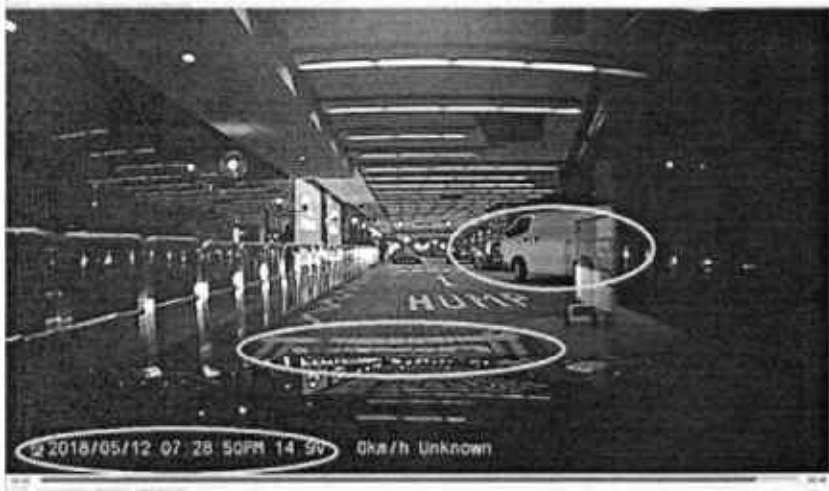
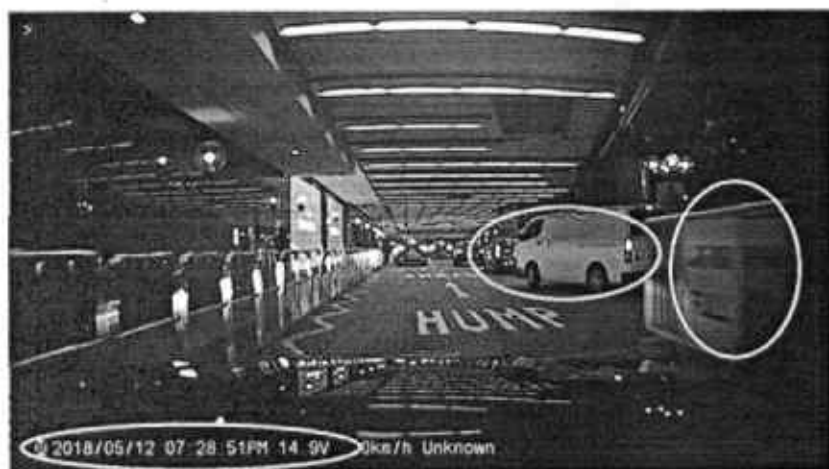
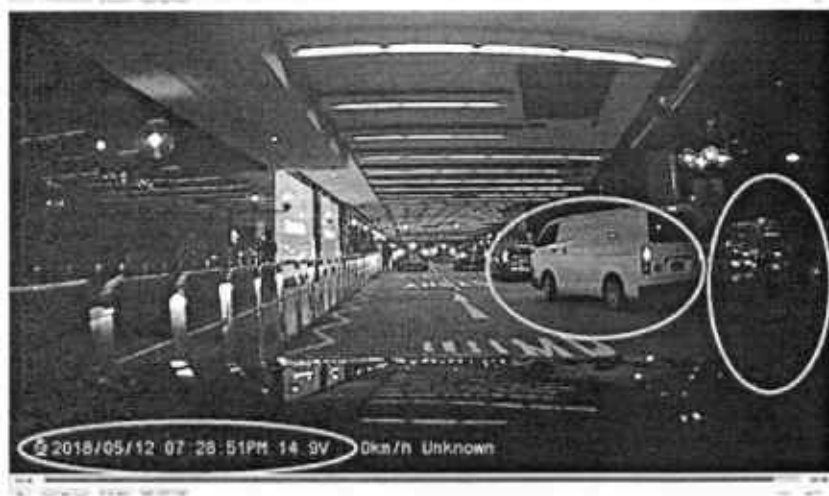
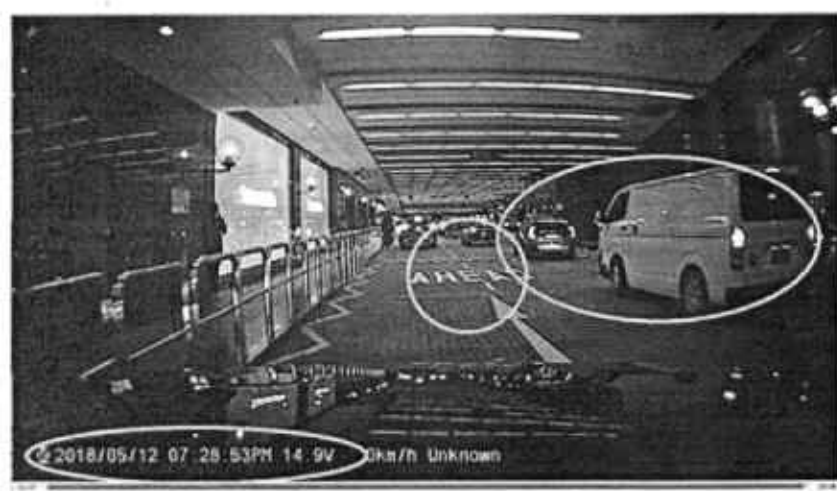
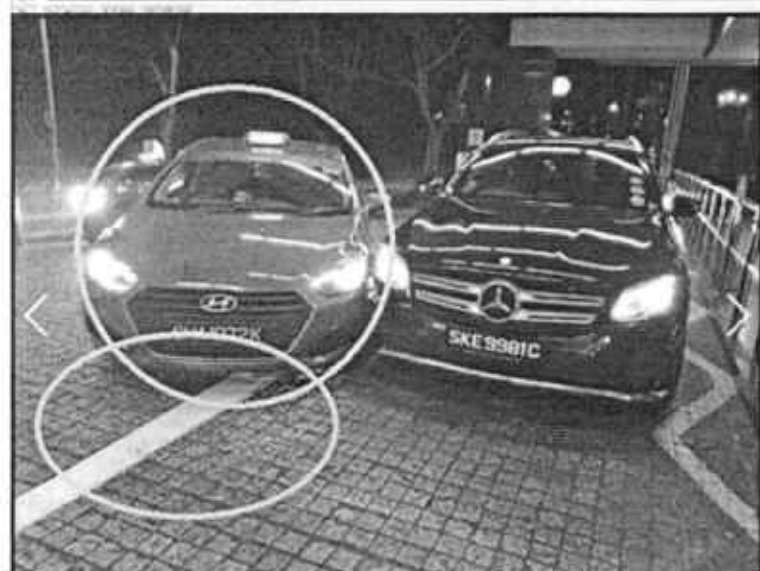
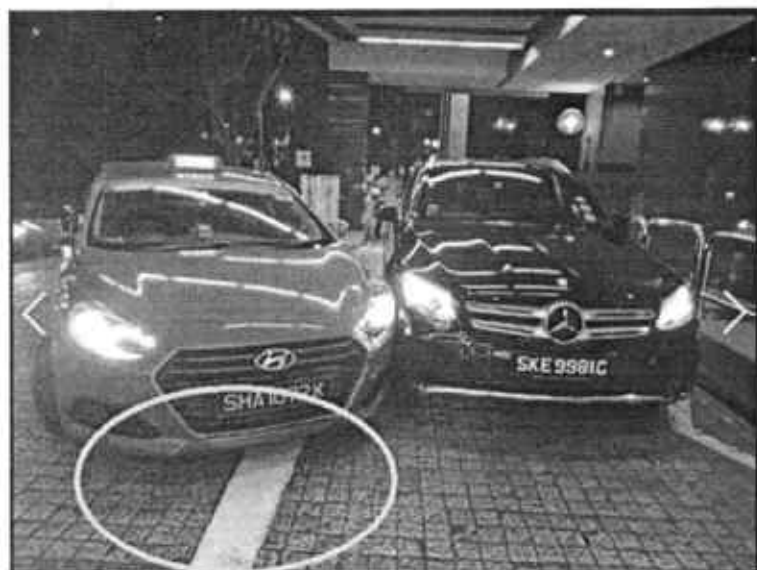
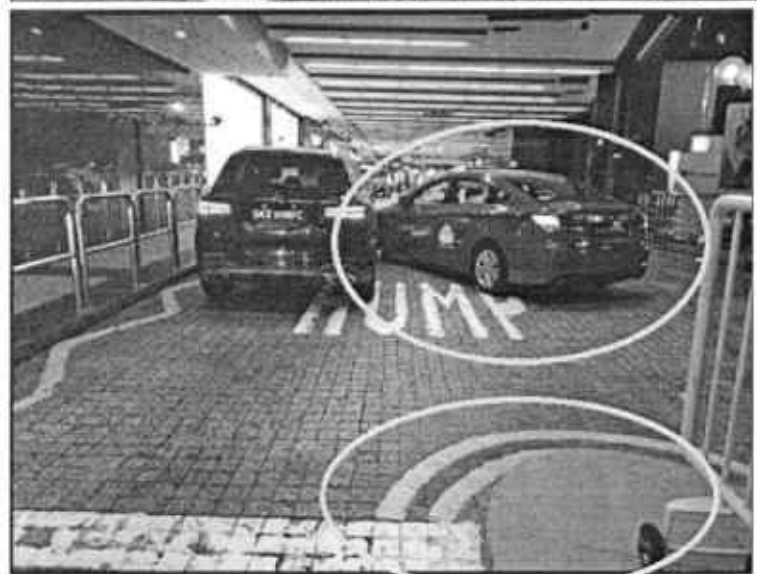
Before my customer get into the Takashimaya gateway, your insured in-front still have 2-3 vehicles to turn into Takashimaya gateway.

Photo showing the timing and all the vehicles in-front was travelling in their own lane even inside the gateway.

After checking for the oncoming vehicle to clear in my customer path. He manage to move out in safe.

But out of sudden, your insured drive into my customer lane and hit onto my customer car right front portion. Causing the tyre rim got scratches.

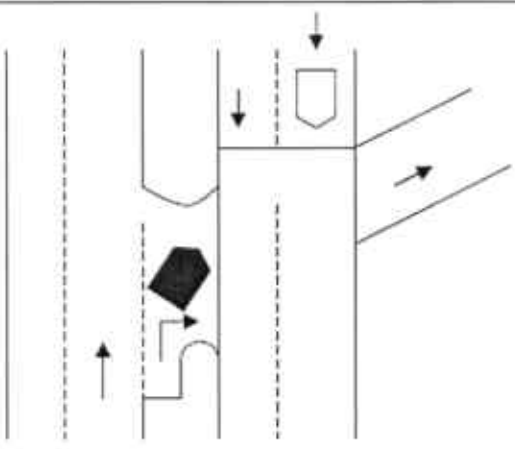
| 2. | | <p>Vehicle X – Turning Out from Side Road<br/>Vehicle Y – Moving Straight Ahead</p> <p><b>Reason:</b> Vehicle making a turn at an intersection should exercise greater degree of care towards on-coming traffic</p> | 100% | 0% |

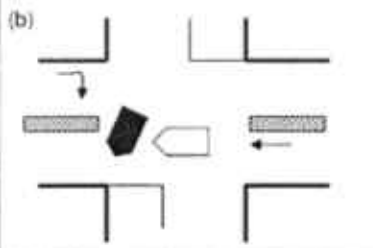
| 11. | (a)<br> | <p>Vehicle X – U-turning<br/>Vehicle Y – Moving Straight Ahead</p> <p>*All U-turns (legal / illegal), or turns not prohibited by road markings.</p> | 100% | 0% |
| 11. | (b)<br> | <p><b>Reason:</b> All vehicles making turn or u-turn across main road must exercise greater caution.</p> | | |
