# LKK Auto Consultants Pte Ltd

**Preliminary Advice**

Insured Vehicle No	: SJL1324C		
TP Vehicle No	: SLE3659L	Accident Date	: 20/05/2018
Make	: BMW 420I COUPE	Assignment Date	: 23/05/2018
Date of Inspection	: 23/05/2018	Est. Duration of Repair	: 6.00
Inspection At	: PERFORMANCE MOTORS LIMITED (ALEXANDRA) 303 ALEXANDRA ROAD, SIME DARBY PERFORMANCE CENTRE SINGAPORE 159941

## VEHICLE DAMAGE INSPECTION REPORT

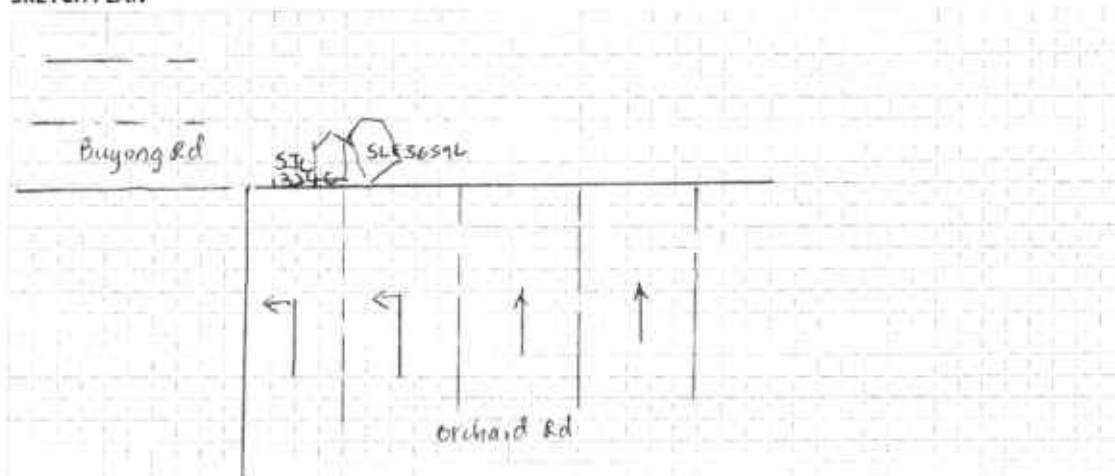
### SKETCH PLAN

Red Light Orchard Rd turning to Bayong Road  
SJC 1324C on extreme left lane  
SLE 3659L on second left turn lane  
Once Red light turn green, SLE365L start to move forward  
to turn left, SJC 1324C did not see on his right  
and not suppose to come to my lane. He said he  
wanted to go straight but was a turning lane.  
His car hit on my front left
