## VEHICLE DAMAGE INSPECTION REPORT

Our File No: CS/CTI18009370/T1QD3N2

Handling Insurer:	China Taiping Insurance (Singapore) Pte. Ltd.	Policy No:	DMPCSN1512131803
Claimant Vehicle No :	SLX4422X	Insured Vehicle No :	SGL1418B
Date of Loss:	19/05/2018	Nature of Claim:	TP
		Claim No:	SNM18D02568C02

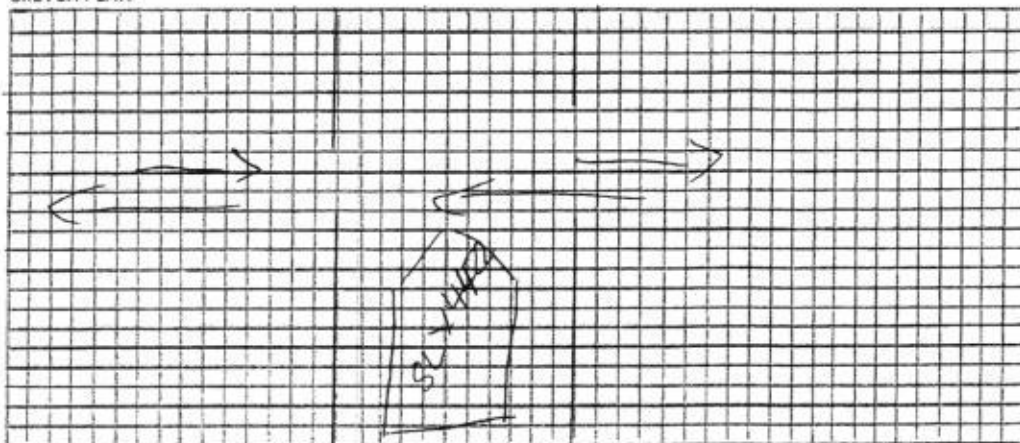
## SKETCH PLAN

SLX 4422 was parked at Currey Court Carpark on Saturday 19th May at about 1pm. When I returned from my shopping I noticed some scratches to the vehicle. I was informed by the security guard that another vehicle had damaged my vehicle as they drove off their car out of the lot.
