**Preliminary Advice**

Insured Vehicle No	: SJX7383D	Accident Date	: 21/05/2018
TP Vehicle No	: SLV9229R	Assignment Date	: 23/05/2018
Make	: BMW 216I	Est. Duration of Repair	: 3.00
Date of Inspection	: 04/06/2018		
Inspection At	: PERFORMANCE MOTORS LIMITED (ALEXANDRA) 303 ALEXANDRA ROAD, SIME DARBY PERFORMANCE CENTRE SINGAPORE 159941

The vehicle sustained impact / damages rear portion and parts claimed are consistent to the accident.

## VEHICLE DAMAGE INSPECTION REPORT

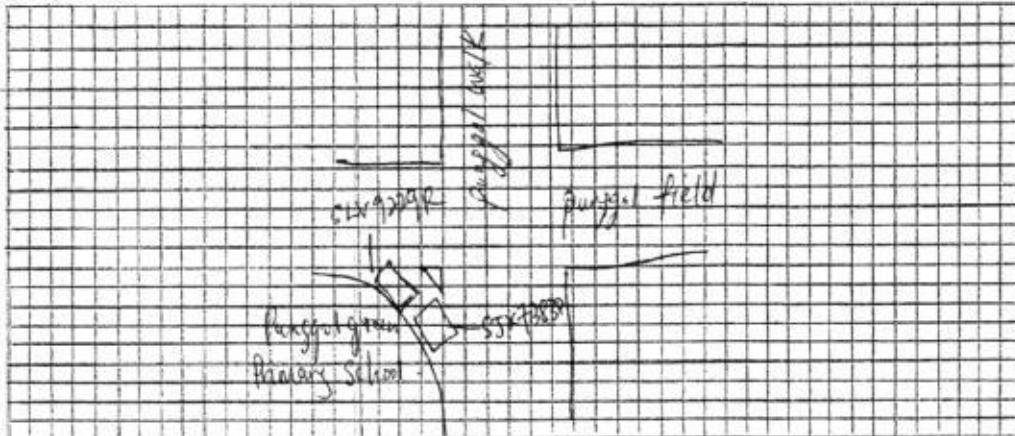
## SKETCH PLAN

On 21st May 2018 at around 0640am, I was travelling at Punggol walk turning toward Punggol field on my left. While turning left on the faster lane, I came to an stop because of on comingorry. Suddenly, ~~red~~ vehicle number SJX7383D knock my ~~rear~~ vehicle from behind. Please refer to video clip.
