AUTOMOBILE INSPECTION REPORT

VEHICLE REGISTRATION NO. : SDZ 8822 H **APPENDIX A**

VEHICLE DAMAGE INSPECTION REPORT

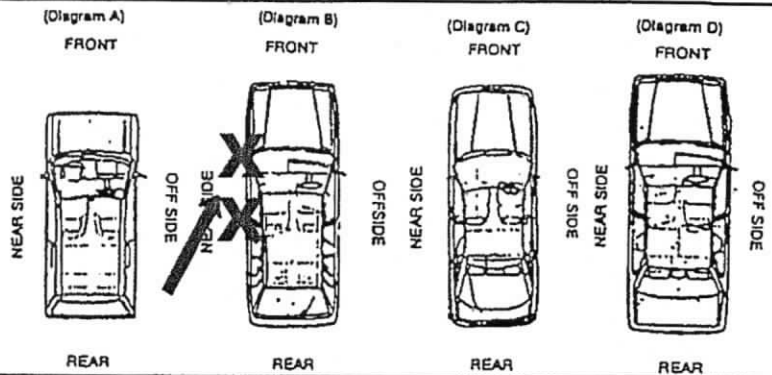
POINT OF IMPACT

The vehicle sustained impact on its N/s Front Portion. (see Diagram B)

The front n/s door, front n/s fender and mirror were dented.
