VEHICLE DAMAGE INSPECTION REPORT

Our File No: CS/MSG18009533/USD3E2

Handling Insurer: MSIG Insurance (Singapore) Pte. Ltd.	Policy No:	29053077MKC
Claimant Vehicle No : SLR9365B	Insured Vehicle No :	YP6443K
Date of Loss: 23/05/2018	Nature of Claim:	TP
		Claim No: 559205

Reg No:	SLR9365B	Engine No:	2ZR1984730
Make & Model:	TOYOTA PRIUS ALPHA HYBRID, 1.8 S CVT (A)	Chassis No:	ZVW400026003
Reg. Date:	31/08/2017 (Man. Year: 2017)	Odometer:	71732 km
Colour:	Blue		
Engine Capacity:	1797 cc		
Market Value/New Car Price:	N/A		
Sum Insured (S\$):	Market Value/New Car Price

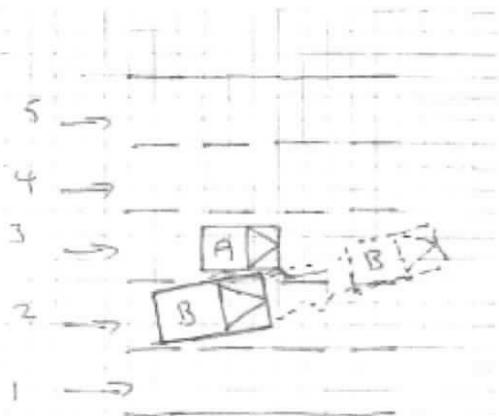
SKETCH PLAN

VEHICLE A - SLR 9365B
 VEHICLE B - SP6443K

I WAS TRAVELLING ALONG THE TOWARDS CHANGE DIRECTION,
 I WAS ON THE THIRD LANE.

WHILE TRAVELLING FORWARD IN MY LANE, SUDDENLY I HEARD
 A LOUD SOUND AND FOLLOW WITH A IMPACT FROM THE RIGHT
 SIDE OF MY VEHICLE, AND REALIZED THE RIGHT SIDE MIRROR
 OF MY VEHICLE WAS TOTALLY DAMAGED.

ALIGHTED FROM MY VEHICLE AND REALIZED IT WAS A TRUCK
 BEARING (SP 6443K) THAT HIT ONTO THE RIGHT SIDE REGION
 OF MY VEHICLE WHEN HE CUTTED INTO MY LANE FROM
 SECOND LANE, (LANE 2).
