Preliminary Advice

Insured Vehicle No	: SKZ5091L		
TP Vehicle No	: PC2328L	Accident Date	: 22/05/2018
Make	: NISSAN URVAN	Assignment Date	: 28/05/2018
Date of Inspection	: 25/05/2018	Est. Duration of Repair	: 6.00
Inspection At	: FASTECH AUTO PTE LTD (HQ) 1 KAKI BUKIT AVE 6, #01-46/48/50 AUTOBAY SINGAPORE 417883

VEHICLE DAMAGE INSPECTION REPORT

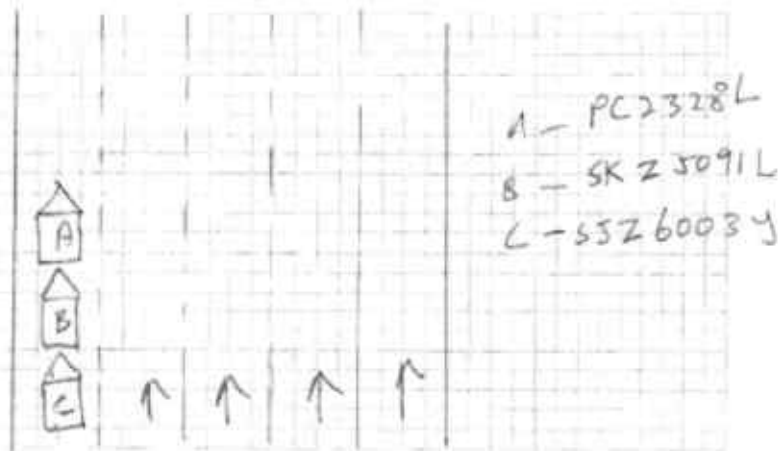
SKETCH PLAN

On 27/5/2018 at 7.50am, I was driving my vehicle A along Thomson Road. I stop my car due to in front vehicle stop. Suddenly vehicle B hit on my rear portion. There were 3 cars involving in an accident. I felt double impact.
