# LKK Auto Consultants Pte Ltd

Ref : CS/GAI18009625/Utd3

**PRELIMINARY ADVICE OF VEHICLE NO. GBF 270G .**

## ADJUSTMENT ON REPAIR COST FOR VEHICLE NO. GBF 270G

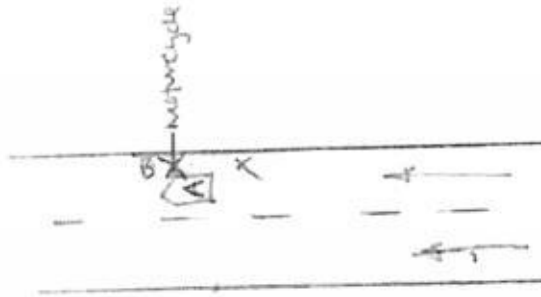
SKETCH PLAN

I FILTERED TO THE RIGHT LANE.

As such, I changed my lane onto the right lane and out of a sudden, one black motorbike suddenly appeared which caused the right side of my lorry to hit against the motorbike. As a result, I jammed brake my lorry and the motorbike fell onto the road.

Due to impact, the lorry's right door suffered some dent and scratches with damages with the right mirror.
