**-PRE-REPAIR INSPECTION - ACCIDENT INVOLVING OUR INSURED VEHICLE
SDM980E AND SJV1154Z ON 24/5/2018**

ACCIDENT INVOLVING SJV1154Z & SDM980E ALONG CTE/SLE AFTER ANG MO KIO AVE 1 EXIT ON 24/05/2018 @ 20:50

VEHICLE DAMAGE INSPECTION REPORT

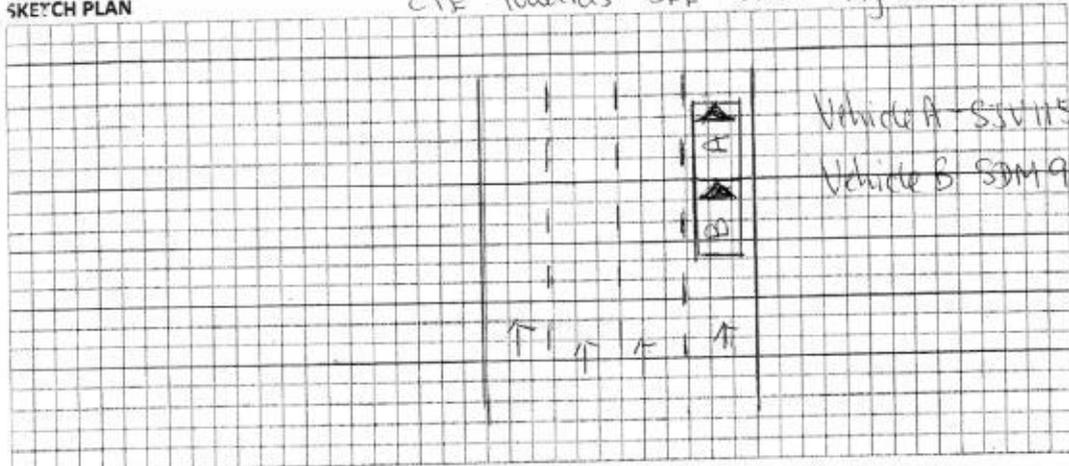
SKETCH PLAN

CTE towards STE after Ang Mo Kio Ave1 Exit

On the stated date and time, at the stated venue, I vehicle 'A' SJV 1154Z was travelling straight on my rightful lane. The vehicle in front of me slowed down, so I followed suit. Suddenly I felt a great impact on my rear portion. Vehicle 'B' SDM 980E had collided onto the rear portion of my vehicle.

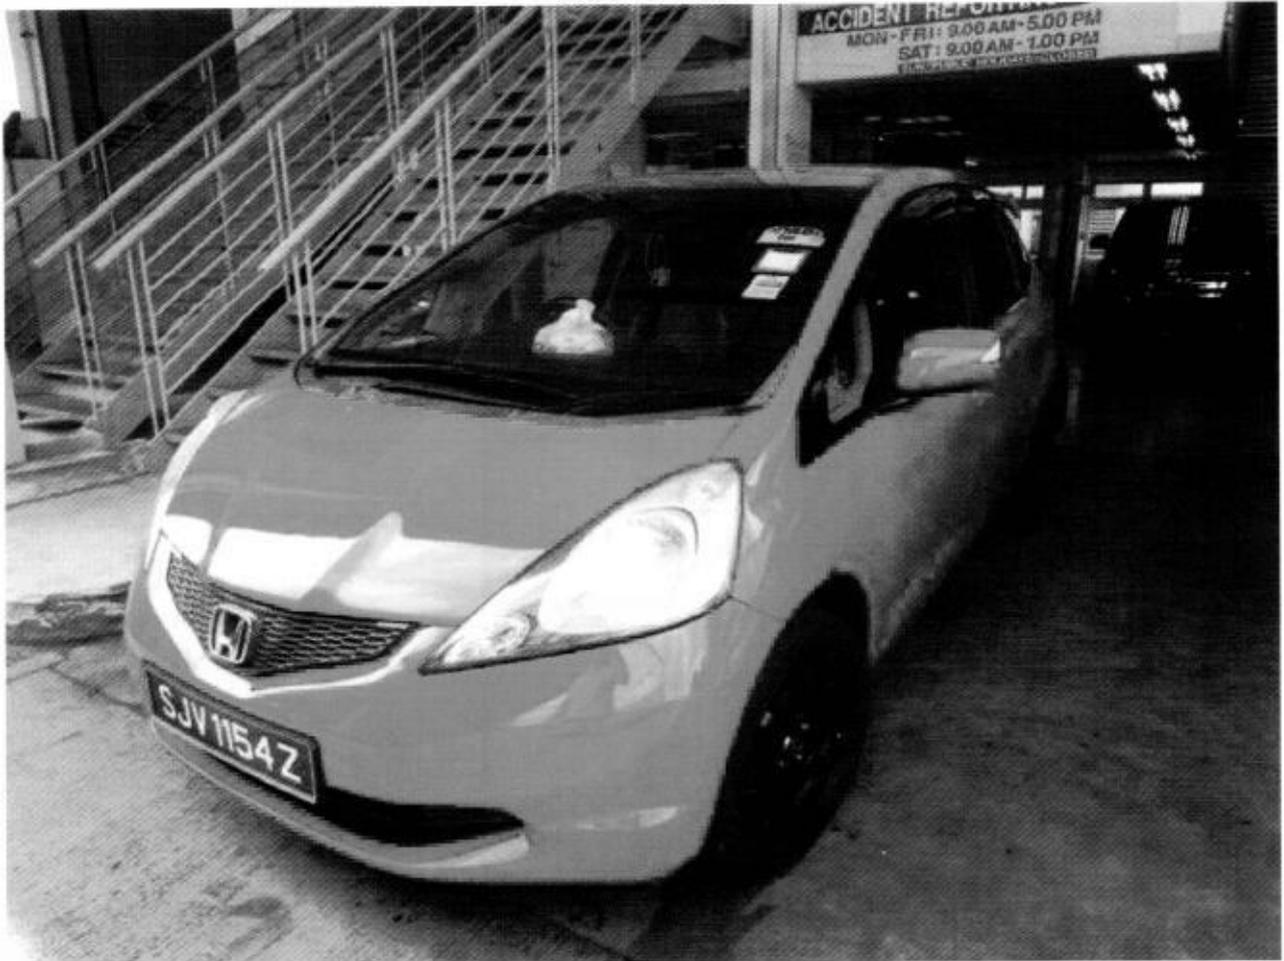
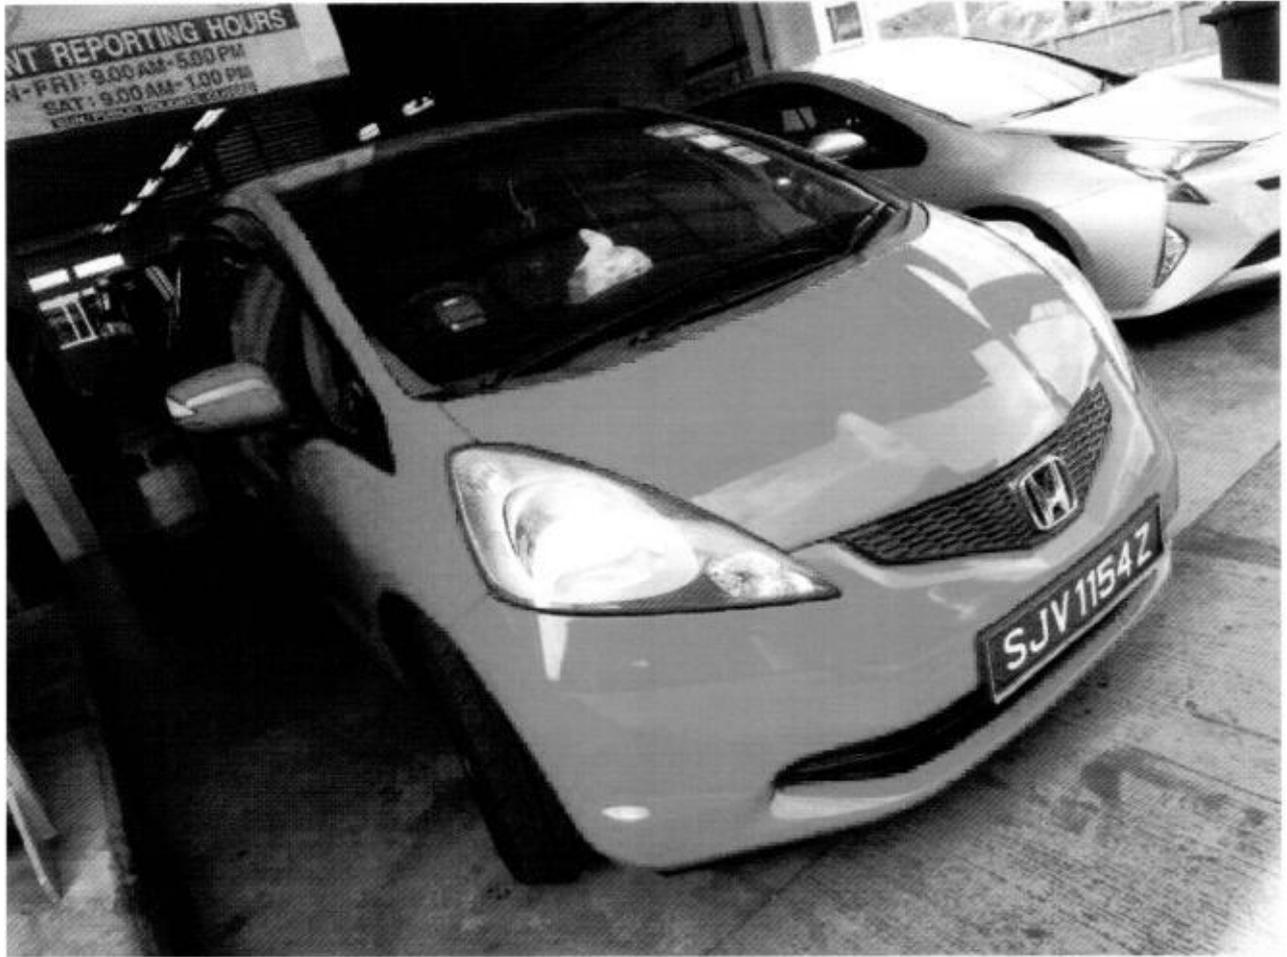
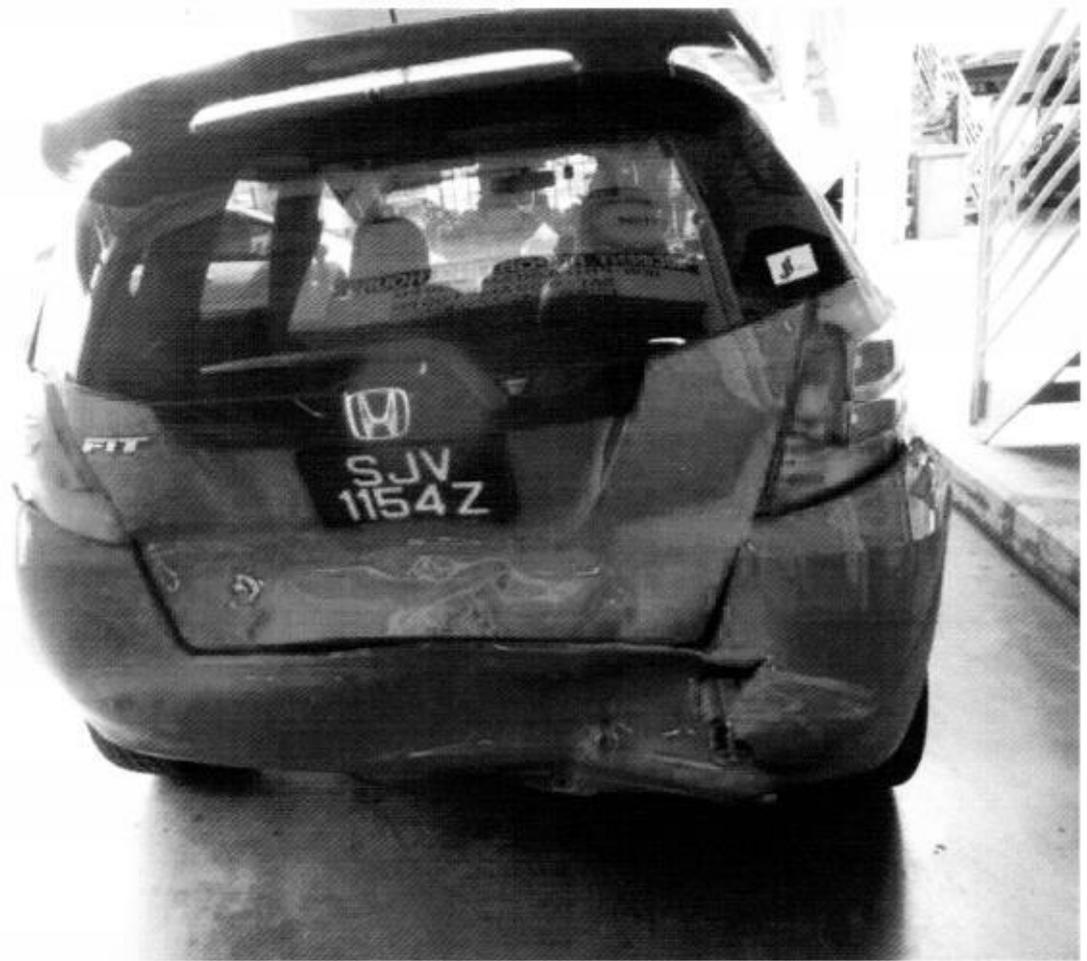
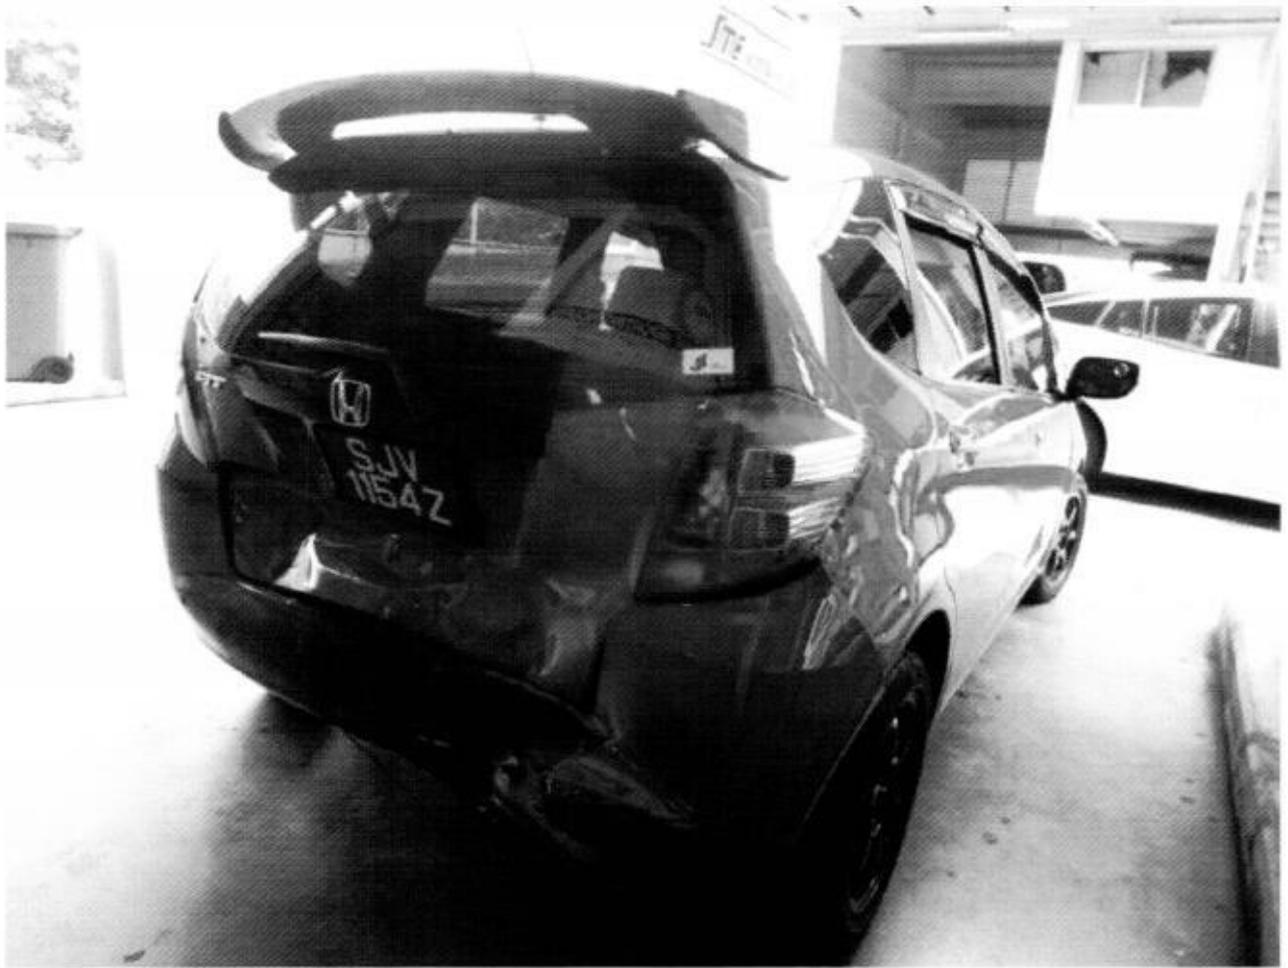
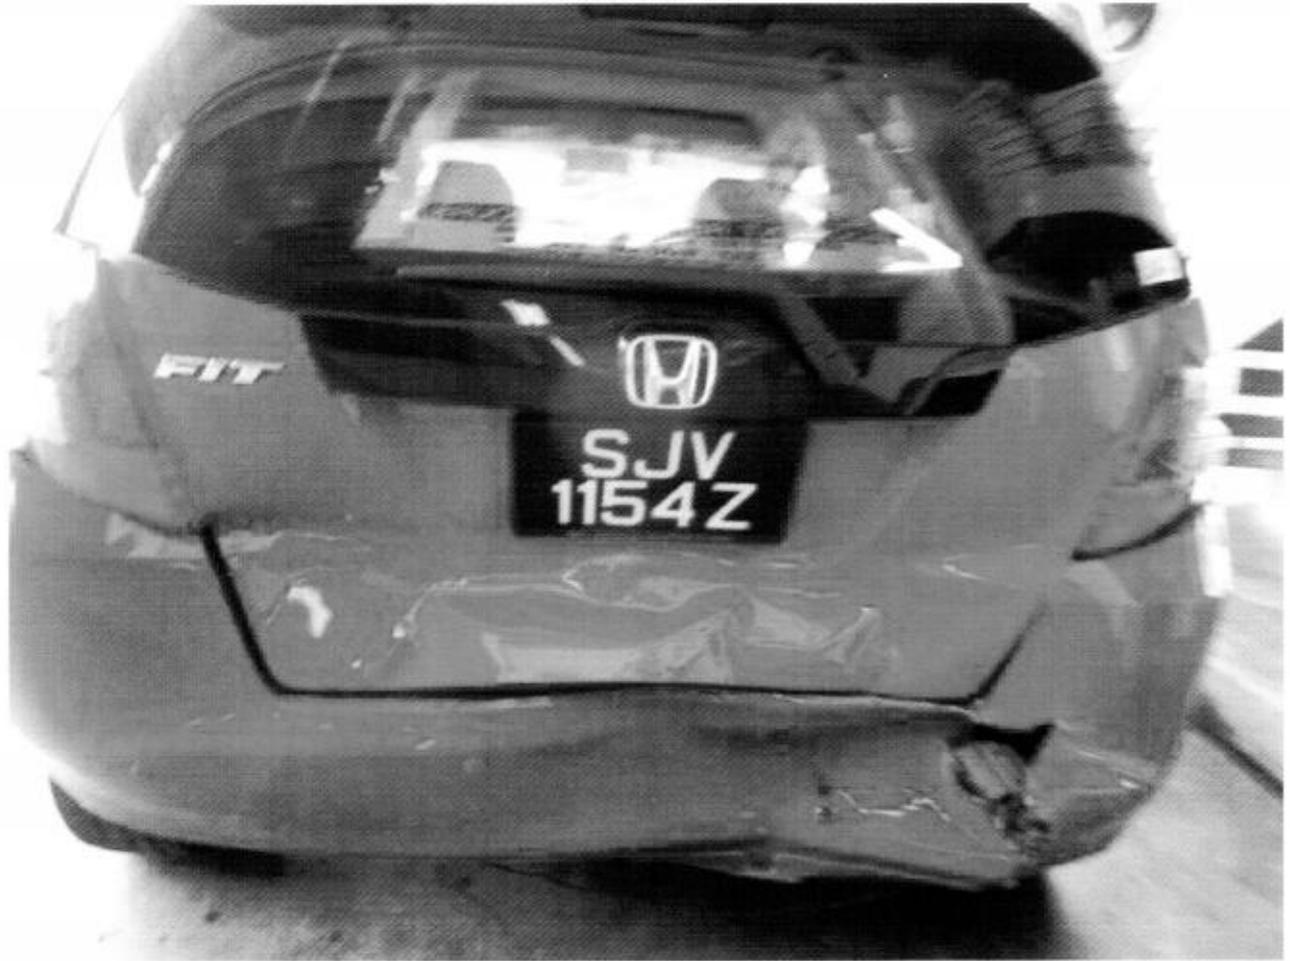
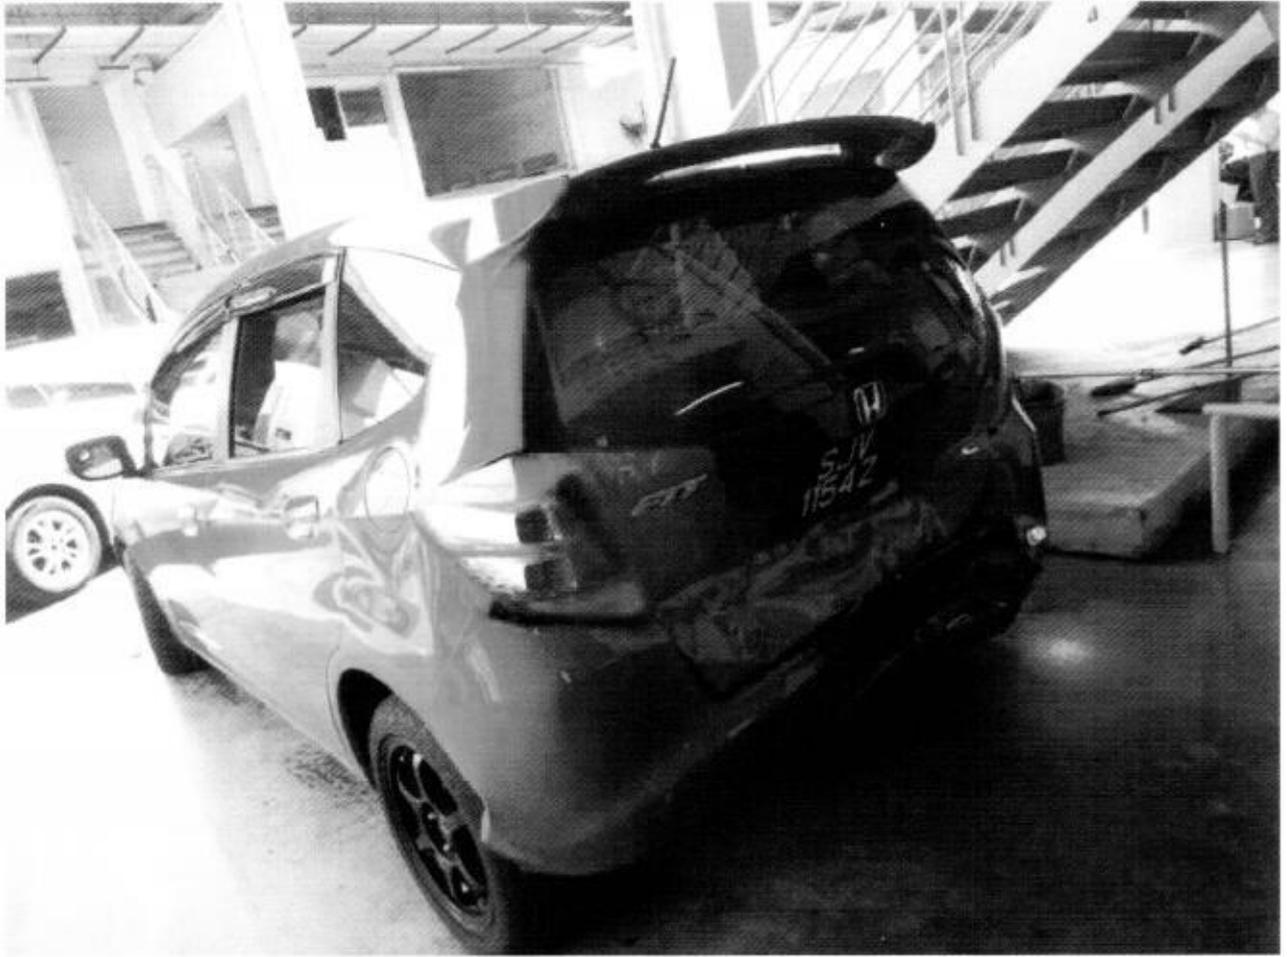
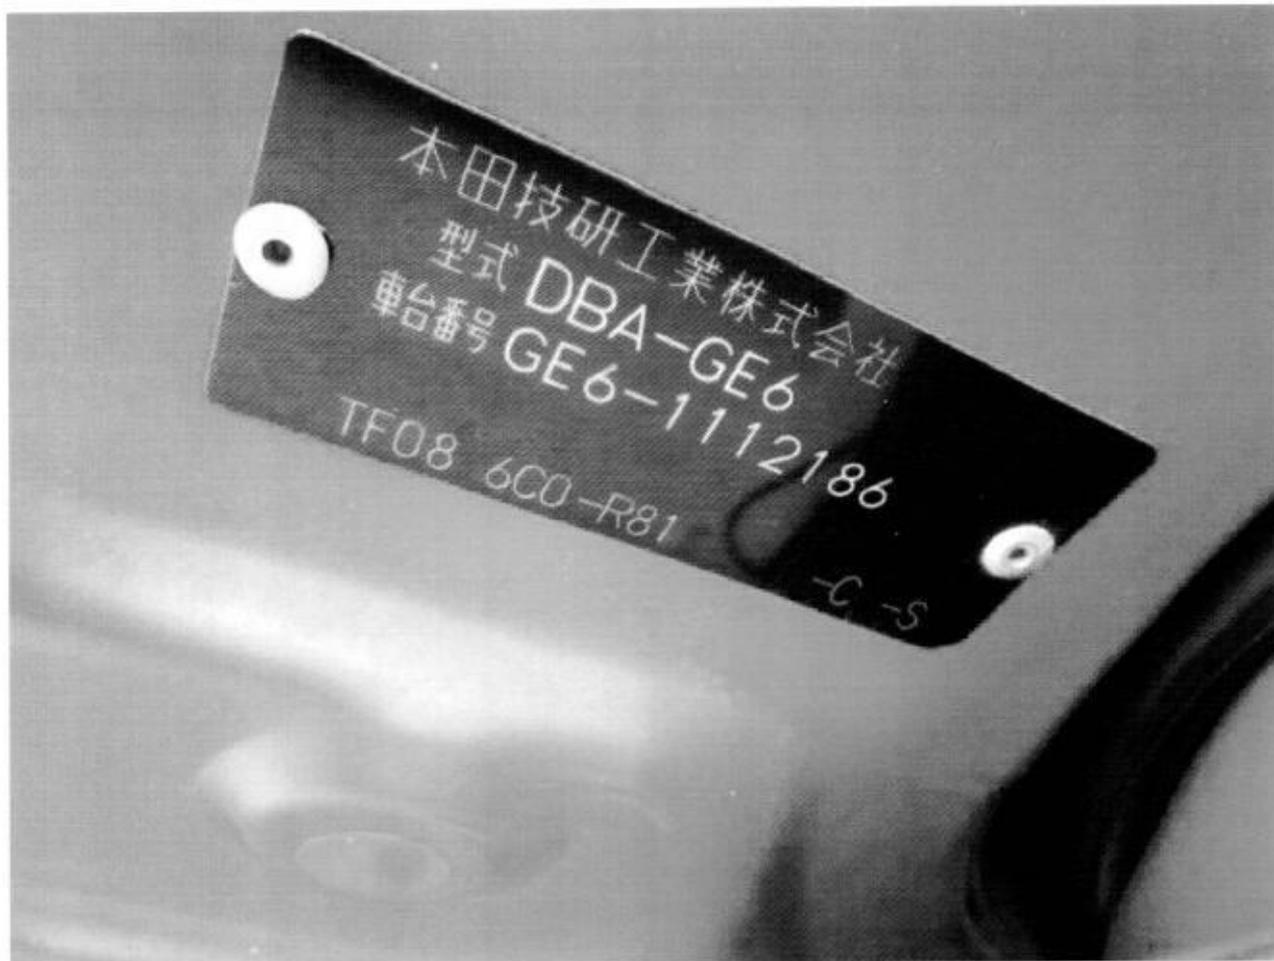
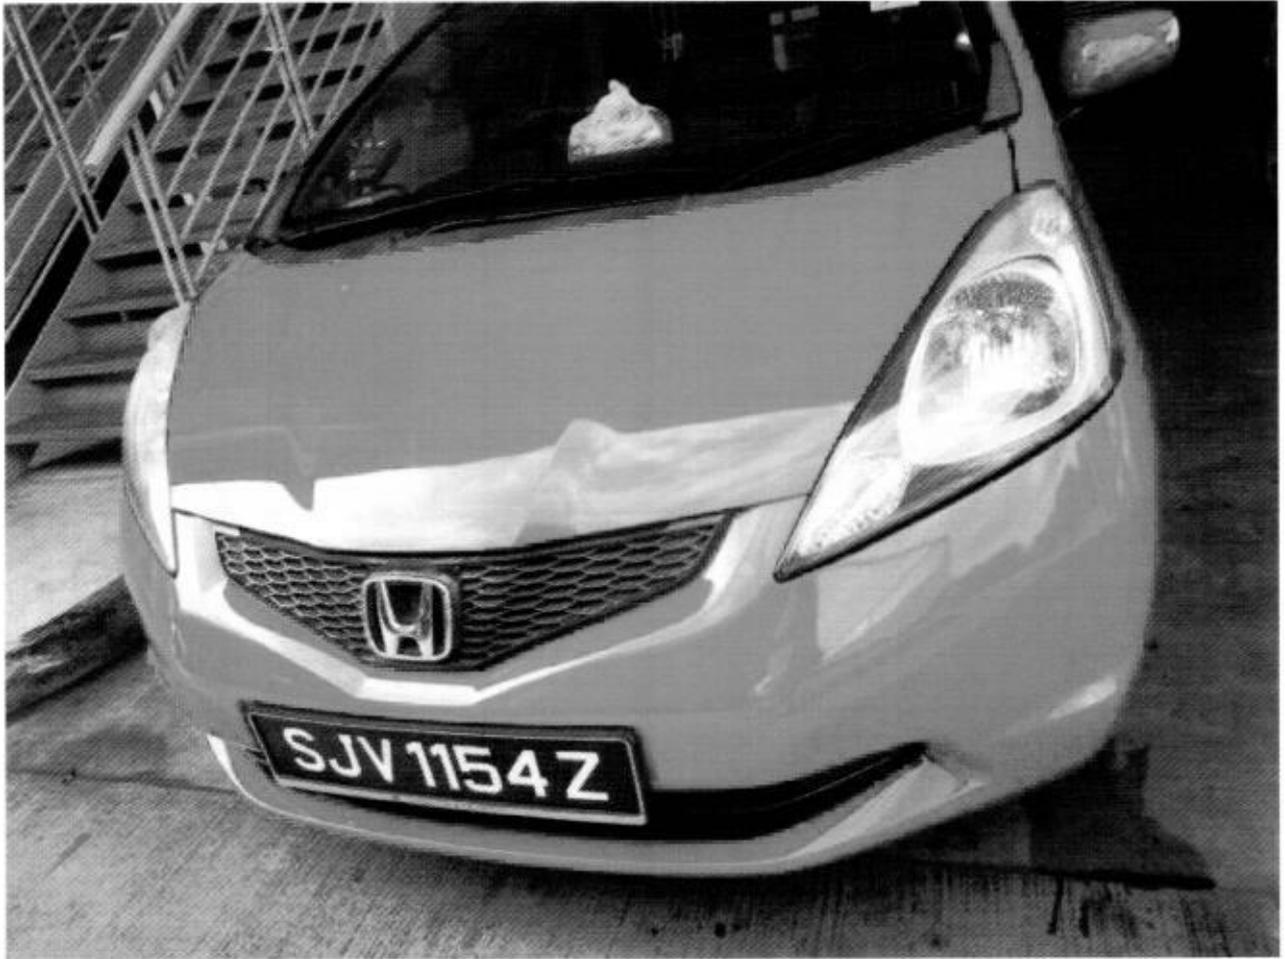
Accident Photo

ON THE STATED DATE AND TIME, AT THE STATED VENUE, VEHICLE A (SJV1154Z) WAS TRAVELLING STRAIGHT ON MY RIGHTFUL LANE. THE VEHICLE IN FRONT OF ME SLOWED DOWN, SO, I FOLLOWED SUIT. SUDDENLY, I FELT A GREAT IMPACT ON MY REAR PORTION. VEHICLE B (SDM980E) HAD COLLIDED ONTO THE REAR PORTION OF MY VEHICLE.

No.	Qty	Part No.	Particulars	Condition	Repairer's	Amount
1	1		*REAR NUMBER PLATE	Bent	0.00 F	*-F
2	1		*REAR NUMBER PLATE BASE	Deformed	0.00 F	*-F
3	1		*REAR BUMPER	Deformed	0.00 F	*-F
4	1		*REAR BUMPER TOW COVER	Broken	0.00 F	*-F
5	1		*REAR BUMPER CLIPS	Necessary	0.00 F	*-F
6	2		*REAR BUMPER SIDE RETAINER	Necessary	0.00 F	*-F
7	1		*REAR BUMPER REINFORCEMENT	Dented	0.00 F	*-F
8	1		*REVERSE SENSOR	Damaged	0.00 F	*-F
9	1		*REAR END PANEL	Dented	0.00 F	*-F
10	1		*REAR END PANEL TOP GARNISH	Deformed	0.00 F	*-F
11	1		*REAR LH TAILLAMP	Cracked	0.00 F	*-F
12	1		*REAR RH TAILLAMP	Cracked	0.00 F	*-F
13	1		*TAILGATE	Buckled	0.00 F	*-F
14	2		*TAILGATE EMBLEM	Necessary	0.00 F	*-F
15	1		*TAILGATE OUTER HANDLE	Deformed	0.00 F	*-F
16	1		*TAILGATE INNER TRIM BOARD	Deformed	0.00 F	*-F
17	1		*TAILGATE WIPER MOTOR	Not Working	0.00 F	*-F
18	1		*TAILGATE GLASS MOULDING	Necessary	0.00 F	*-F
19	1		*TAILGATE GLASS SEALANT	Necessary	0.00 F	*-F

20	1		*TAILGATE LOCK	Bent	0.00 F	*-F
21	1		*TAILGATE RUBBER	Twisted	0.00 F	*-F
22	1		*SPARE TYRE BOARD	Deformed	0.00 F	*-F
23	1		*SPARE TYRE PANEL	Distorted	0.00 F	*-F
24	1		*REAR EXHAUST PIPE	Bent	0.00 F	*-F
25	2		*REAR EXHAUST MOUNTING	Bent	0.00 F	*-F
26	1		*REAR EXHAUST HEAT SHIELD	Buckled	0.00 F	*-F
27	1		*REAR LH CHASSIS MEMBER	Repair	0.00 F	*-F
28	1		*REAR RH CHASSIS MEMBER	Repair	0.00 F	*-F
29	1		*REAR LH FENDER	Buckled	0.00 F	*-F
30	1		*REAR LH FENDER INNER TRIM	Deformed	0.00 F	*-F
31	1		*REAR LH FENDER INNER SHIELD	Deformed	0.00 F	*-F
32	1		*REAR RH FENDER	Buckled	0.00 F	*-F
33	1		*REAR RH FENDER INNER TRIM	Deformed	0.00 F	*-F
34	1		*REAR RH FENDER INNER SHIELD	Deformed	0.00 F	*-F
35	1		*SPEAKER BOARD	Deformed	0.00 F	*-F
