AUTO & GENERAL INSURANCE (S) PL

Ref : CS/AGI18009855/Kvd3

1. Policy Particulars :- THIRD PARTY CLAIM

ADJUSTMENT ON REPAIR COST FOR VEHICLE NO. SJG 2099Y

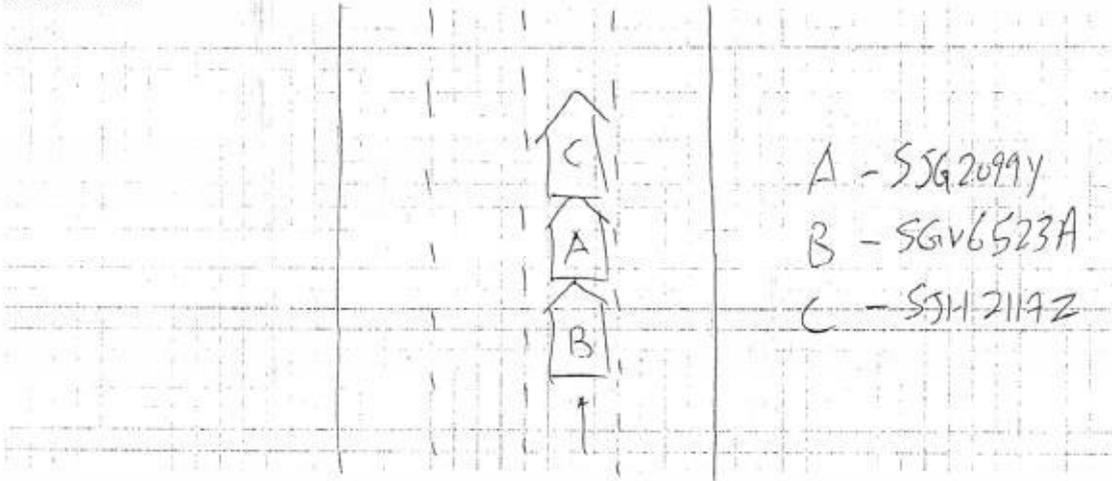
SKETCH PLAN

DESCRIBE CIRCUMSTANCES OF THE ACCIDENT

I was travelling on PIE along Bendiner Rd and taking Exit suddenly the car in front of me got brake. I managed to stop behind in time but suddenly behind me bang into me and my car was push forward and then gently touch the car in front of me.
