To: MSIG Insurance (Singapore) Pte. Ltd. 4 Shenton Way #21-01 SGX Centre 2 Singapore 068807	From: LKK Auto Consultants Pte Ltd 51 Ubi Ave 1 #01-25 Paya Ubi Industrial Park Singapore 408933
Attn: Eliza Ho Teng Boon	Date: 26 Jul 2018
<u>Preliminary Advice</u>

Vehicle No	: SJF3719R	Accident Date	: 25/05/2018
Make	: VOLVO V70	Policy No.	: D27098633QMY
Assignment Date	: 30/05/2018	Excess	: S\$1,500.00
Date of Inspection	: 31/05/2018	Est. Duration of Repair	: 5.00
Inspection At	: SPECIALISTS MOTOR PTE LTD (HQ) BLK 3018A UBI ROAD 1, #01-24/25/26 SINGAPORE 408711

VEHICLE DAMAGE INSPECTION REPORT

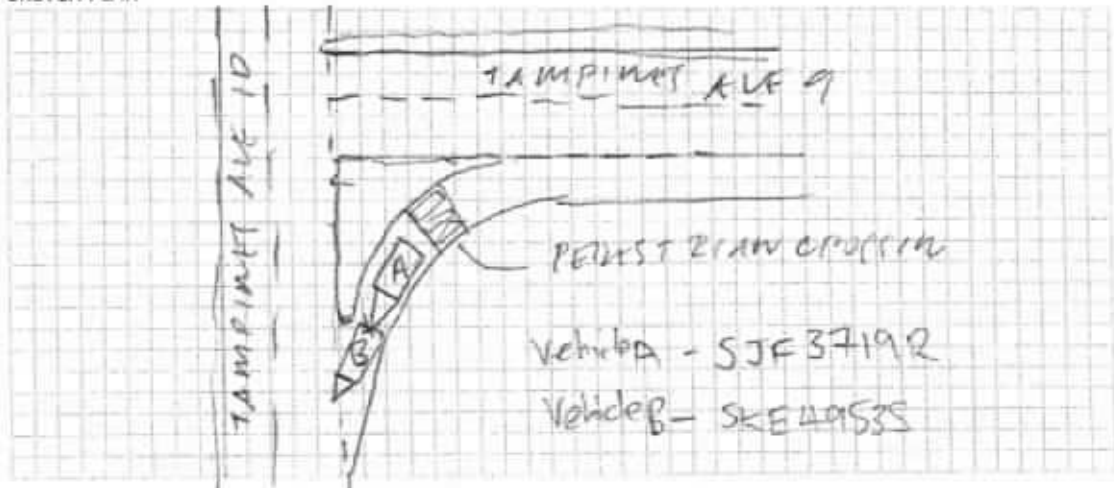
SKETCH PLAN

At 8am, I was turning left from Tampines Ave 9 into Tampines Ave 10. The car in front (SKE49535) Toyota Fortuner braked suddenly, and I was unable to brake in time to avoid contact.
