## VEHICLE DAMAGE INSPECTION REPORT

**Our File No:** CS/TMI18009868/K1TD3S2  
**Date:** 02/07/2018

Handling Insurer:	Tokio Marine Insurance Singapore Ltd	Policy No:	MV003144
Claimant Vehicle No :	SHC1011B	Insured Vehicle No :	SKR274B
Date of Loss:	26/05/2018	Nature of Claim:	TP
		Claim No:	M1802668

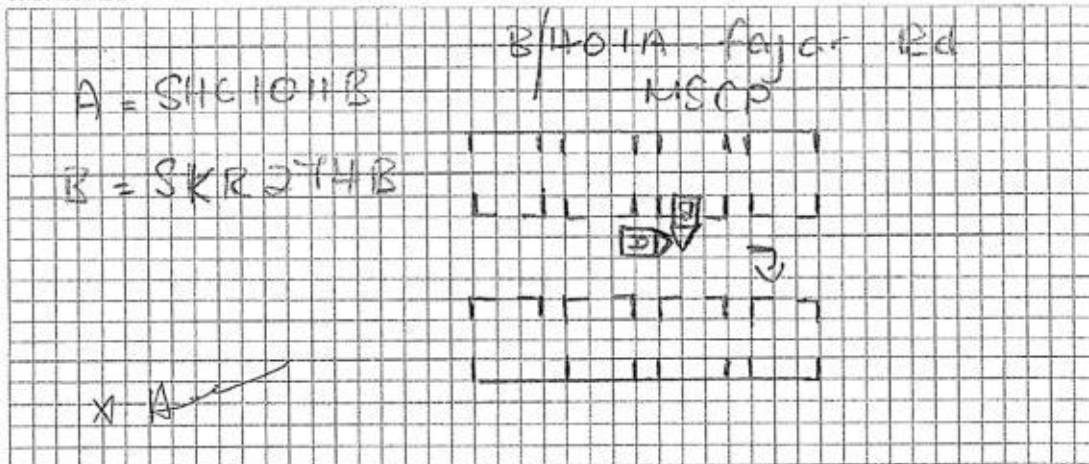
## SKETCH PLAN

On 26/5/18 @ abt 1830hrs, I was driving straight at above location. Suddenly a car SKR274B drove out of the parking lot hit the front left portion of my taxi. No pax on board & no one is injured at the point of accident.
