Vehicle No	: SCW2808S	Accident Date	: 28/05/2018
Make	: BMW 218i	Policy No.	: 27855060SMP
Assignment Date	: 31/05/2018	Excess	: S\$500.00
Date of Inspection	: 31/05/2018	Est. Duration of Repair	: 12.00
Inspection At	: PERFORMANCE MOTORS LIMITED (ALEXANDRA) 303 ALEXANDRA ROAD, SIME DARBY PERFORMANCE CENTRE SINGAPORE 159941

Point of Impact / General Description of Damages

The vehicle sustained impact / damages front portion and parts claimed are consistent to the accident.

VEHICLE DAMAGE INSPECTION REPORT

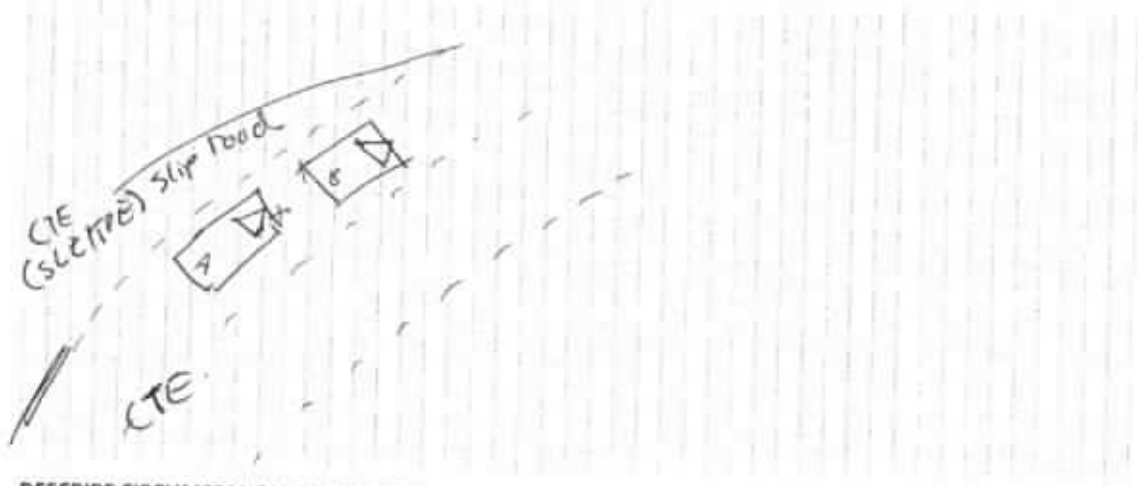
SKETCH PLAN

DESCRIBE CIRCUMSTANCES OF THE ACCIDENT

Was driving on CTE (SLEET/PE) Slip Road onto CTE. CAR in front of taxi stopped suddenly and causing taxi to stop suddenly. Was not able to stop in time as I was checking side mirror at the time first car stopped.
