## VEHICLE DAMAGE INSPECTION REPORT

Our File No: CS/MSG18009943/KRD3Q2

Claimant Vehicle No: SLP2694H

Reg No: SLP2694H

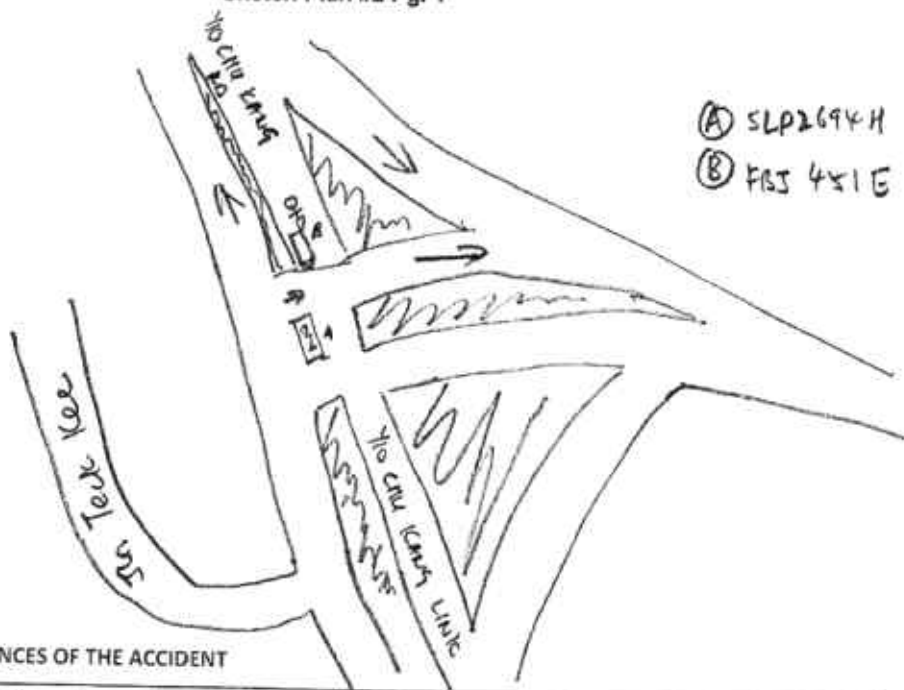
### SKETCH PLAN

On 30/05/18 at about 1330, I was travelling along Yio Chu Kang Road towards Yio Chu Kang Link on the extreme right lane <sup>when</sup> approaching the traffic junction, traffic lights turned from amber to red. I slowed down my vehicle preparing to stop. I noticed from the rear mirror motorbike FBJ 451E approaching at a very fast speed. I drove my car slightly forward. However the motorbike still hit on the rear left portion of my car causing damages.
