PRELIMINARY ADVICE OF VEHICLE NO. XE 1265K .

1. Policy Particulars :- THIRD PARTY CLAIM				
Insured Veh.	FORKLIFT		Veh. Inspected	XE 1265K
Policy No.			Coverage (\$)	0.00
Claim No.	AR2018/00177		Excess (\$)	0.00
Assign From	JESSIE SIM		Assign Date	31/05/2018

ADJUSTMENT ON REPAIR COST FOR VEHICLE NO. XE 1265K

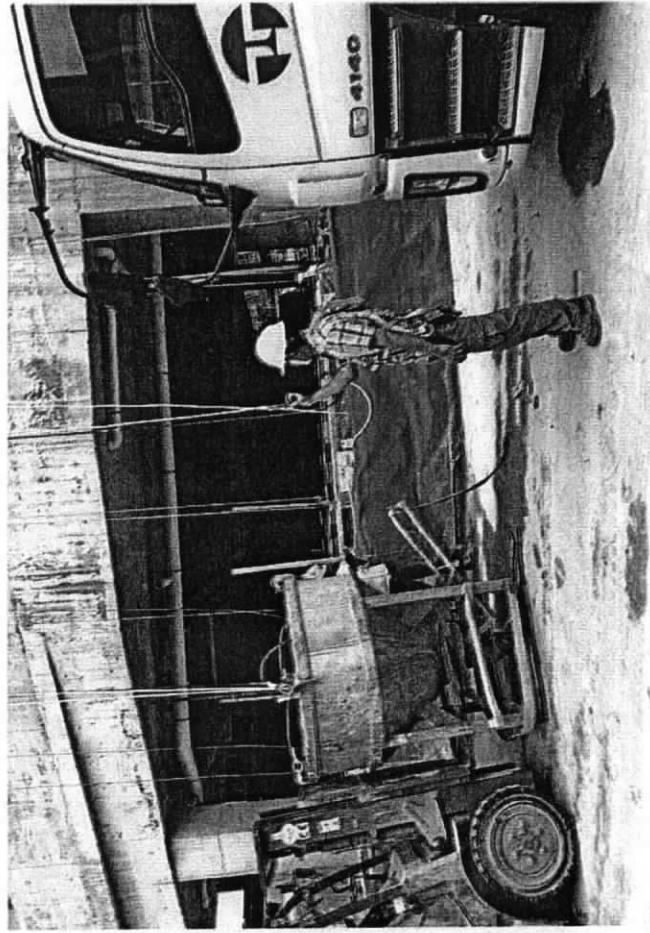
On 23.05.2018 at 6.20pm I was unloading the steel plate at Jurong west street 41 (Lakegrande site), Suddenly I heard big sound from my vehicle that time the Main con forklift carry with concrete bucket to hit my vehicle front side. My Vehicle got damaged front side.

Date: 23/05/2018. Time: 06.10 PM

Place: Lake Garden (China on site)

@ Juvong west Street 41.

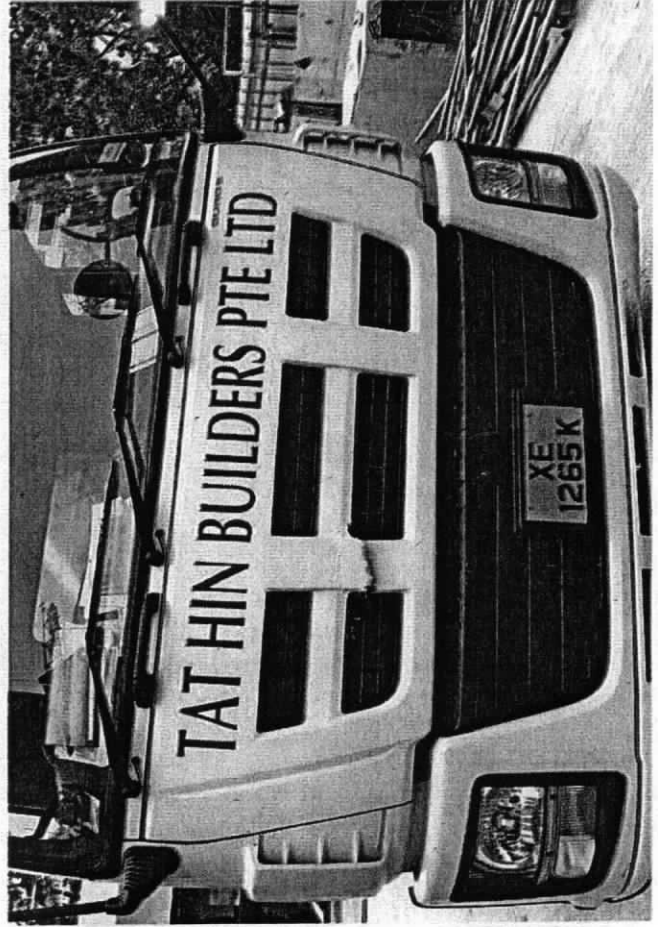
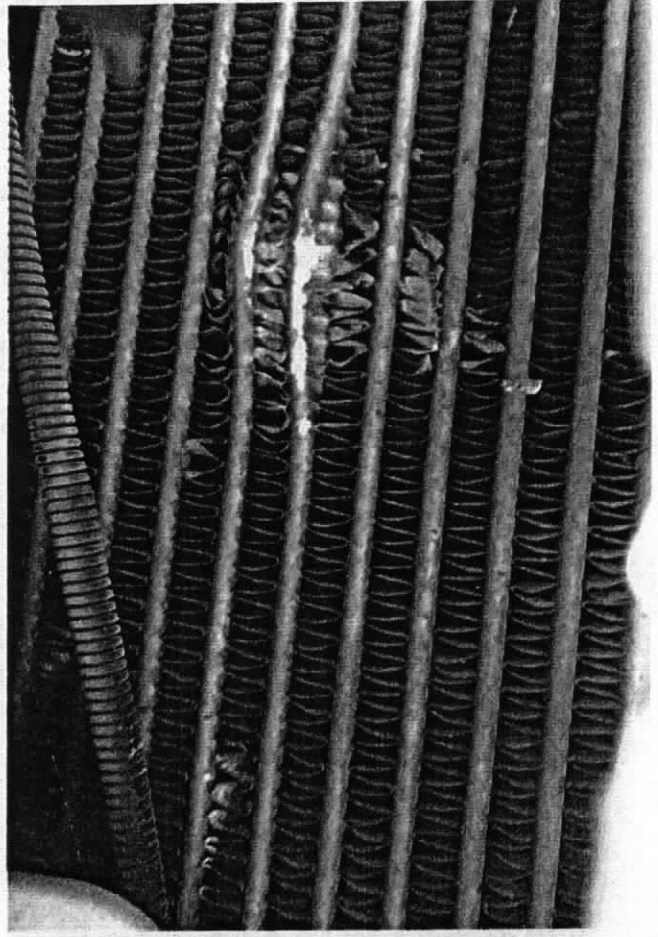
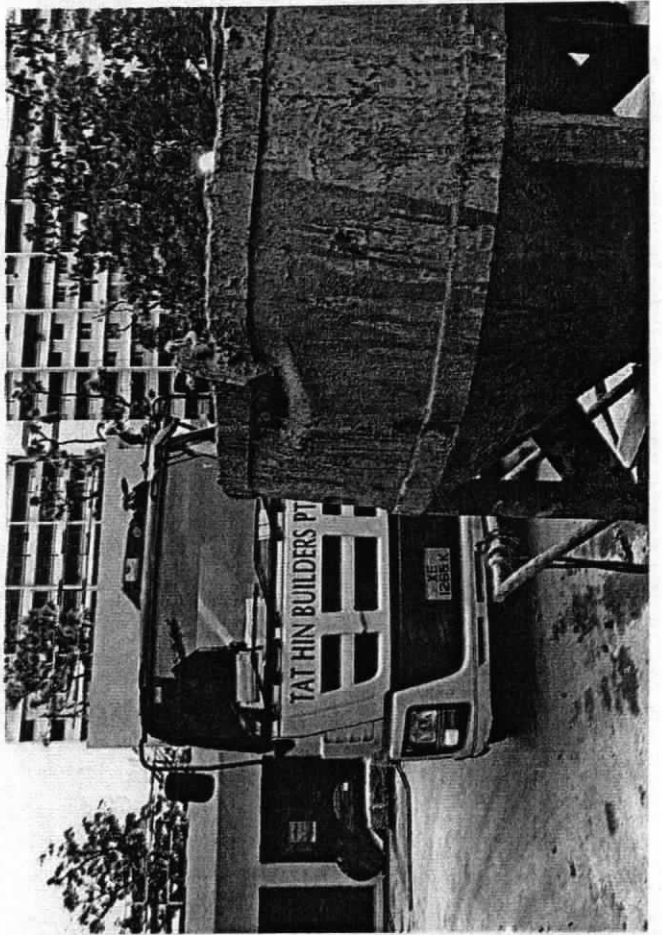
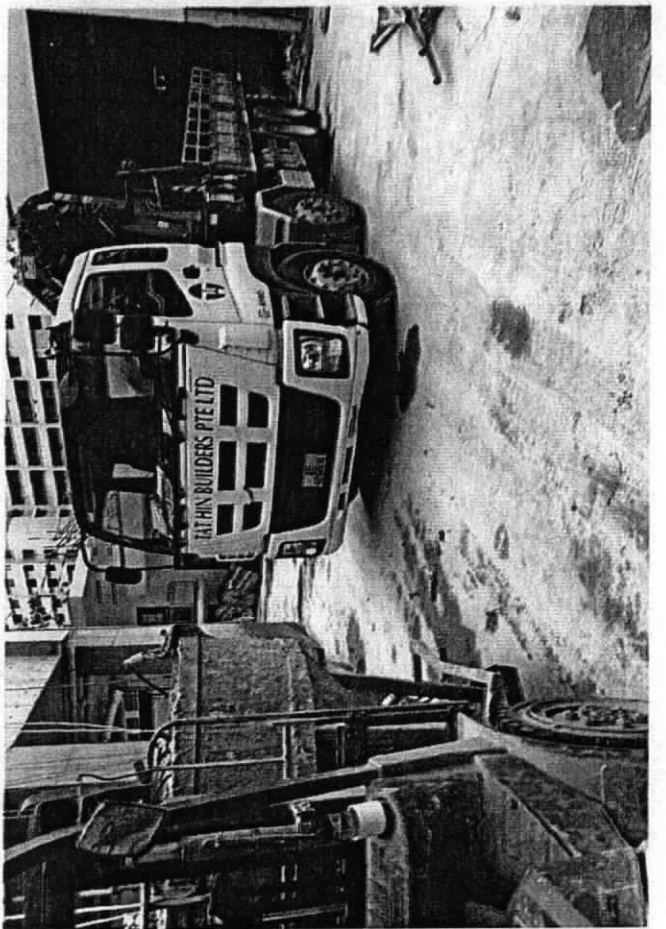
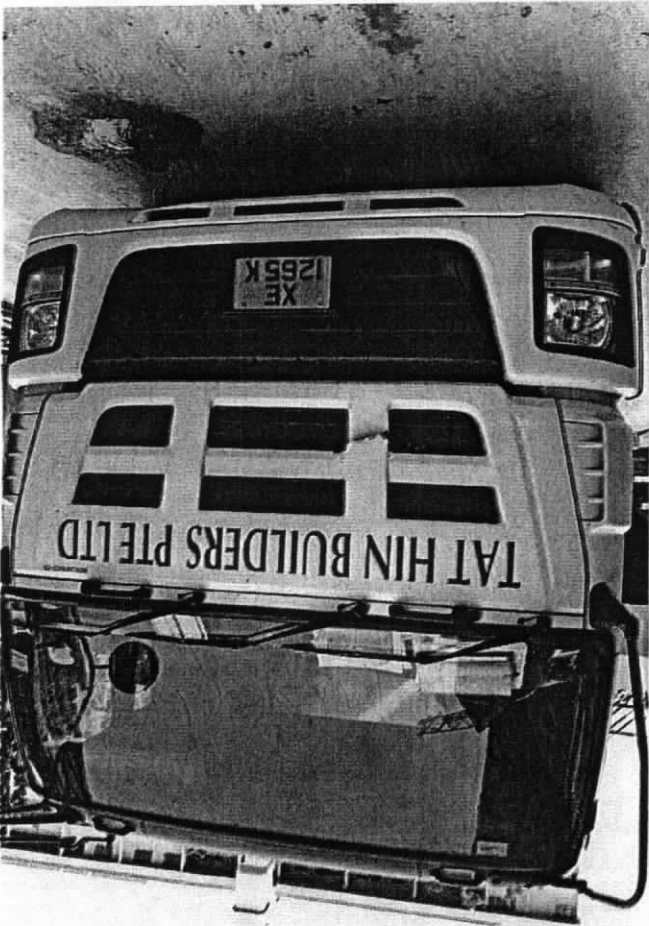
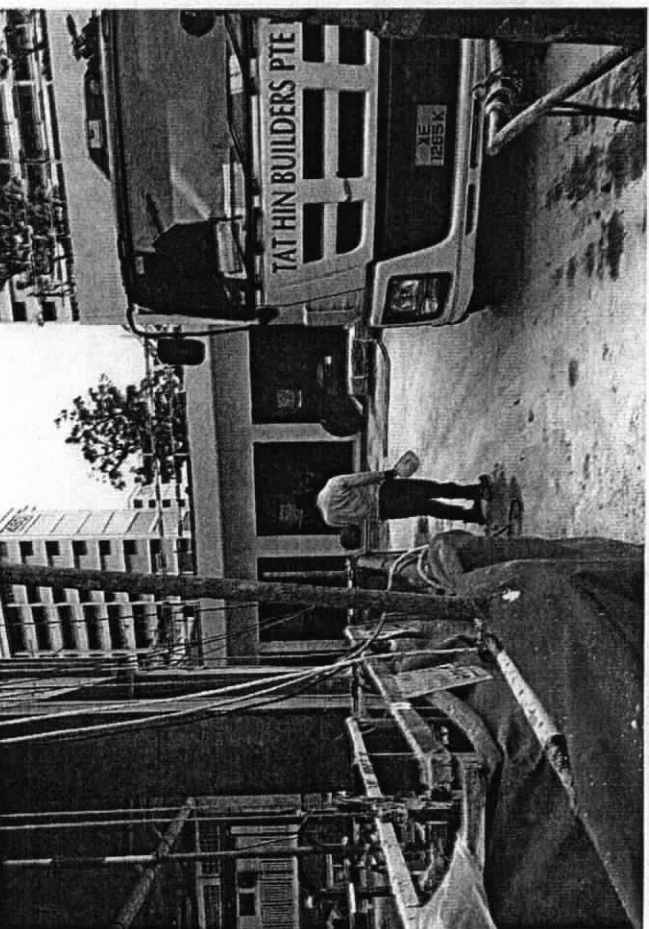
The vehicle sustained damages at the front portion.

4. Description of Damages				
THE VEHICLE SUSTAINED DAMAGES AT THE FRONT PORTION. DAMAGES SEE DETAILS.				
5. General Information				
Accident Date	23/05/2018		Inspection Date	04/06/2018
Survey held at	TRIANGLE AUTO PTE LTD 20 TUAS AVE 2 . SINGAPORE 639451			
5a. Remarks				
A)THE INSPECTION WAS CONDUCTED ON A"WITHOUT PREJUDICE" BASIS. B)IN ACCORDANCE TO YOUR INSTRUCTIONS, WE HAVE NOT AUTHORISED REPAIRS.				
5b. Estimate Days of Repair				
ESTIMATED NORMAL PERIOD FOR REPAIR:			6 Working Days

Qty	Description of Parts	Condition	Estimate By Workshop (\$)	Our Adjusted (\$)
<u>REPLACEMENT OF PARTS</u>				
1	FRONT LID	CRACKED	1,533.00	1,533.00
1	GRILLE PAD	CRACKED	160.00	160.00
1	INTERCOOLER	DENTED	5,843.00	5,843.00
1	GRILLE RAD, RH	CRACKED	57.00	57.00
1	CAB TILT OIL CYLINDER	* CHECK	1,952.00	-
1	HEIGHT SENSOR	DISTORTED	231.00	231.00
1	GRILLE PAD, LH	NOT NECESSARY	57.00	-
	LESS 20% DISCOUNT		-1,966.60	-1,564.80
			7,866.40	6,259.20
<u>SPECIAL NETT ITEMS</u>				
1	FRONT DECAL (COMPANY NAME) (SN)	NECESSARY	120.00	120.00

120.00	120.00
<u>LABOUR</u>				
	CAB HYDRAULIC CYL - REPL.	* CHECK	56.00	-
	HEIGHT SENSOR, AIR CAB SUSPN, FRT - REPL.		60.00	60.00
	INTERCOOLER ASSY (TURBO) - R&R OR REPL.		92.00	92.00
	LESS 10% DISCOUNT		-20.80	-15.20
	CHECK & RECTIFY CAB FRONT WIRING.		120.00	120.00
	TROUBLE SHOOTING AND PERFORMANCE TEST.		180.00	180.00
	PANEL BEATING & FRONT LID REPLACEMENT.		285.00	285.00
	TO SPRAY PAINT FRONT LID.		400.00	400.00
	DIAGNOSIS WITH TECH II OR G-IDSS.		72.00	72.00
			1,244.20	1,193.80
GRAND TOTAL			9,230.60	7,573.00
RECOMMENDED COST OF REPAIRS (REPAIR COST NOT CONCLUDE) (EXCLUDE CHECK ITEMS S\$1,612.00NETT)				7,573.00
