SLW 2232X - CC3/ALH18009968 / Agonz

Date Of Report	28/05/2018 15:20
Date Of Accident	28/05/2018 10:25
Exact Location Of Accident	30 SEGAR ROAD CARPARK
Country/State of Loss	SINGAPORE

VEHICLE DAMAGE INSPECTION REPORT

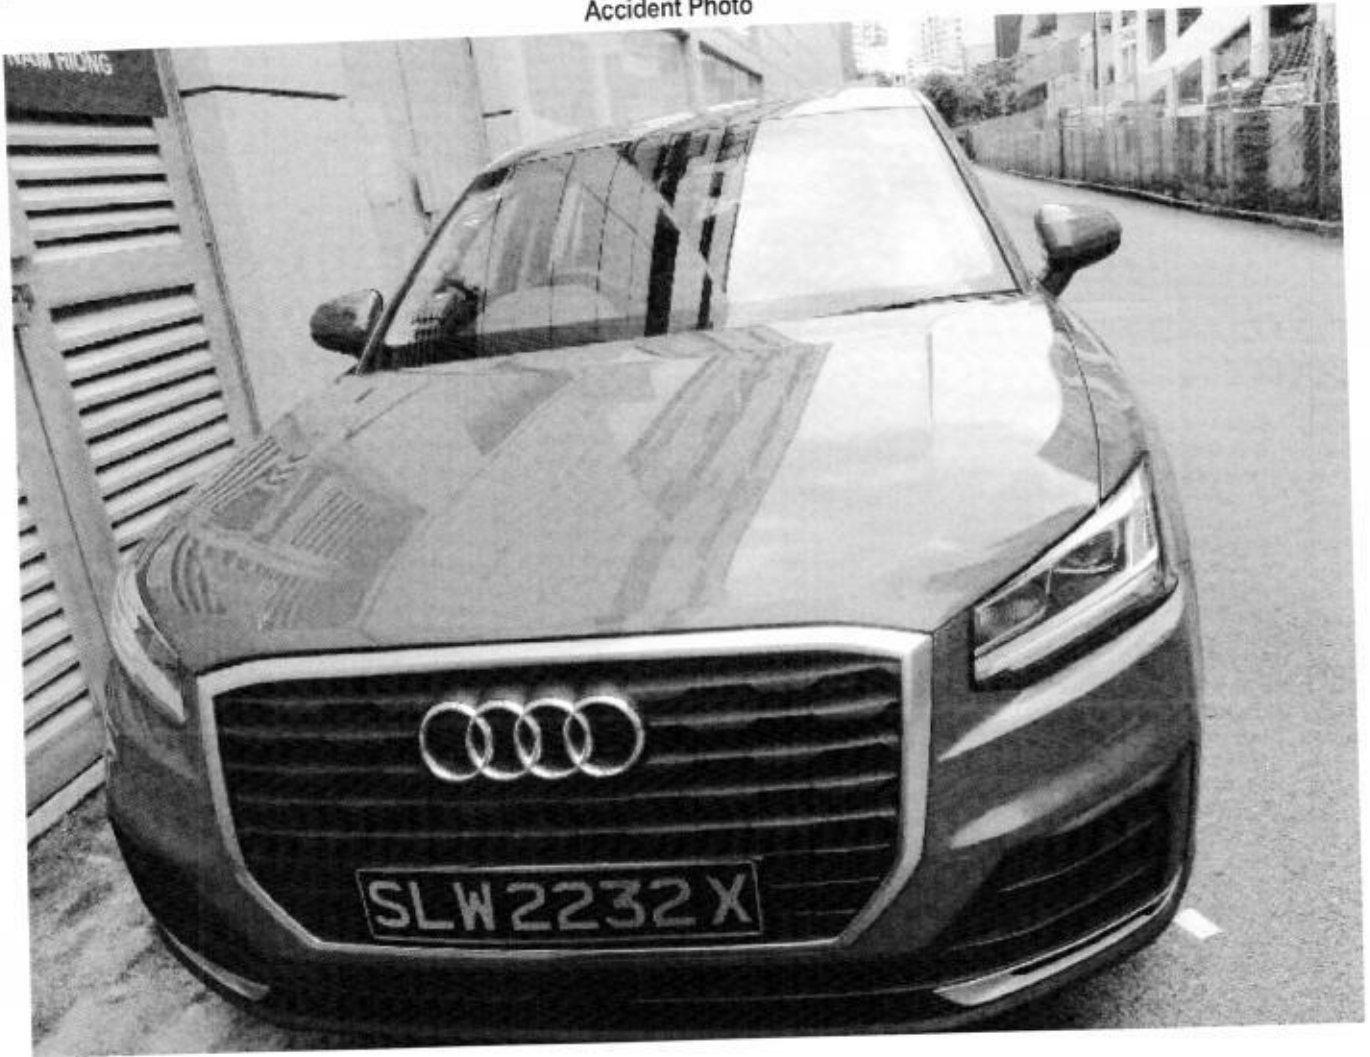
Accident Photo

WHILE TURNING OUT FROM MY PARKING LOT, I DIDNT NOTICE THE PILLAR BESIDE MY CAR AND SCRAPPED AGAINST IT.

While turning out from my parking lot, I didn't notice the pillar beside my car and scraped against it.
