# ASSIGNMENT

Veh No: SCZ 5977B Yr Regn: 6/9/2016

Make: Honda Odyssey CC 2356

**ADJUSTMENT ON REPAIR COST FOR VEHICLE NO. SCZ 5977B**

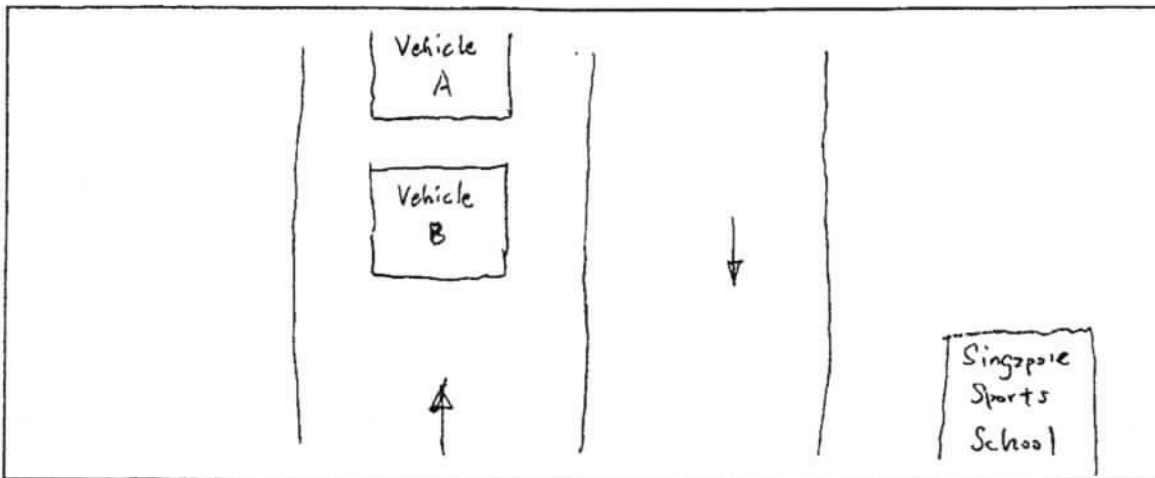
## SKETCH PLAN

Accident Date: 03/01/2018 Time: 07:58 Location: SLE after Singapore Sports School towards KJE  
 My Vehicle A: SCZ 5977 B Vehicle B: SGV 5290 Y Vehicle C/Others: \_\_\_\_\_

On 3 January 2018 about 07:58 am my vehicle was hit from the back ~~at~~ by Vehicle B. There was a slowdown in traffic and I reduced my vehicle speed to 60 km/h just after passing the Singapore Sports School on my right. Suddenly there was a loud bang from the back and I realised that Vehicle B did not stop in time to cause the accident. I presumed her speed was at 75-80 km/h which caused a serious dent to the tailgate and bumper of my vehicle. The weather was fine and bright at the time of the accident. Vehicle B was driven by the driver by the name of Wendy (Mobile: 8786 7223)
