From: Hew, LeeFong <LeeFong.Hew@awac.com> on behalf of Motorsurvey <Motorsurvey@awac.com>
Sent: Tuesday, 5 June, 2018 11:06 AM
To: 'assignments'
Cc: 'SUR'; 'account5 leasing'
Subject: TP Survey assignment for SLQ 493D - DOA: 03/06/2018 Our ref: NSV1800342/TKL

Affiliated to Federation Internationale Des Experts En Automobile				
ALLIED WORLD ASSURANCE COMPANY LTD		Ref : CS/AWA18010214/Gsbe2		
(SINGAPORE BRANCH) 60 ANSON ROAD #08-01 (8th FLOOR) MAPLETREE ANSON SINGAPORE 079914		Date : 27-07-2018

ADJUSTMENT ON REPAIR COST FOR VEHICLE NO. SLQ 493D

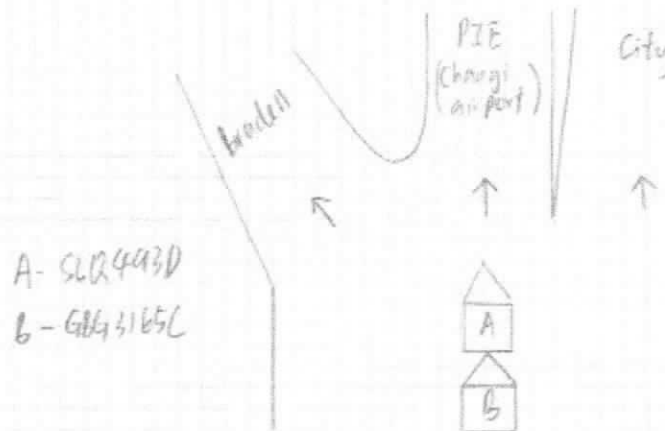
Sketch Plan #2

On 03/06/18 Afternoon 1:15pm. I drive grab (SLQ493D) at CTE. to PIE (Changi Airport) direction, front car drive slowly. suddenly, a car GB63165L bang my car rear side.
