# LKK Auto Consultants Pte Ltd

## **Preliminary Advice**

The vehicle sustained impact / damages rear n/s portion and parts claimed are consistent to the accident.

## VEHICLE DAMAGE INSPECTION REPORT

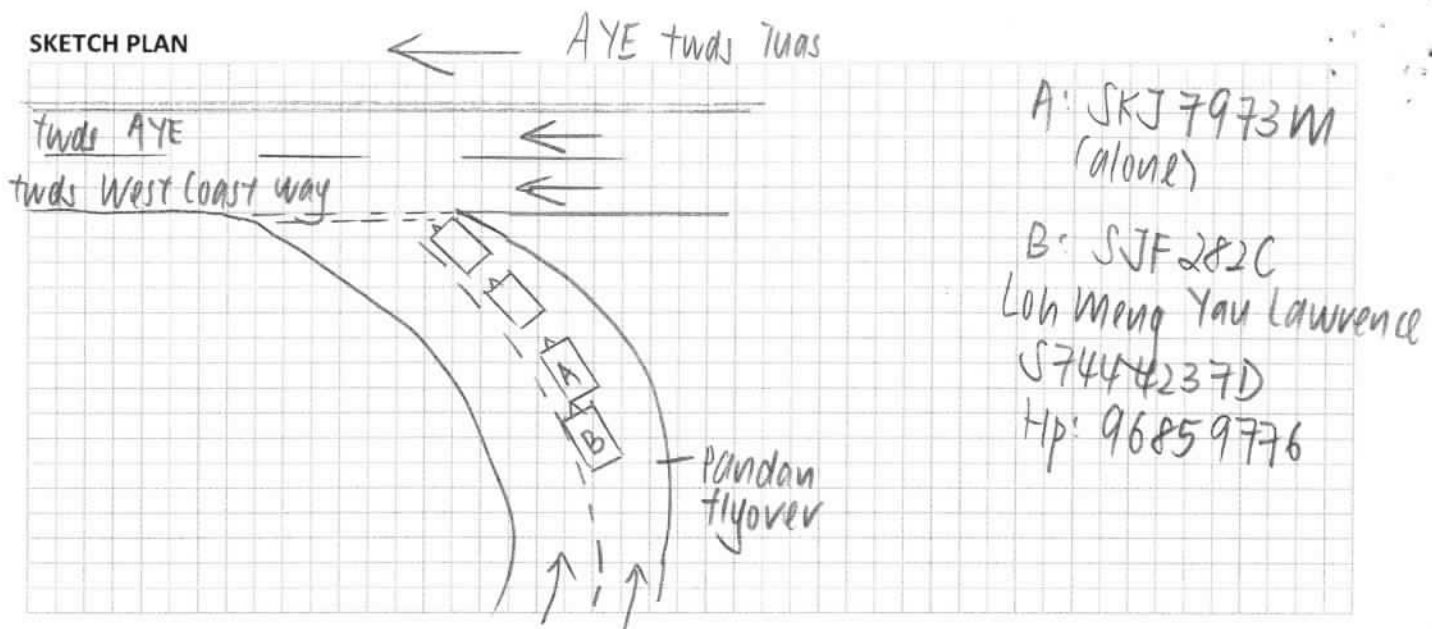
### SKETCH PLAN

I was driving along the bend of Pandan Flyover and slow down my vehicle as vehicles in front stop to give way to traffic on the right. Motor car SJF282C came from behind and hit onto my vehicle rear LH portion. I felt giddy on that night & went to A & E (@ Ng Teng Fong Hospital) to seek for medical treatment. I was given 3 days MC on 23/06/18 early morning.

Note: my rear reverse camera could not fully extend after the accident.
