VEHICLE DAMAGE INSPECTION REPORT

Our File No: CC3/MSG18010271/USBQ2

Handling Insurer: MSIG Insurance (Singapore) Pte. Ltd. Policy No: 29004183MKF
 Claimant Vehicle No: SLK6575T Insured Vehicle No: GZ7740G
 Date of Loss: 05/06/2018 Nature of Claim: TP Claim No: 560644

Reg No: **SLK6575T**
 Make & Model: HONDA MOBILIO SV, 1.5 CVT (A) Engine No: L15Z12874015
 Reg. Date: 23/01/2017 (Man. Year: 2016) Chassis No: MRHDD4870GP000348
 Colour: Blue Odometer: 35543 km
 Engine Capacity: 1497 cc
 Market Value/New Car Price: N/A
 Sum Insured (S\$): **Market Value/New Car Price**

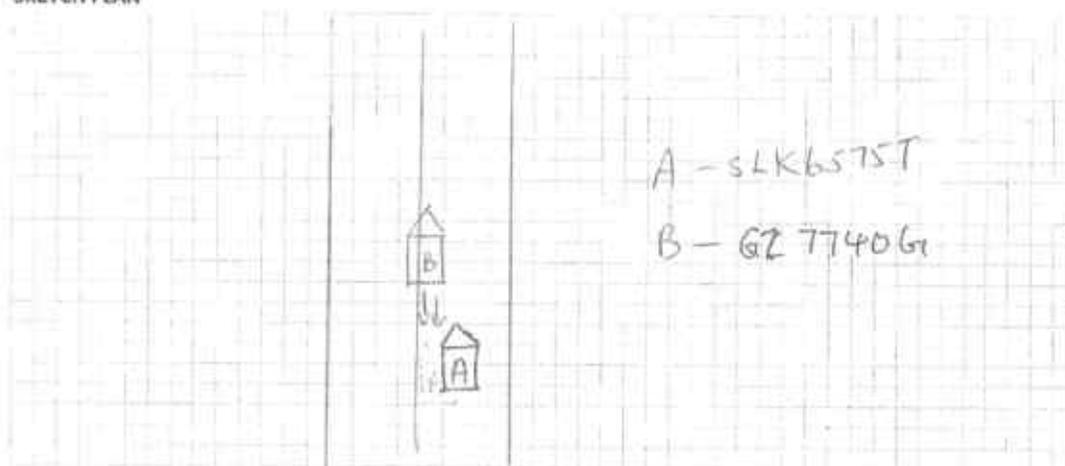
SKETCH PLAN

DESCRIBE CIRCUMSTANCES OF THE ACCIDENT

on the above date and time. I was at Wan Lee
Road behind of vehicle B. Suddenly the van reversed
and hit on my LH portion.
