PAPER SURVEY OF SLW4116K

Part By Part repair of SLW 4116 K

ADJUSTMENT ON REPAIR COST FOR VEHICLE NO. SLW 4116K

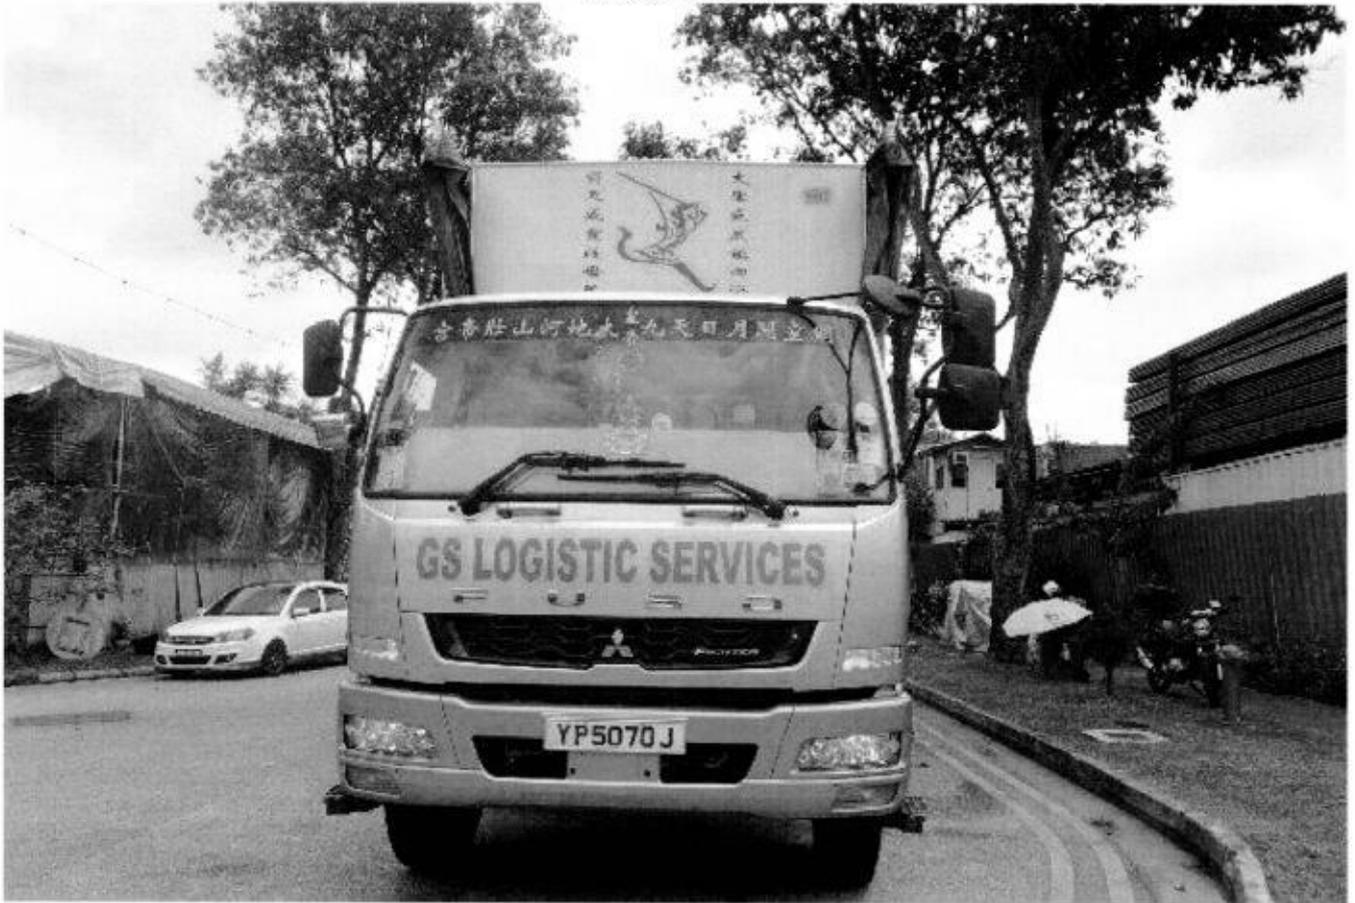
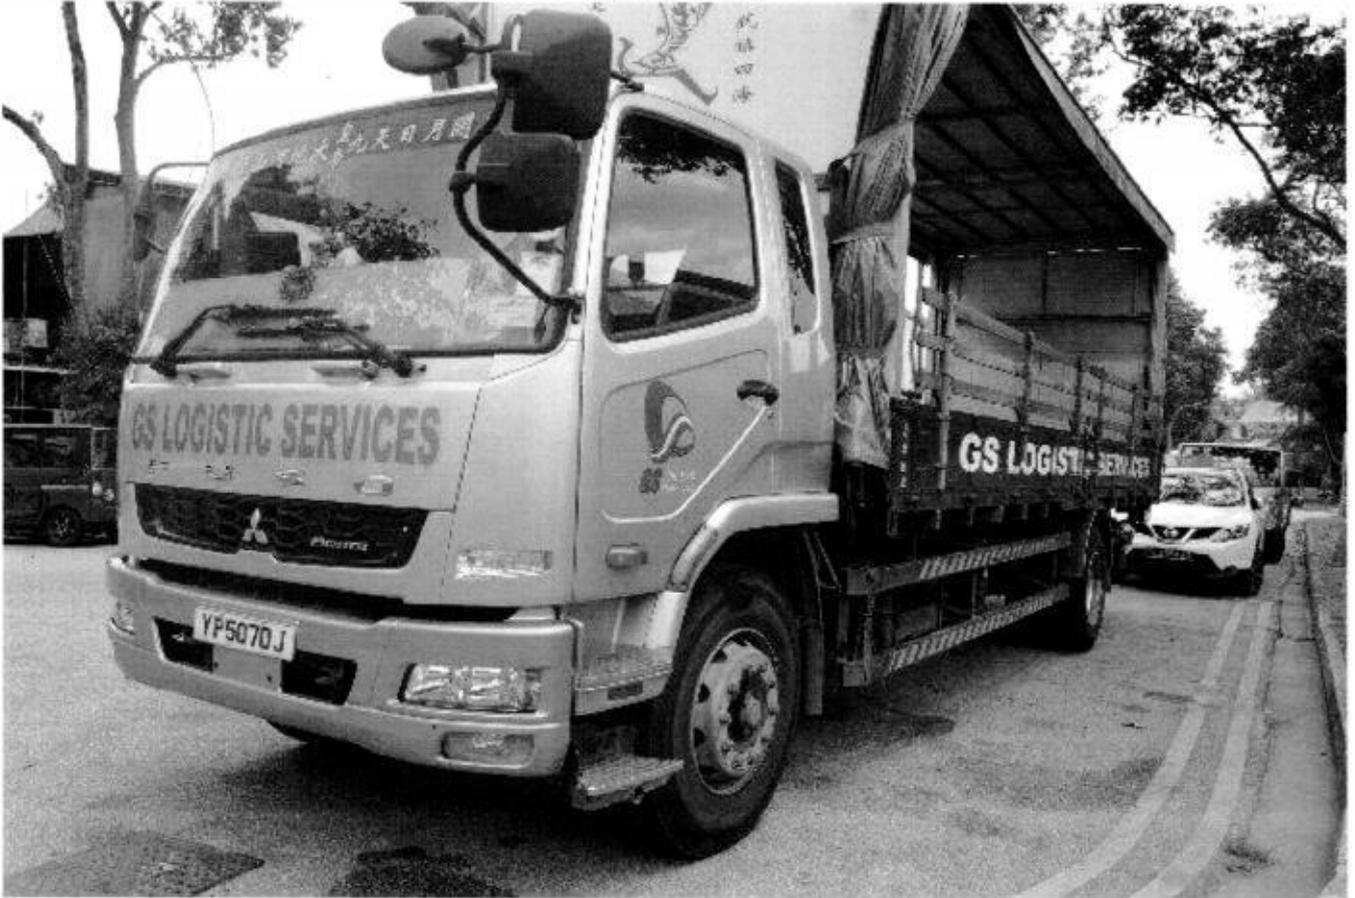
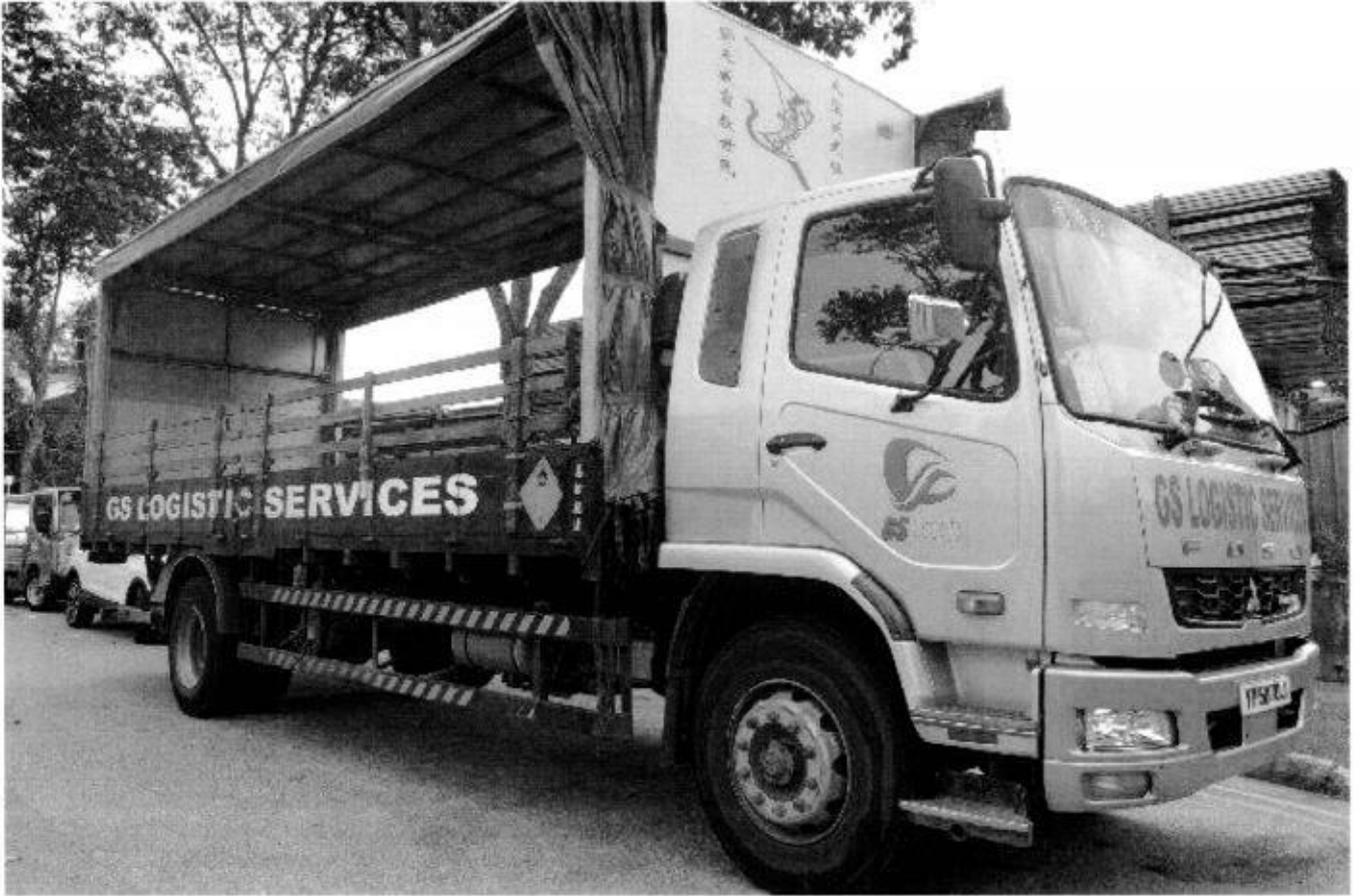
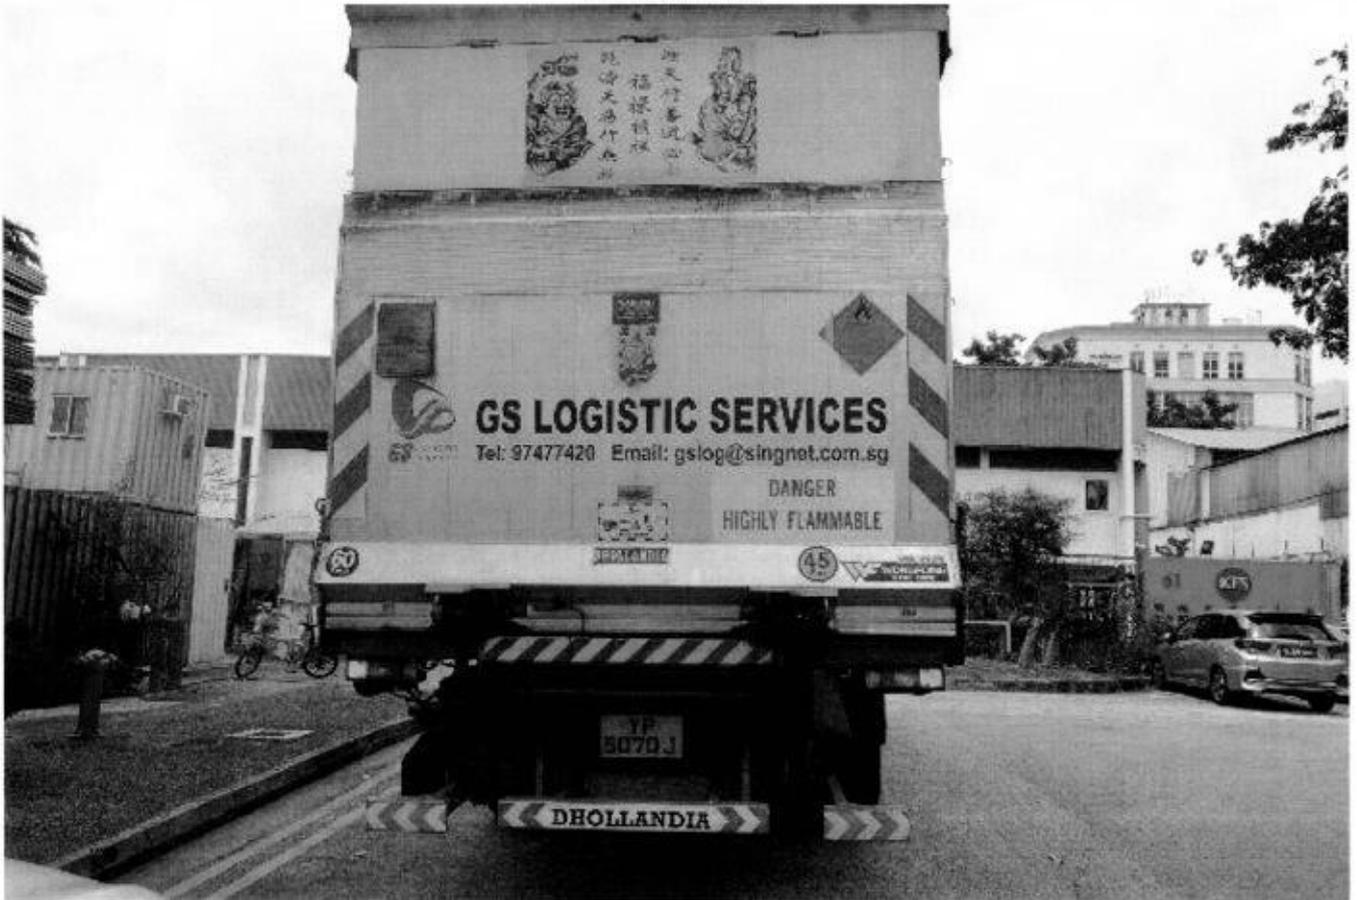
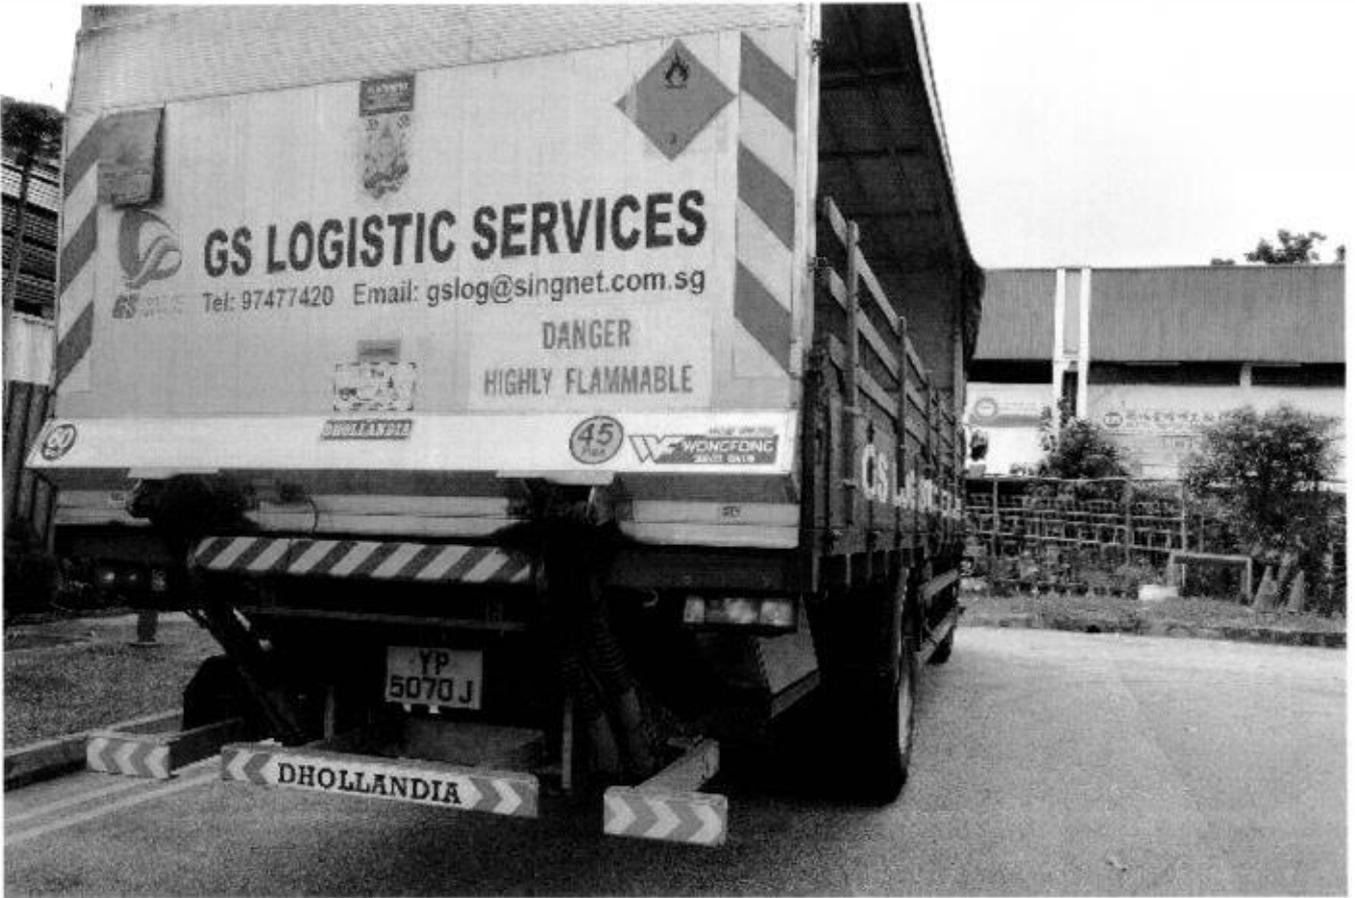
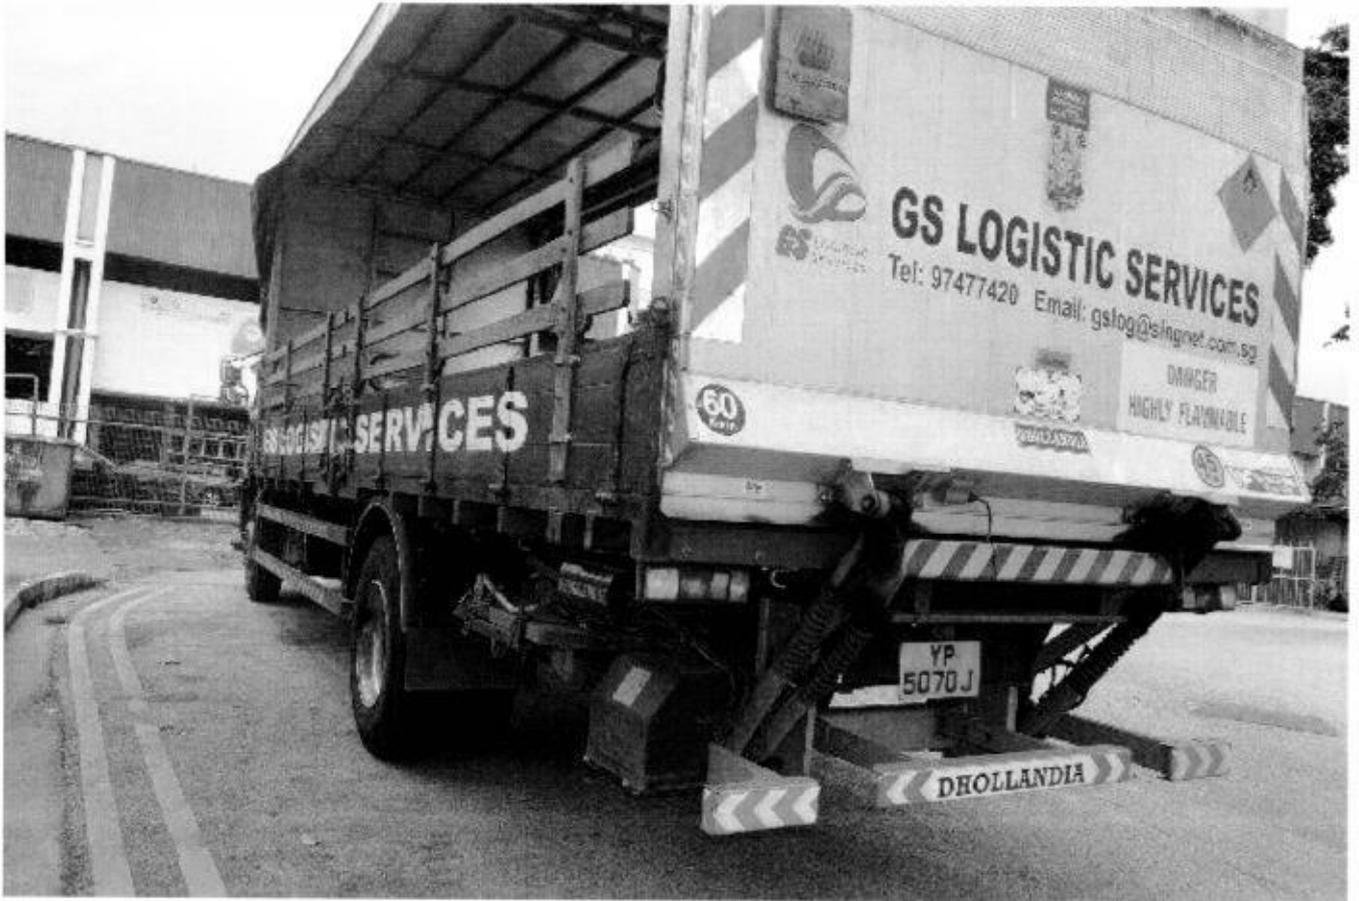
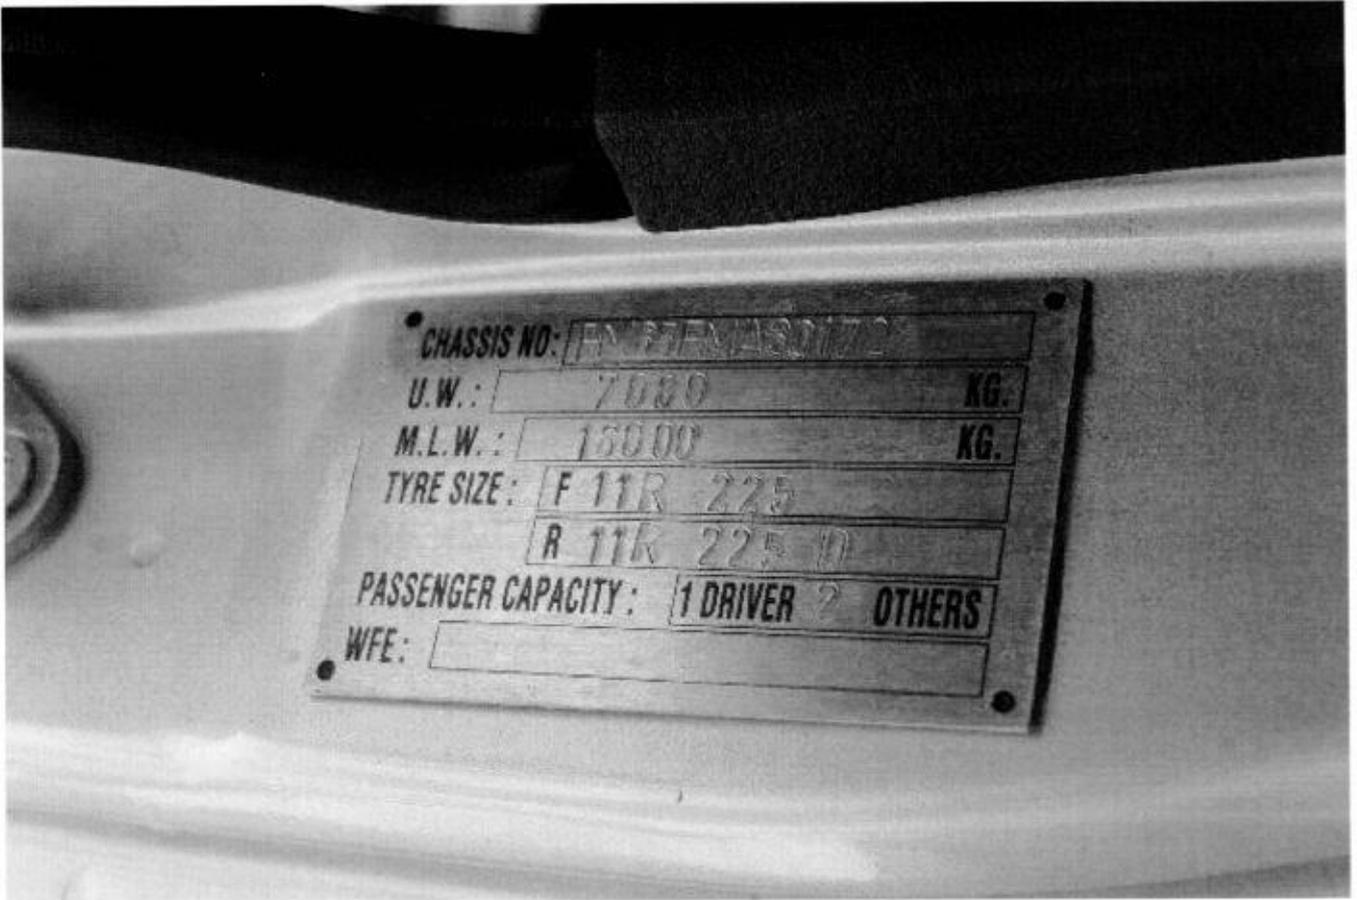
Accident Photo

At the time of inspection, we noted that the vehicle has sustained an impact damages on the n/s portion(s). For more detail of the damages, please see photograph attached.

4. Description of Damages			
THE VEHICLE SUSTAINED DAMAGES AT THE N/S FRONT PORTION. DAMAGES SEE DETAILS.			
5. General Information			
Accident Date	22/02/2018	Inspection Date	21/03/2018
Survey held at	Z-ONE AUTOMOTIVE PTE LTD 1 KAKI BUKIT AVE 6, BLK C, #01-52 AUTOBAY SINGAPORE 417883		
5a. Remarks

Recommended PART BY PART Repair Amount of: \$ **1556.24**
