VEHICLE DAMAGE INSPECTION REPORT

Our File No: CS/CTI18010462/KVD3N2

Handling Insurer:	China Taiping Insurance (Singapore) Pte. Ltd.	Policy No:	DMCVSN3043961700
Claimant Vehicle No :	SLX6099H	Insured Vehicle No :	GBB8985X
Date of Loss:	05/06/2018	Nature of Claim:	TP
		Claim No:	SNM18D02857C02

Reg No:	SLX6099H	Engine No:	3ZRB581750
Make & Model:	TOYOTA HARRIER, 2.0 Elegance (A)	Chassis No:	ZSU600048435
Reg. Date:	06/08/2015 (Man. Year: 2015)	Odometer:	49016 km
Colour:	Metallic Black		
Engine Capacity:	1986 cc		
Market Value/New Car Price:	N/A		
Sum Insured (S\$):	Market Value/New Car Price

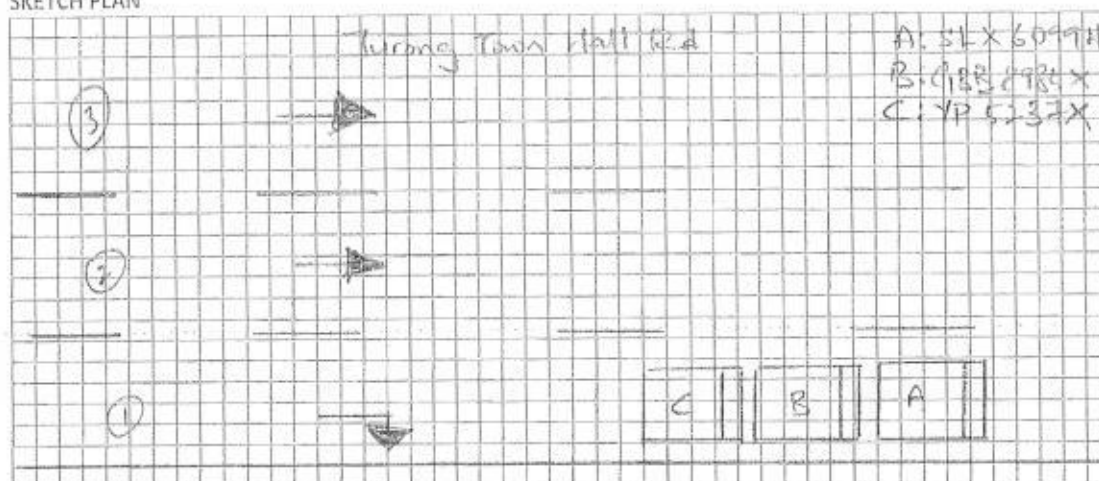
SKETCH PLAN

On 5th June, 6:12pm I was driving along Jurong Town Hall Road after exiting AYE. I came to a stop at the traffic light and was waiting at the traffic light (red light) to turn right onto Jurong East St. 11.

I was at the most right lane and suddenly I heard a bump and almost immediately there was a bump to my car.

My car surge forward but I did not bump into any cars in front.

He was hit by a lorry behind him.
