**INITIAL INSPECTION REPORT OF VEHICLE NO. SLR 5043G .**

THE VEHICLE SUSTAINED DAMAGES AT THE FRONT N/S AND N/S FRONT PORTION. DAMAGES SEE DETAILS.
---

**ADJUSTMENT ON REPAIR COST FOR VEHICLE NO. SLR 5043G**

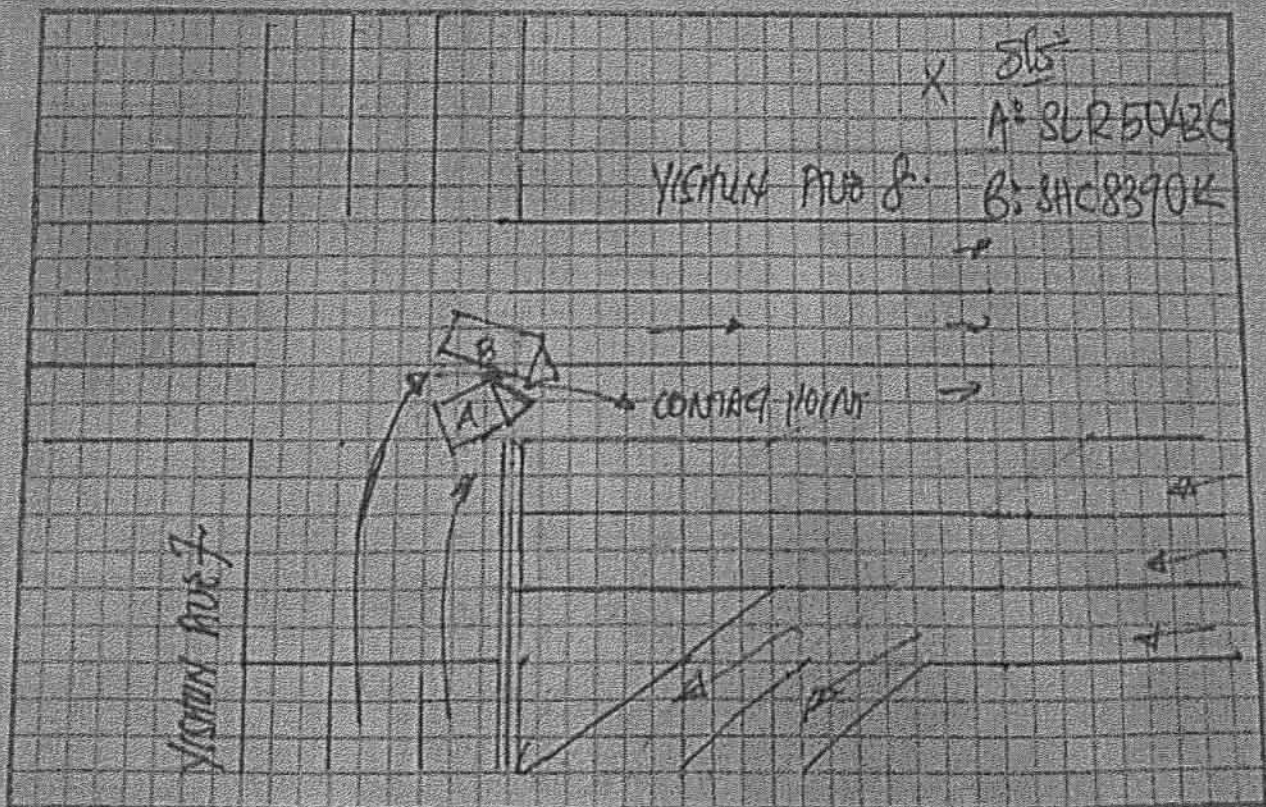
### Sketch Plan

ON THE DATE & TIME MENTIONED I WAS DRIVING AT THE SHIP JUNCTION, AND WHEN I WAS MAKING A RIGHT TURN INTO YUSMIN AVE 8, ON THE EXTREME RIGHT LANE, VEHICLE B, COMING FROM MY LEFT, CUT INTO MY PATH AND COLLIDED ON TO THE FRONT LEFT PORTION OF MY VEHICLE. THIS INCIDENT WAS CAPTURED BY THE IN-CAR VIDEO WHICH WAS SUBMITTED TO THE NSI WORKSHOP. THE DRIVER OF VEHICLE B, DID NOT GIVE HIS PARTICULARS & I WAS ASKED BY HIM TO LOGIC. A REPORT.
