ASSIGNMENT

To Inspect Vehicle No: SKV 19014

Make: Audi, AS c.c. 1984

VEHICLE DAMAGE INSPECTION REPORT

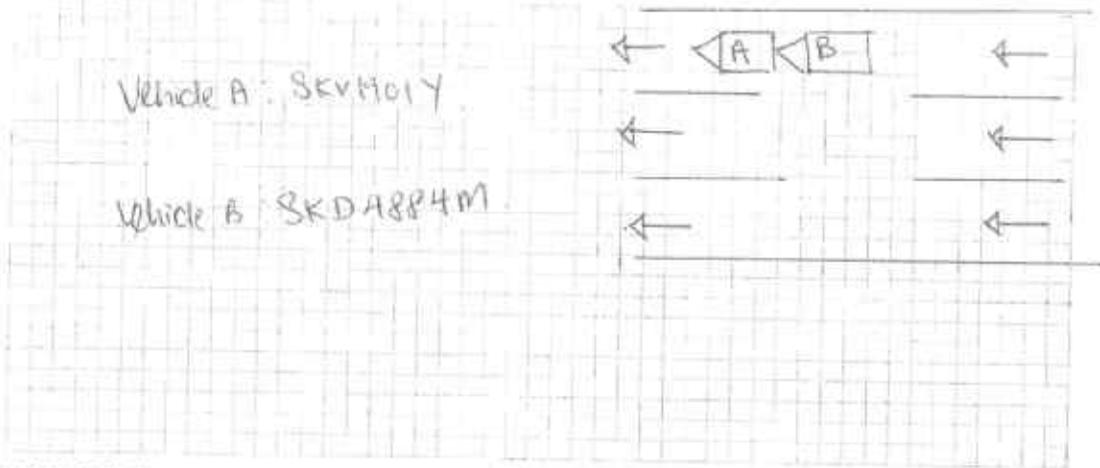
SKETCH PLAN

On the stated date & time, I was driving on the stated vehicle. The traffic flow in front of me was heavy. The front vehicle stopped & I stopped. Suddenly, vehicle B (SKD4884M) could not stop in time and hit onto the rear portion of my car.
