VEHICLE DAMAGE INSPECTION REPORT

Our File No: CS/CTI18010782/NTD3E2

Handling Insurer: China Taiping Insurance (Singapore) Pte. Ltd.	Policy No: DMPCSN3014111700	
Claimant Vehicle No: SLQ6070B	Insured Vehicle No: SJU8452Y	
Date of Loss: 07/06/2018	Nature of Claim: TP	Claim No: SNM18D02897C02

Reg No:	SLQ6070B	
Make & Model:	HONDA VEZEL, 1.5 X SENSING (A)	Engine No: L15B4417800
Reg. Date:	17/07/2017 (Man. Year: 2017)	Chassis No: RU11217801
Colour:	White	Odometer: 29189 km
Engine Capacity:	1496 cc	
Market Value/New Car Price:	N/A	
Sum Insured (S\$):	Market Value/New Car Price

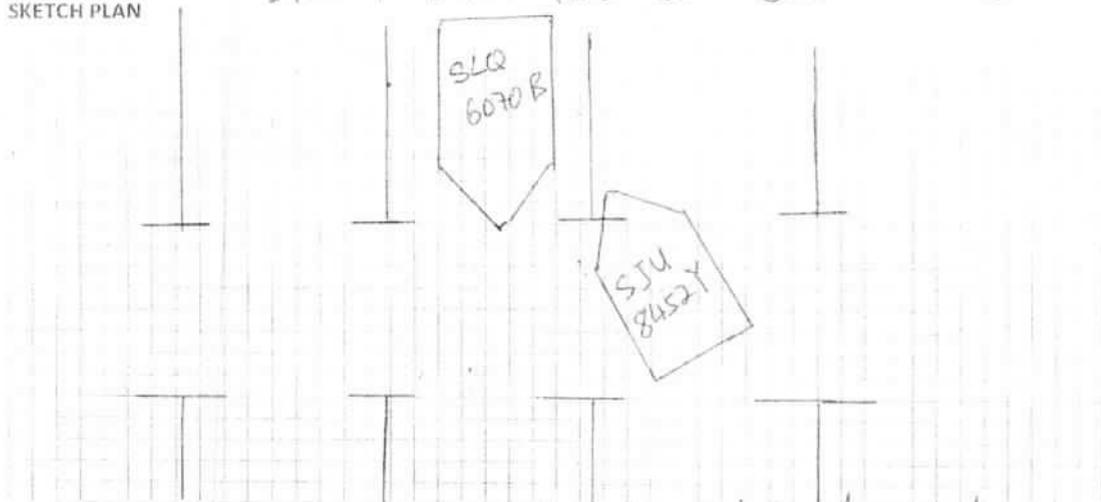
SKETCH PLAN

THE INCIDENT TOOK PLACE ON THE ABOVEMENTIONED LOCATION. AFTER PARKING AND SECURING MY VEHICLE I LEFT HOME. WHEN I COME BACK 16:50 AND TO REALISED THERE IS DAMAGED TO MY VEHICLE. I THEN RETREIVE FROM MY IN CAR CAMERA AND SAW VEHICLE B-SJU8452Y HAS COLLIDED ONTO MY VEHICLE LEFT HAND SIDE WHEN HE WAS DOING THE REVERSING INTO THE LOT BEHIND. VEHICLE FRONT PORTION COLLIDED ONTO MY VEHICLE LEFT HAND SIDE.
