## Policy Particulars :- THIRD PARTY CLAIM

**Estimated Cost of Repair job for SBS6430D (Accident on 12/06/18, along Killiney Road / Penang Road involving SBS6430D & SHC8789U)**

**ADJUSTMENT ON REPAIR COST FOR VEHICLE NO. SBS 6430D**

Report Ref No. CS/FCI18010816/K1td3n2

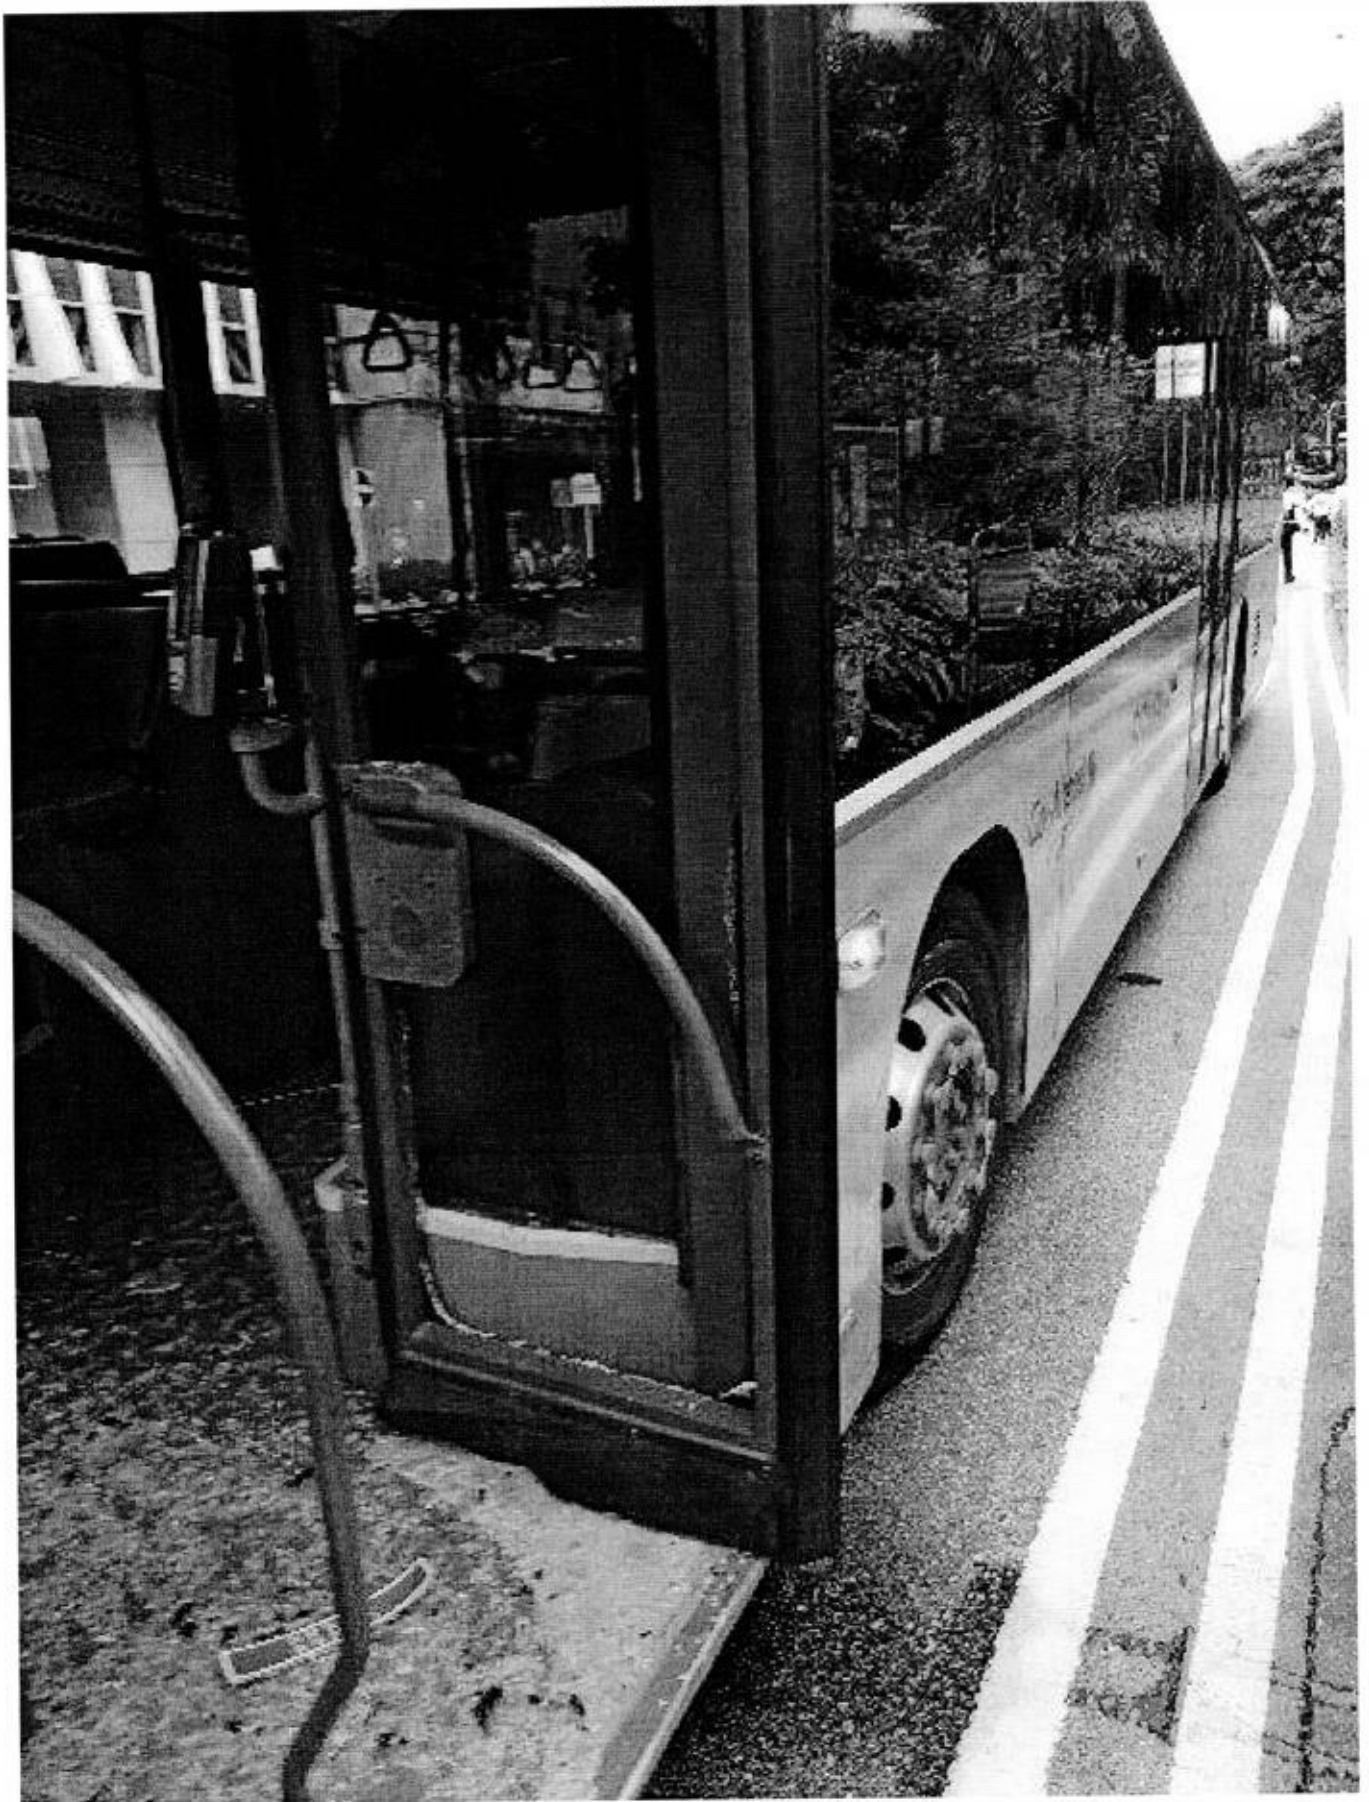
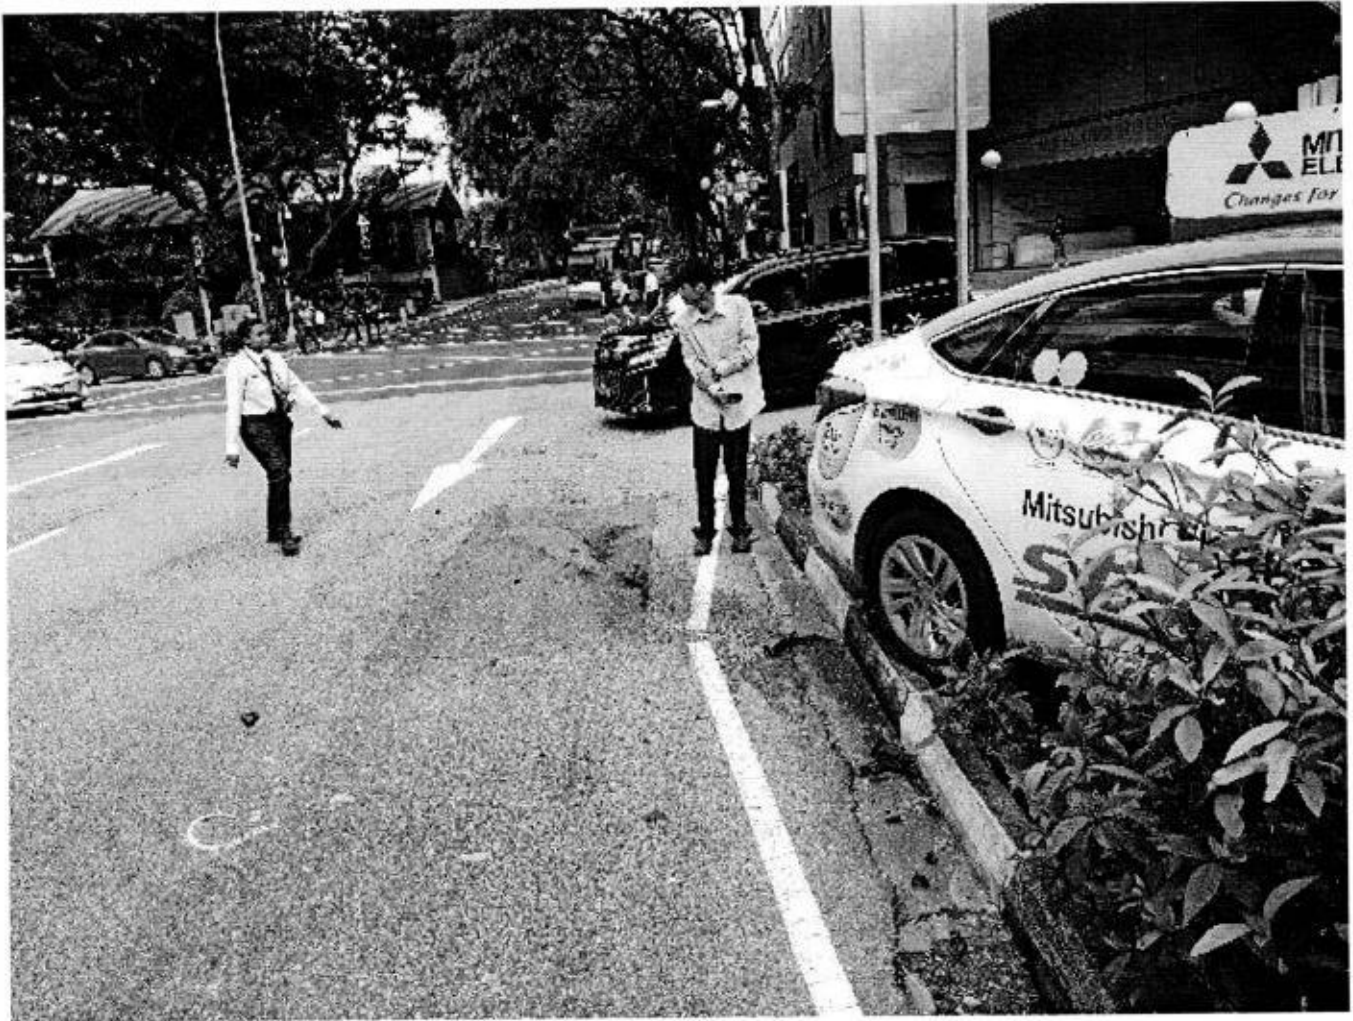
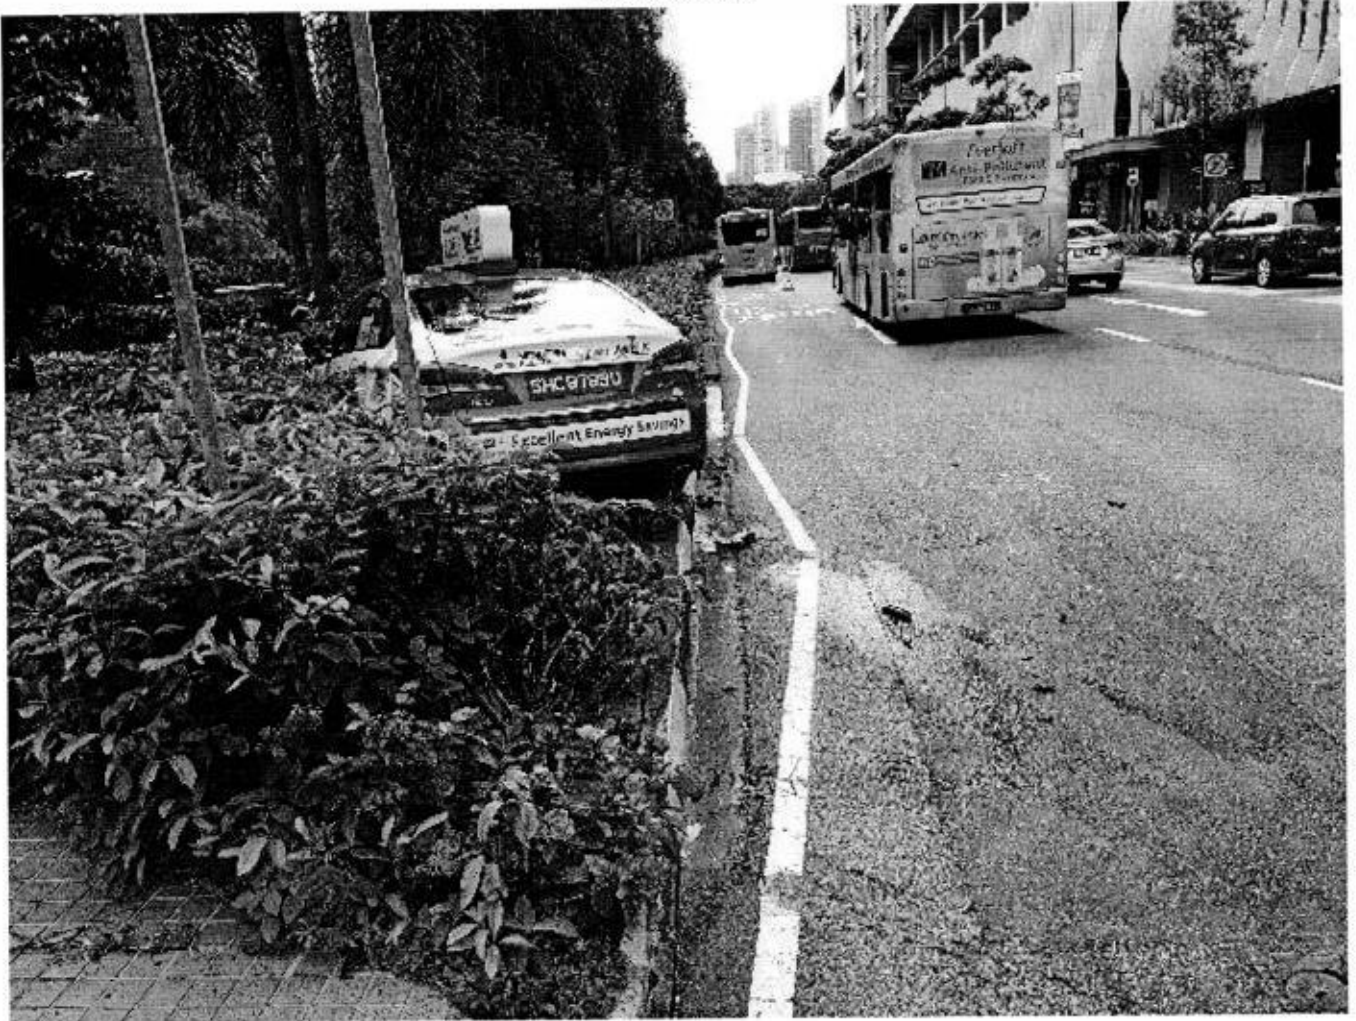
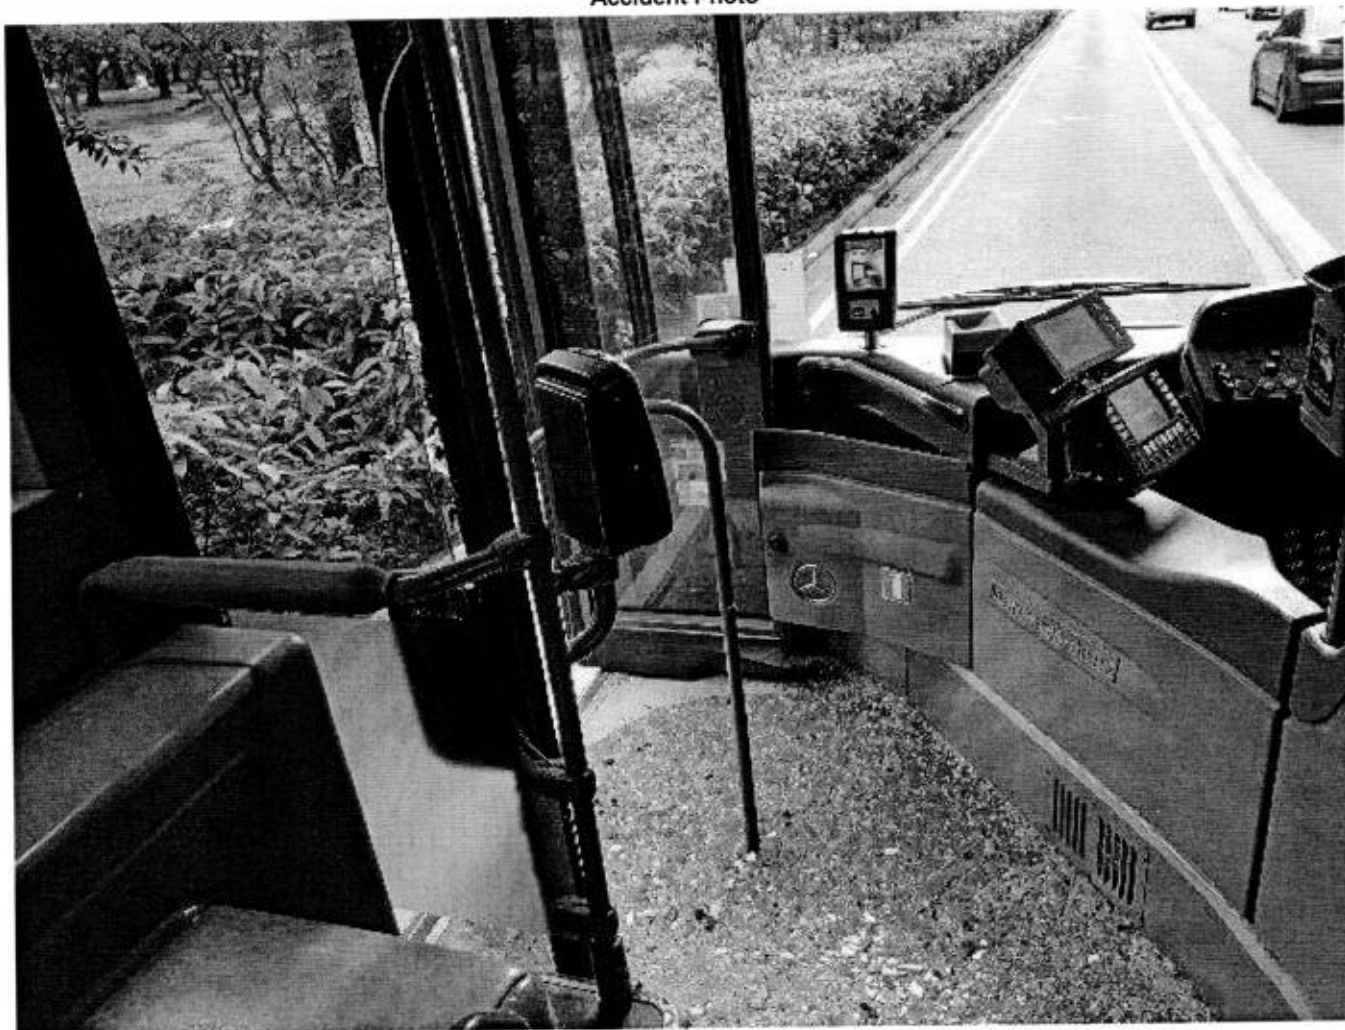
Accident Photo

N/S Front.

The U/C / Chassis frame / Body Structure affected due to collision.

| Affiliated to Federation Internationale Des Experts En Automobile | | | | |
|---|---|---|---|---|
| THE VEHICLE SUSTAINED DAMAGES AT THE N/S FRONT PORTION.<br>DAMAGES SEE DETAILS. | | | | |

| Qty | Description of Parts | Condition | Estimate By Workshop (\$) | Our Adjusted (\$) |
|---|---|---|---|---|
| <b>RECOMMENDED COST OF LUMP SUM REPAIRS (TO ITS PRE-ACCIDENT CONDITION)</b> | | | | <b>3,250.00</b> |
