VEHICLE DAMAGE INSPECTION REPORT

Our File No: CS/CTI18010884/KSD3N2

Handling Insurer:	China Taiping Insurance (Singapore) Pte. Ltd.	Policy No:	DMPCSN3085771600	
Claimant Vehicle No :	SLR3065G	Insured Vehicle No :	SKU14U	
Date of Loss:	09/06/2018	Nature of Claim:	TP	Claim No: SNM18D02893C02

Reg No:	SLR3065G	Engine No:	L15B4071408
Make & Model:	HONDA GRACE, 1.5 (A)	Chassis No:	GM61001336
Reg. Date:	08/08/2017 (Man. Year: 2015)	Odometer:	26822 km
Colour:	White		
Engine Capacity:	1496 cc		
Market Value/New Car Price:	N/A		
Sum Insured (\$\$):	Market Value/New Car Price

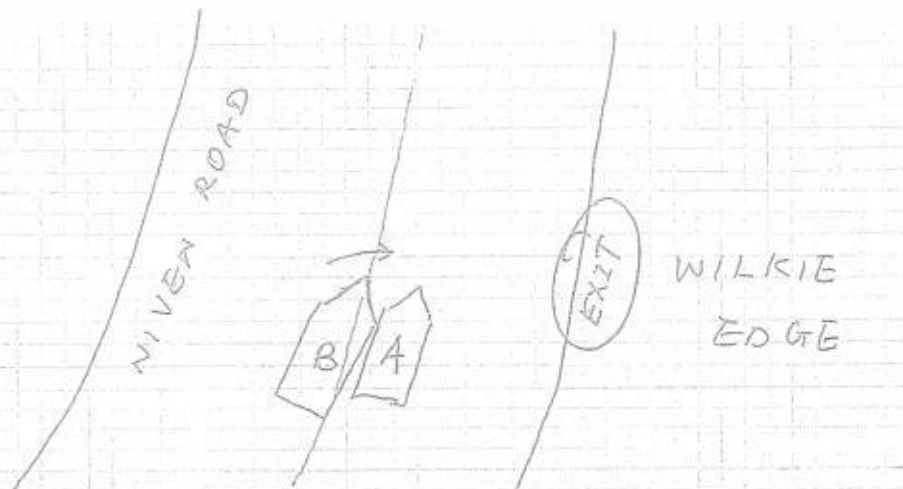
SKETCH PLAN

I was driving along Niven Road on 9/6/18 at around 1150 am. The vehicle SKU 14U was in front of me.

The vehicle braked and was preparing to pull to the side of road. I overtook on the right side but I suddenly saw SKU 14U signal light. I tried to brake and honked at the same time but the vehicle still banged on the front left of my car.

I believe the lady driver mistaken the EXIT of Wilkie Edge at the entrance and she swerved right abruptly without checking her right mirror at all.
