ACCIDENT INVOLVING SJK8946S AND SJP7288M ON 13.06.18

4. Description of Damages				
THE VEHICLE SUSTAINED DAMAGES AT THE REAR PORTION. DAMAGES SEE DETAILS.				
5. General Information				
Accident Date	13/06/2018	Inspection Date	19/06/2018	
Survey held at	TEAMWORK GARAGE PTE LTD 53 UBI AVENUE 1 #01-24 SINGAPORE 408934.			
5a. Remarks				
A)THE INSPECTION WAS CONDUCTED ON A"WITHOUT PREJUDICE" BASIS. B)IN ACCORDANCE TO YOUR INSTRUCTIONS, WE HAVE NOT AUTHORISED REPAIRS.				
5b. Estimate Days of Repair				
ESTIMATED NORMAL PERIOD FOR REPAIR:		7 Working Days

ADJUSTMENT ON REPAIR COST FOR VEHICLE NO. SJK 8946S

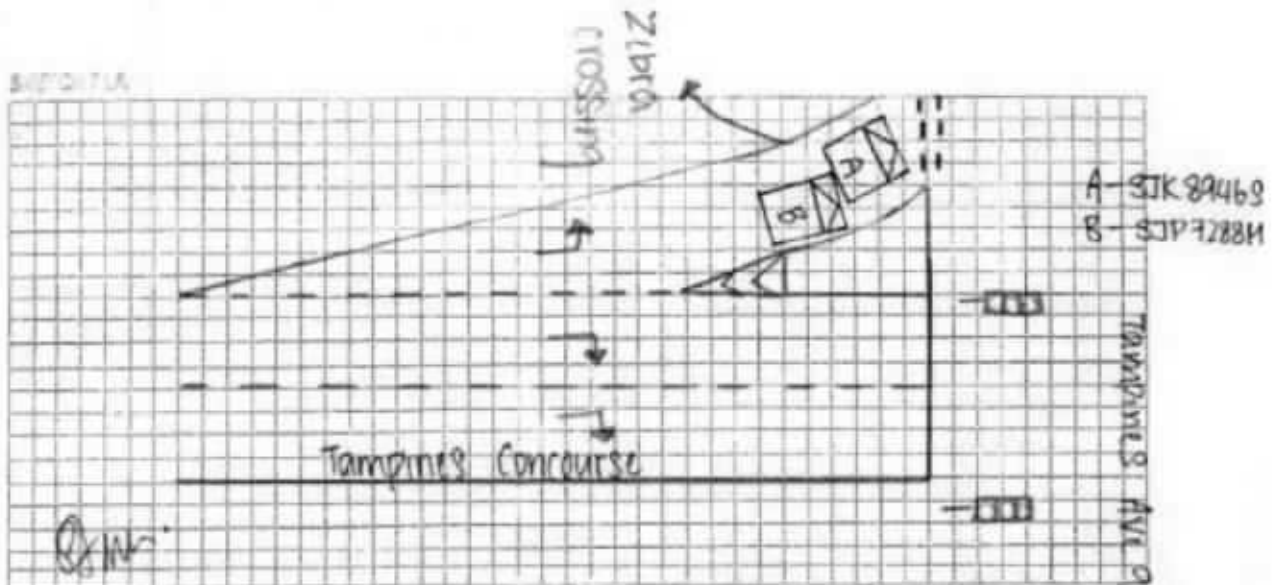
Accident Sketch Plan

I was travelling along Tampines concourse road towards Tampines Ave 9 . When I am turning out from the slip road to Tampines Ave 9 , I stopped to make sure the road is clear before moving out. After stopping for 2-3 seconds , suddenly I felt a huge impact from the rear portion of my vehicle. When I got down of my vehicle , I realized that vehicle B had collided onto the rear right portion of my vehicle.
