Your Ref: Honda Engine
Our Ref : CI/TP18010981/D

18 June 2018

INSPECTION REPORT OF A HONDA ENGINE

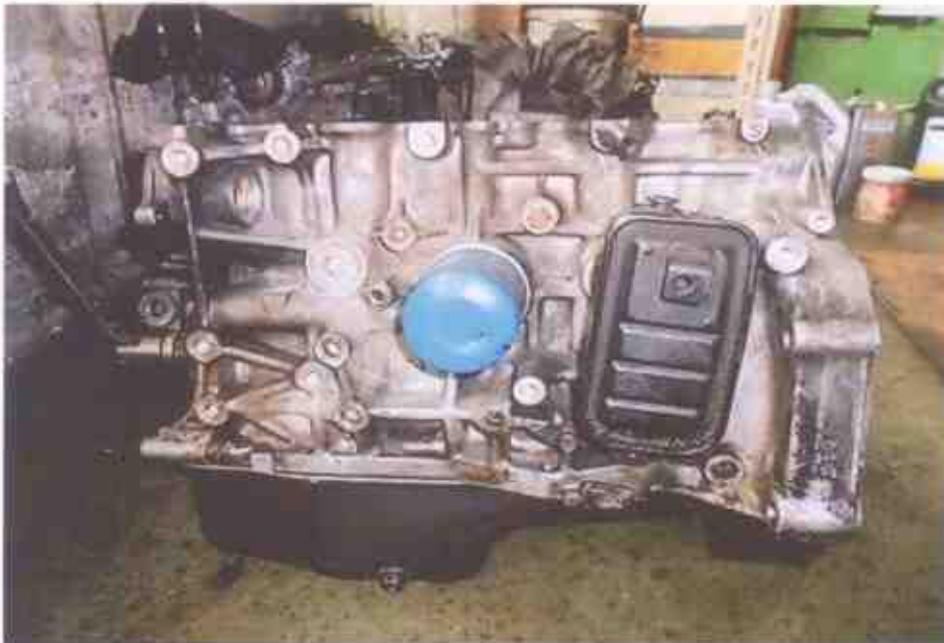
Photo 3 shows a general view of the Honda engine that I had inspected. My visual examination of the engine housing revealed the housing to be of serviceable/satisfactory condition. There was no crack and/or hole observed on the engine housing.

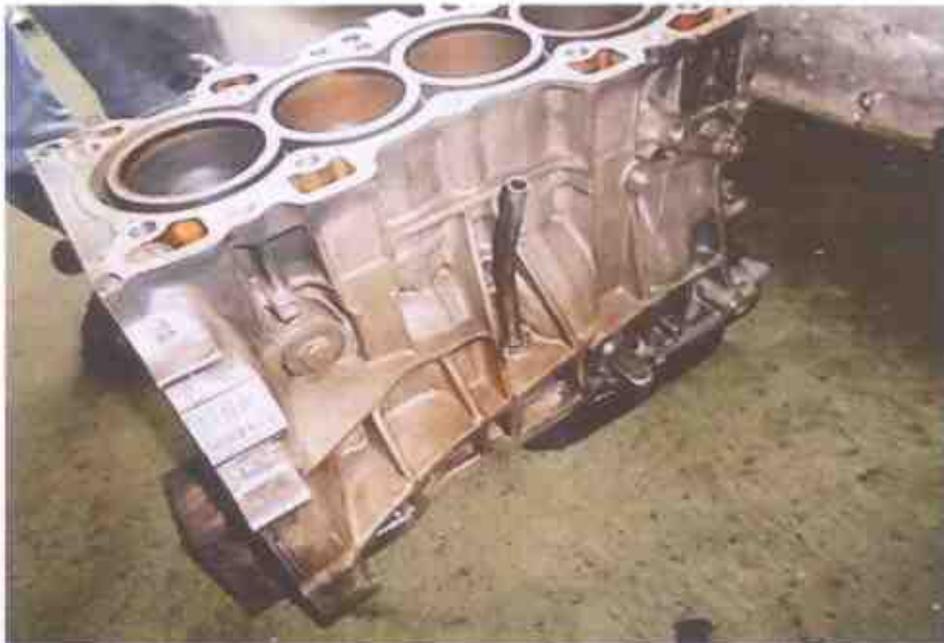
Photo 3 shows a general view of the Honda engine that I had inspected. My visual examination of the engine housing revealed the housing to be of serviceable/satisfactory condition. There was no crack and/or hole observed on the engine housing.

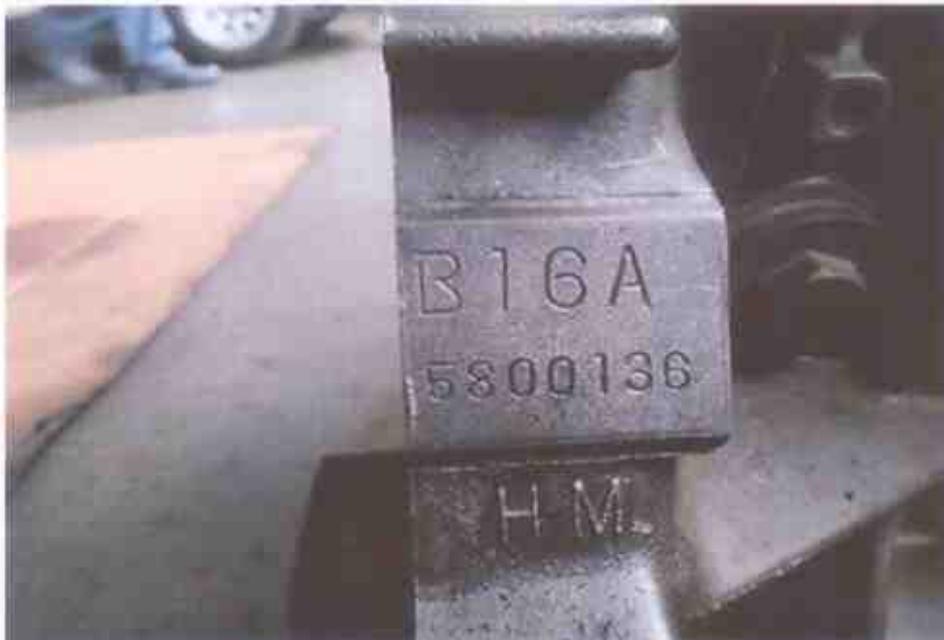
Photo 4 shows the engine number engraved on the housing of the Honda engine that I had inspected. The engine number was B16A5800136.

13. In summary, the Honda engine that I had inspected is a Honda B16A model engine. The engine number engraved on the housing of this Honda engine was ~~B16A~~5800136.

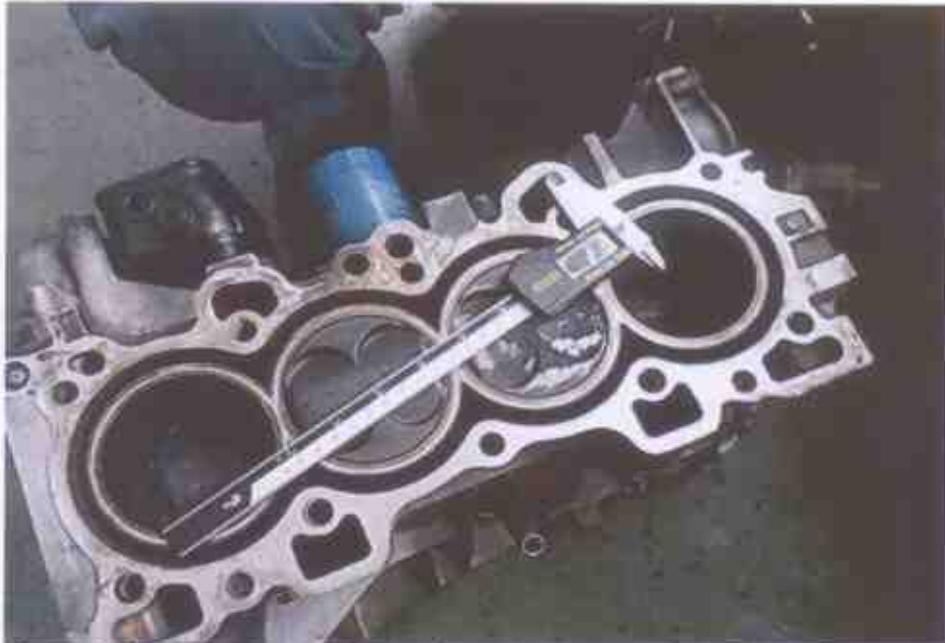
Photo 5 shows the bottom block of the Honda engine and the digital Vernier Caliper that was used to measure the bore and stroke of the Honda engine. The digital Vernier Caliper was calibrated before the start of the measurements.

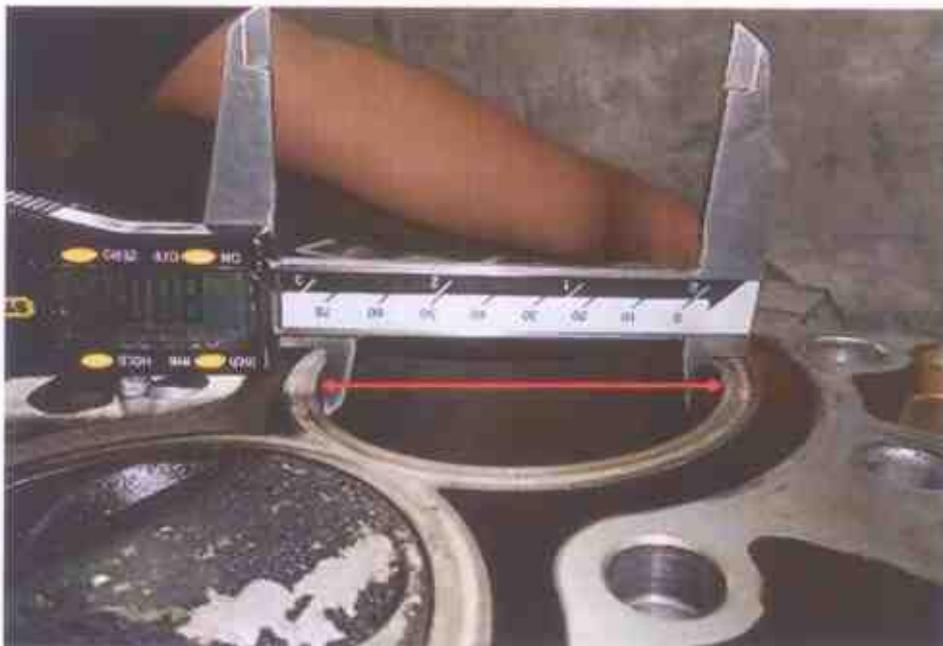
Photo 6 shows measurement being carried out to the bore of cylinder 1 of the Honda engine. The bore measurement of cylinder 1 was recorded to be 80.01mm.

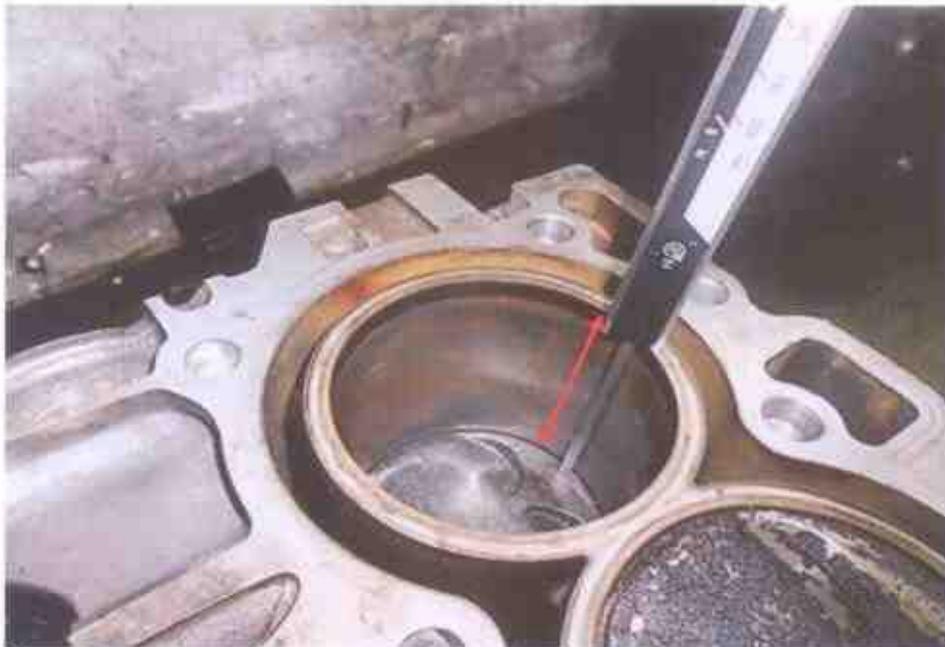
Photo 7 shows measurement being carried out to the stroke of cylinder 1 of the Honda engine. The bore and stroke measurements of the Honda engine were carried out using a digital Vernier Caliper.

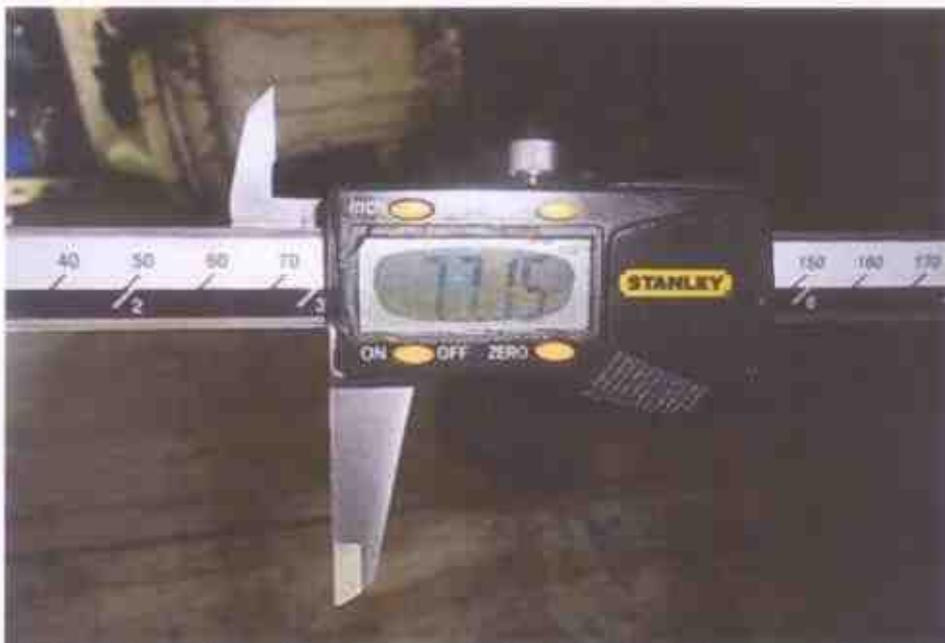
Photo 8 shows the stroke measurement of cylinder 1, which was recorded to be 77.15mm.

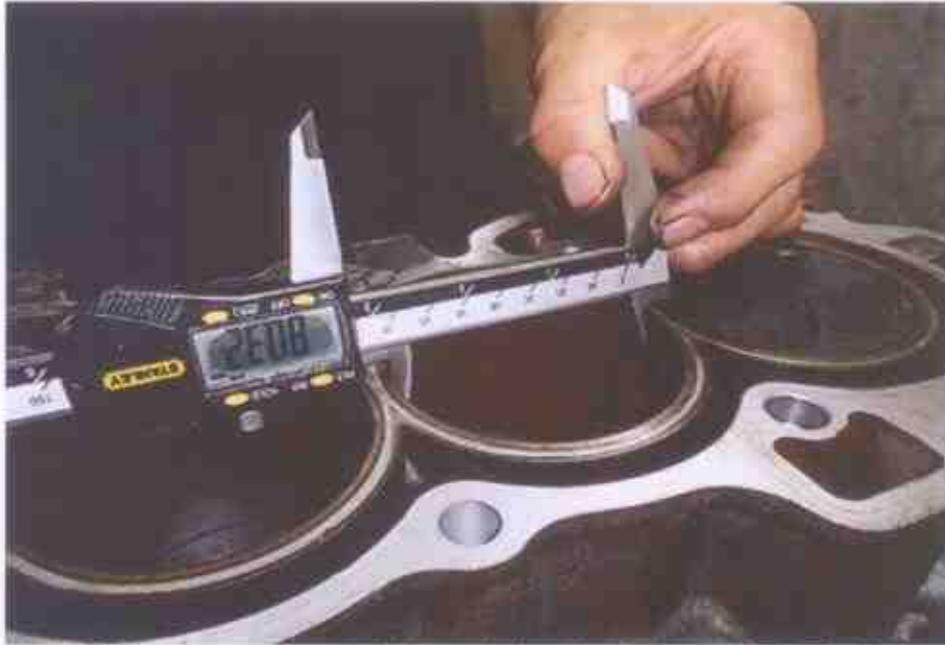
Photo 9 shows measurement being carried out to the bore of cylinder 2 of the Honda engine. The bore measurement of cylinder 2 was recorded to be 80.32mm.

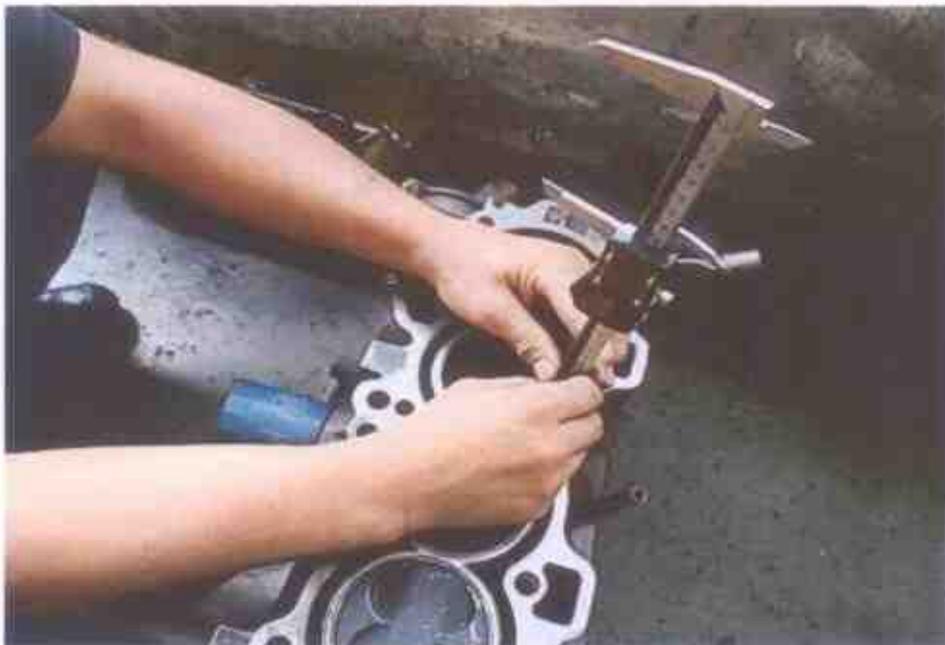
Photo 10 shows measurement of the stroke of cylinder 2 of the Honda engine that I had inspected.

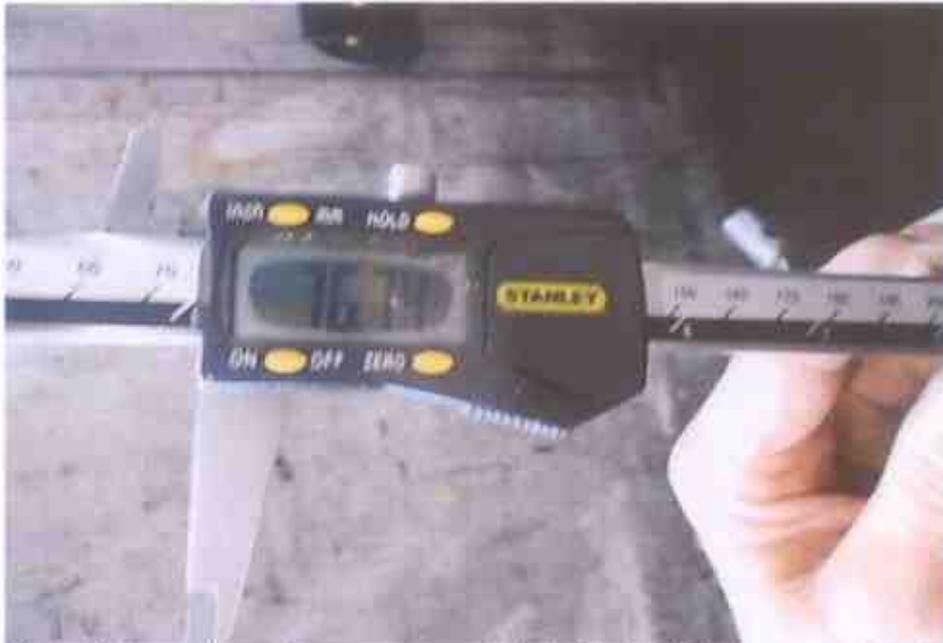
Photo 11 shows the stroke measurement of cylinder 2, which was recorded to be 76.74mm.

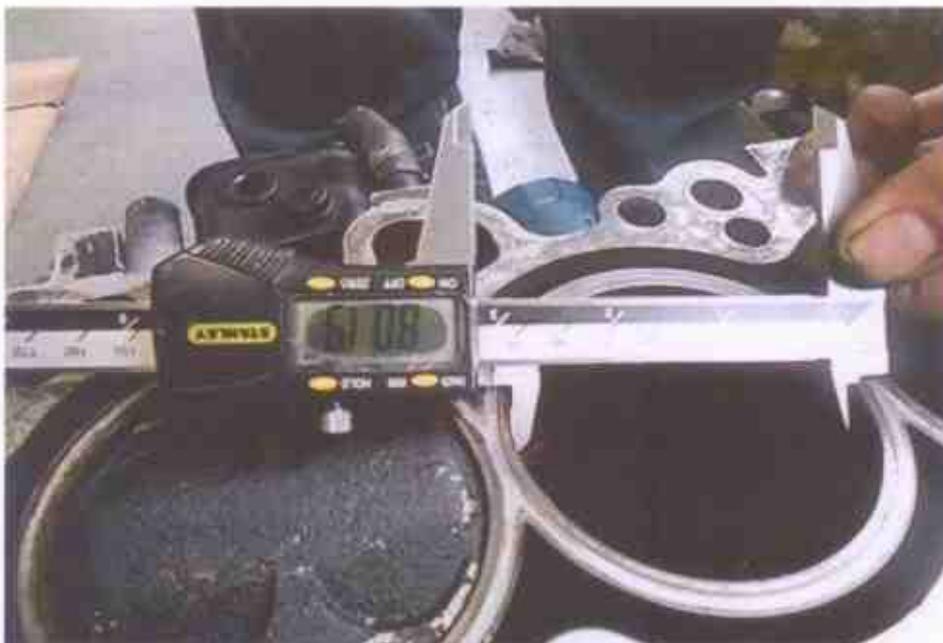
Photo 12 shows measurement being carried out to the bore of cylinder 3 of the Honda engine. The bore and stroke measurements of the Honda engine were carried out using a digital Vernier Caliper. The bore measurement of cylinder 3 was recorded to be 80.19mm.

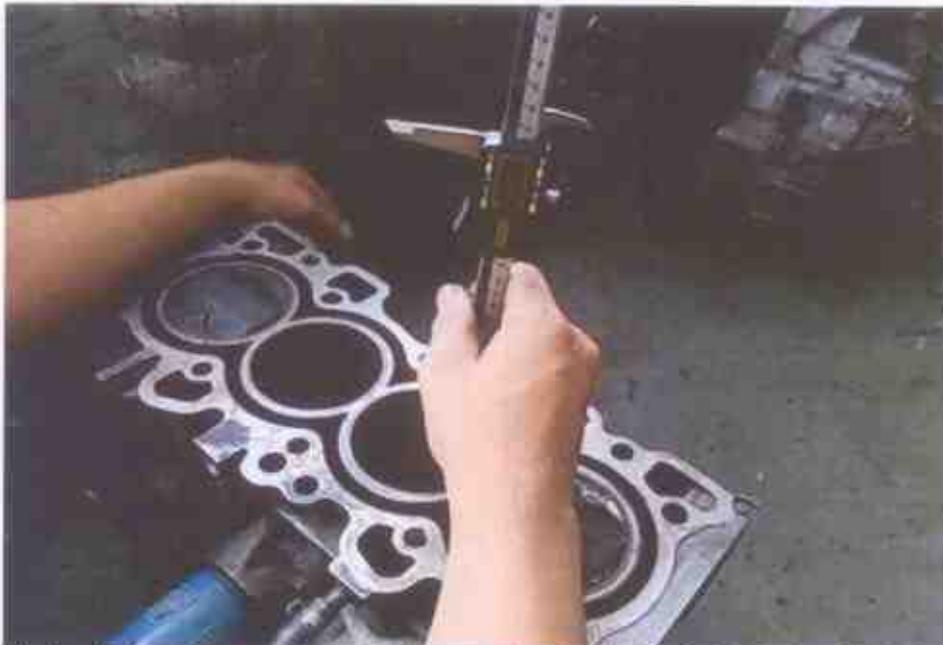
Photo 13 shows measurement of the stroke of cylinder 3 of the Honda engine that I had inspected. The bore and stroke measurements of the Honda engine were carried out using a digital Vernier Caliper that was calibrated before the start of measurements.

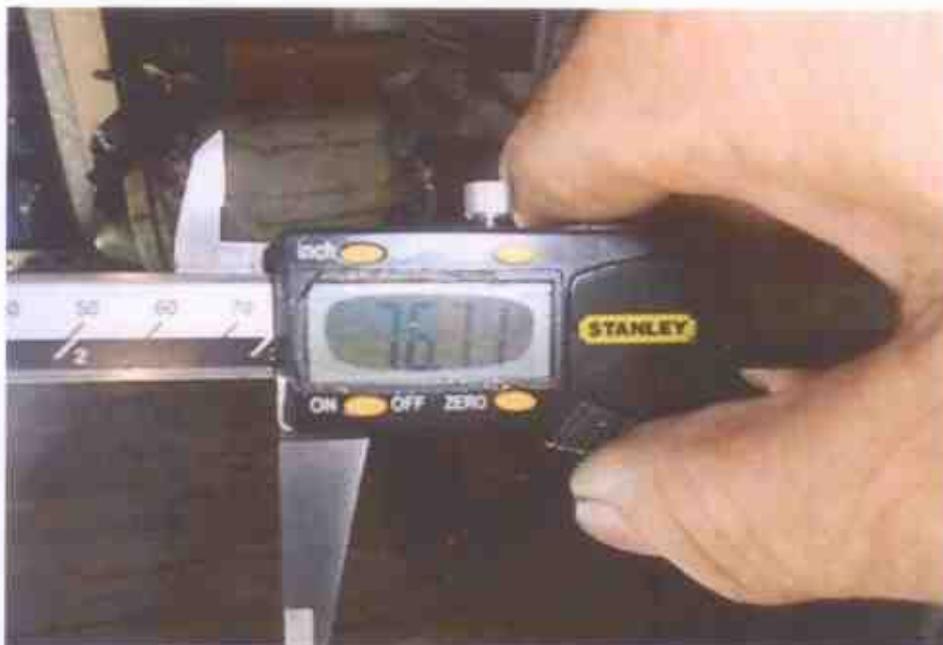
Photo 14 shows the stroke measurement of cylinder 3, which was recorded to be 76.71mm.

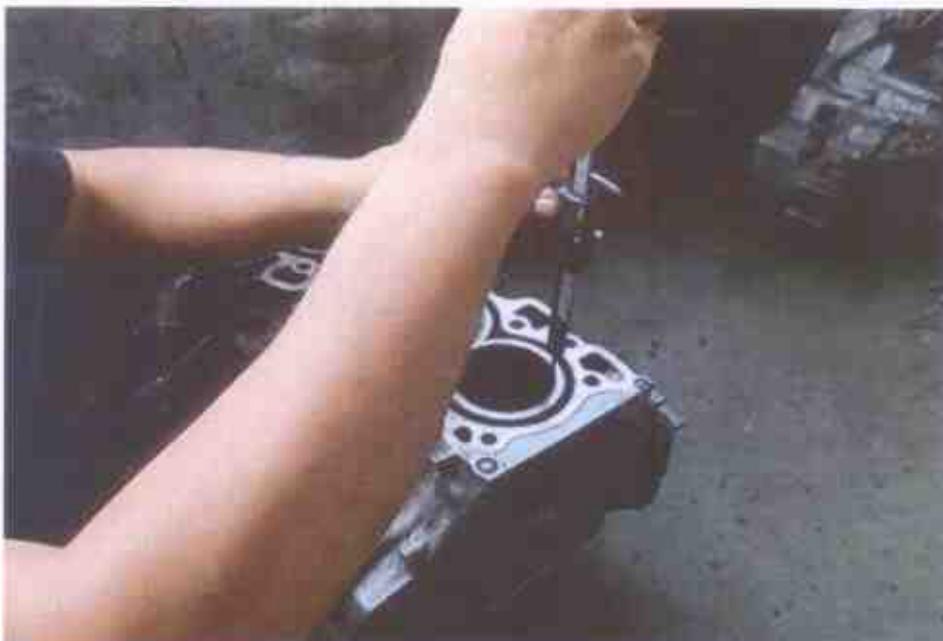
Photo 16 shows measurement being carried out to the stroke of cylinder 4 of the Honda engine. The bore and stroke measurements of the Honda engine were carried out using a digital Vernier Caliper that was calibrated before the start of measurements.

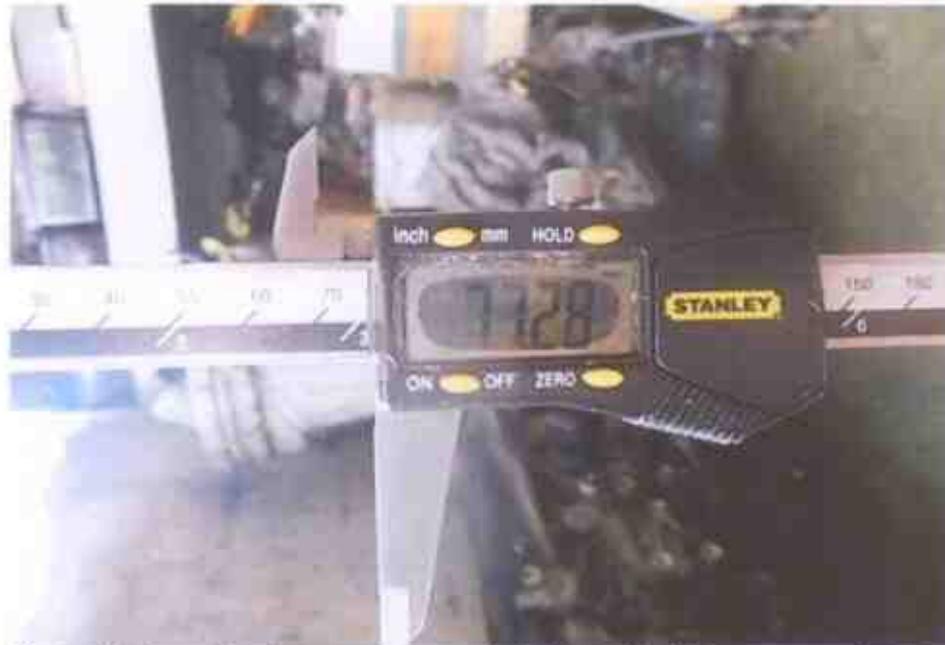
Photo 17 shows the stroke measurement of cylinder 4, which was recorded to be 77.28mm.
