PRELIMINARY ADVICE OF VEHICLE NO. FBG 1276D .

Affiliated to Federation Intern	ationale Des Experts En Autom	obile
SRE	AT AMERICAN IN	SURANCE COMPANY	Ref : CS/GAI180109	91/Uqbs2
#16- 0	MASEK AVENUE 01 CENTENNIAL T GAPORE 039190	OWER	Date: 10-10-2018	
		Policy Particula	ars :- THIRD PARTY CLAI	M
	Insured Veh.	YN 9330T	Veh. Inspected	FBG 1276D
	Policy No.		Coverage (\$)	0.00
	Claim No.	CLMOMVC000003292	Excess (\$)	0.00
	Assign From	RACHEL TAN	Assign Date	18/06/2018

ADJUSTMENT ON REPAIR COST FOR VEHICLE NO. FBG 1276D

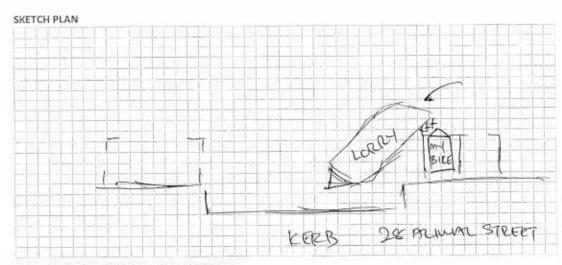
Sketch Plan #2 Pg. 1

MY MUTORCYCLE	WAS PARKED IN A PARKING LOT AT 28 AUWAL
STEKET CINGA	PORCE 199918 . THE LORRY, YN 933DT, TRIES TO DRIVE
INTO AN EMP	TY SPACE BESIDS MY MOTORCYCLE AND IT'S END
CAUGHT M-1 B	WILL MY BIKE FELL ON ITS LEFT HAND SIDE. THE
DRIVER PICK U	P MY BIKE TO ITS OPELLATE POSITION AFTER THE
FALL.	
==
