CB 6579L

Make: Toyota Hiace C.C. 2490

- Pre repair inspection request - CB6579L VS GBB6364B (OI) DOA 23/05/2018

VEHICLE DAMAGE INSPECTION REPORT

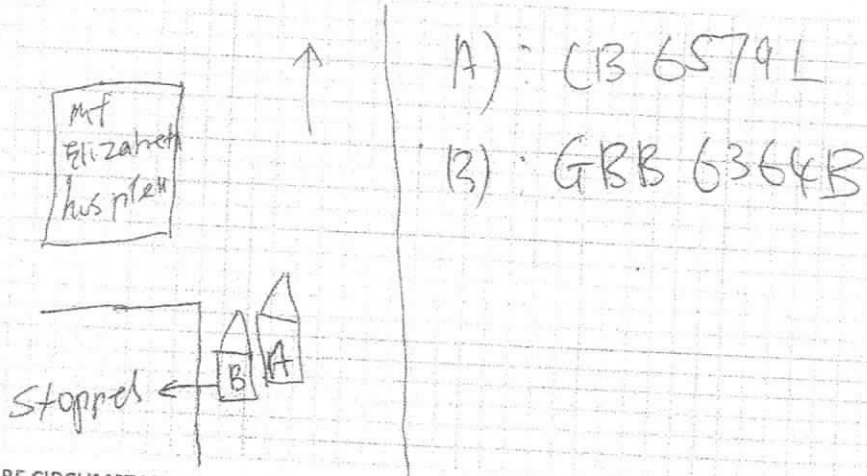
SKETCH PLAN

On 23.05.18 at about 15.57pm I was driving my Van CB 6579L along Mount Elizabeth near to Mt. Elizabeth hospital entrance suddenly the Van GBB 6364B which was stopped there suddenly drive out and hit onto my left front side.
