Preliminary Advice

Vehicle No	: SLL552T	Accident Date	: 09/06/2018
Make	: MERCEDES-BENZ GLA180	Policy No.	: DMPCSN1711821801
Assignment Date	: 19/06/2018	Excess	: S\$1,000.00
Date of Inspection	: 25/06/2018	Est. Duration of Repair	: 5.00
Inspection At	: SNG AH TEE MOTOR & PANEL SERVICE PTE LTD (PIONEER) BLK 3 PIONEER ROAD NORTH, #01-18 SINGAPORE 628457

VEHICLE DAMAGE INSPECTION REPORT

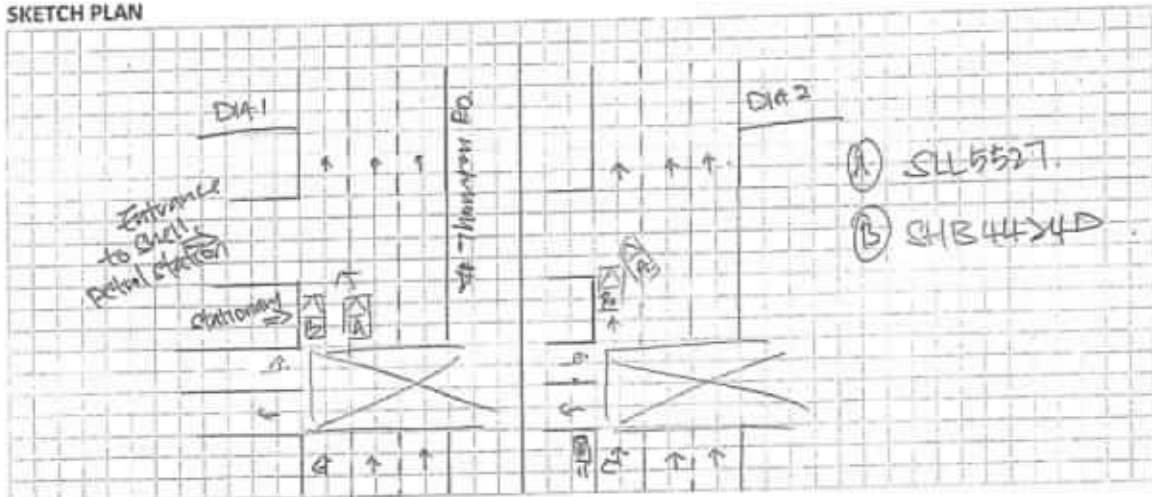
SKETCH PLAN

On 09/06/2018 @ around 22:00 hrs, I was travelling along Thompson RD toward the petrol station Shell. I was on the middle lane as I saw Vehicle B was stationary at that time to pick up customer. I slowly make my way to left to overtake him and allow my vehicle to proceed to turn into the Shell petrol station. But suddenly I almost going to turn into it, I feel impact from my left then I stop & went down to see and notices Vehicle B had Collided onto my left side portion.

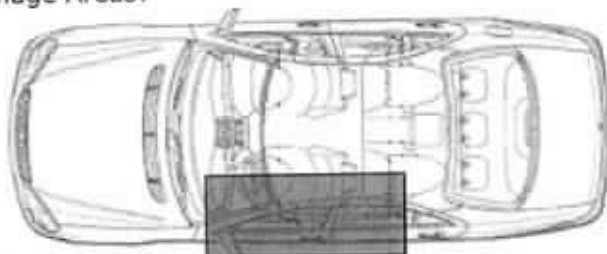
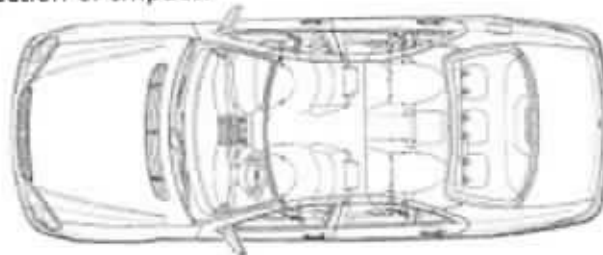
The vehicle sustained impact / damages n/s portion and parts claimed are consistent to the accident.
