INITIAL INSPECTION REPORT OF VEHICLE NO. SGV 600U

1. Policy Particulars :- THIRD PARTY CLAIM

ADJUSTMENT ON REPAIR COST FOR VEHICLE NO. SGV 600U

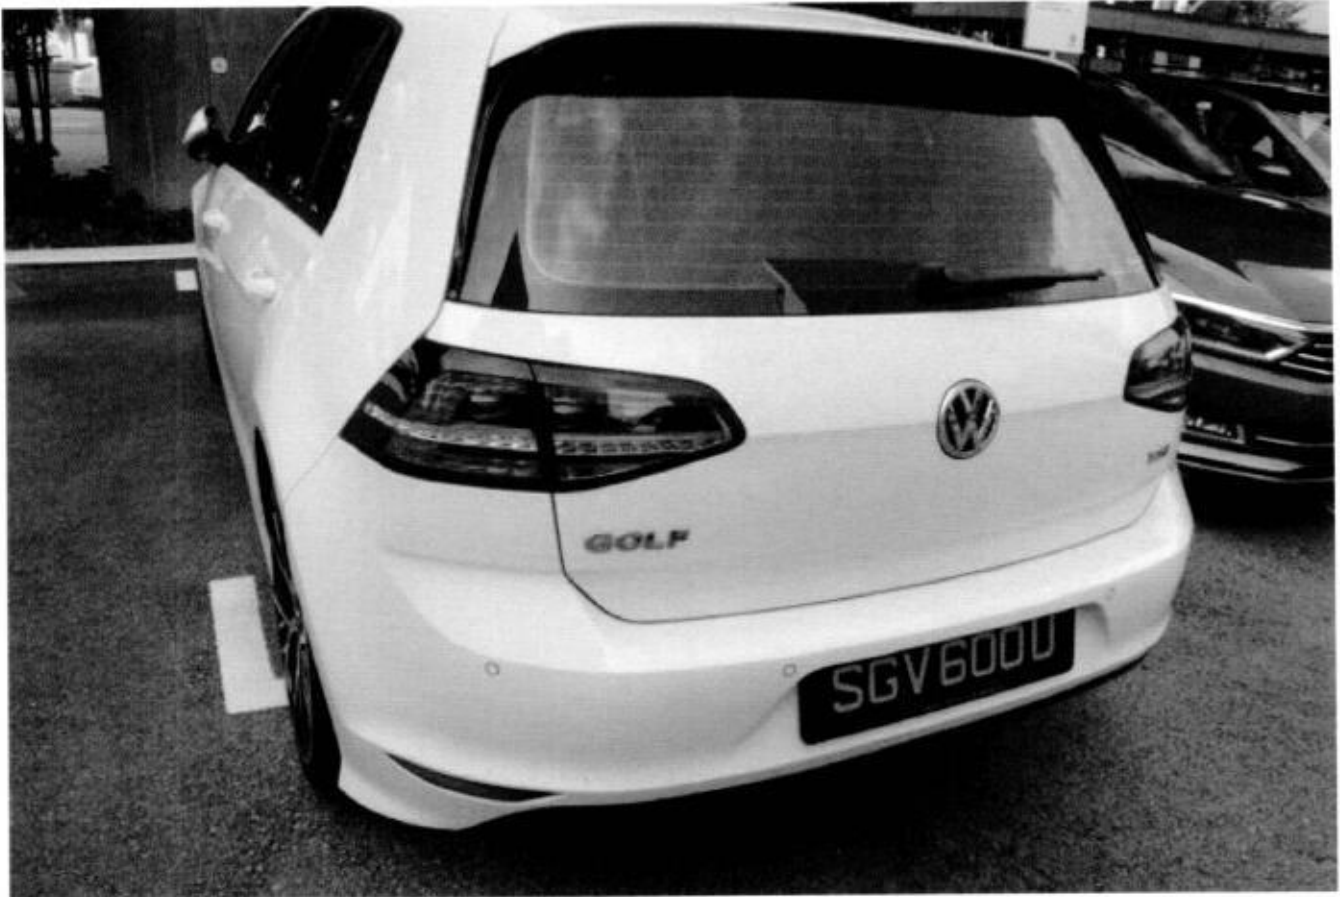
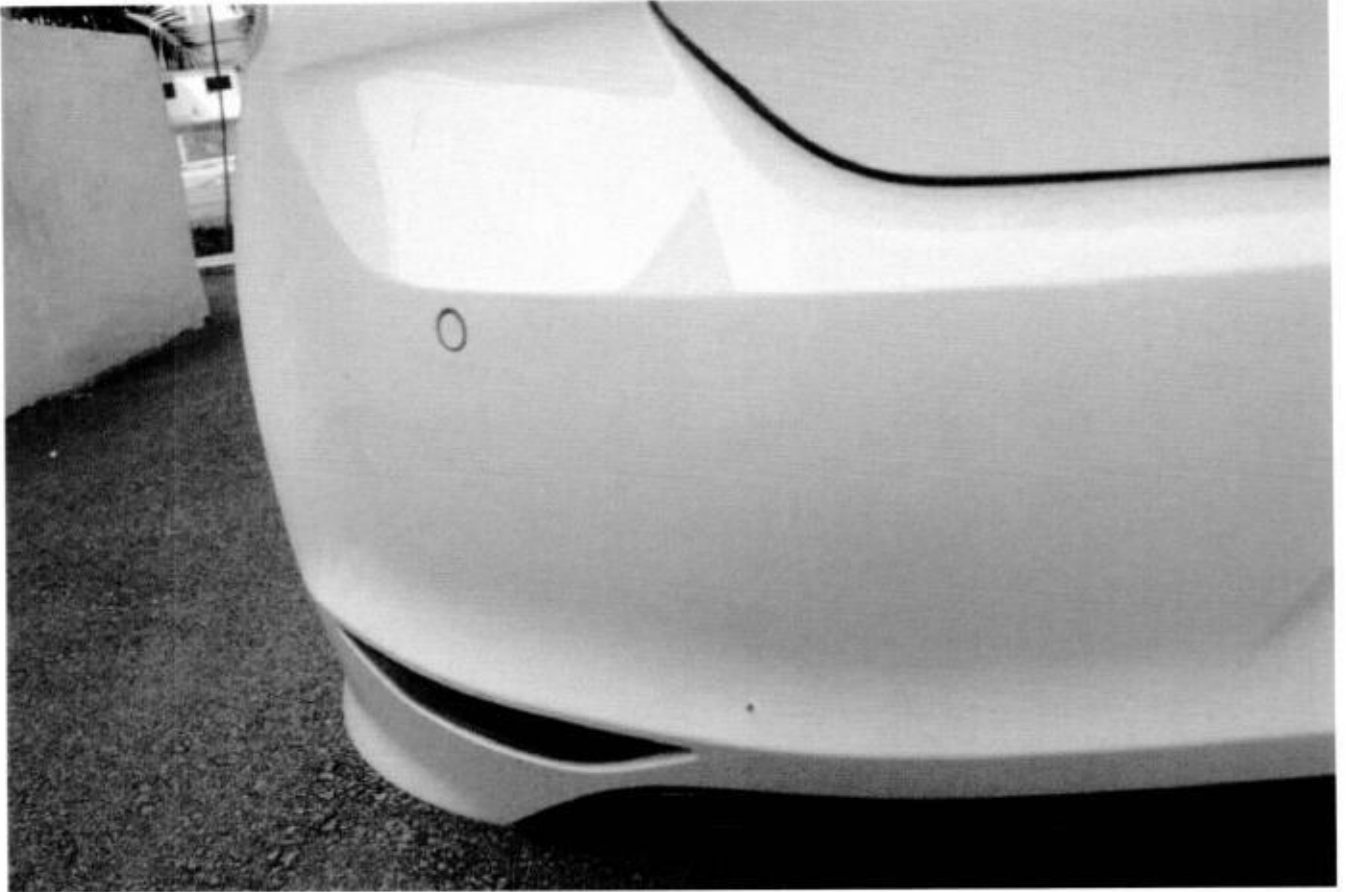
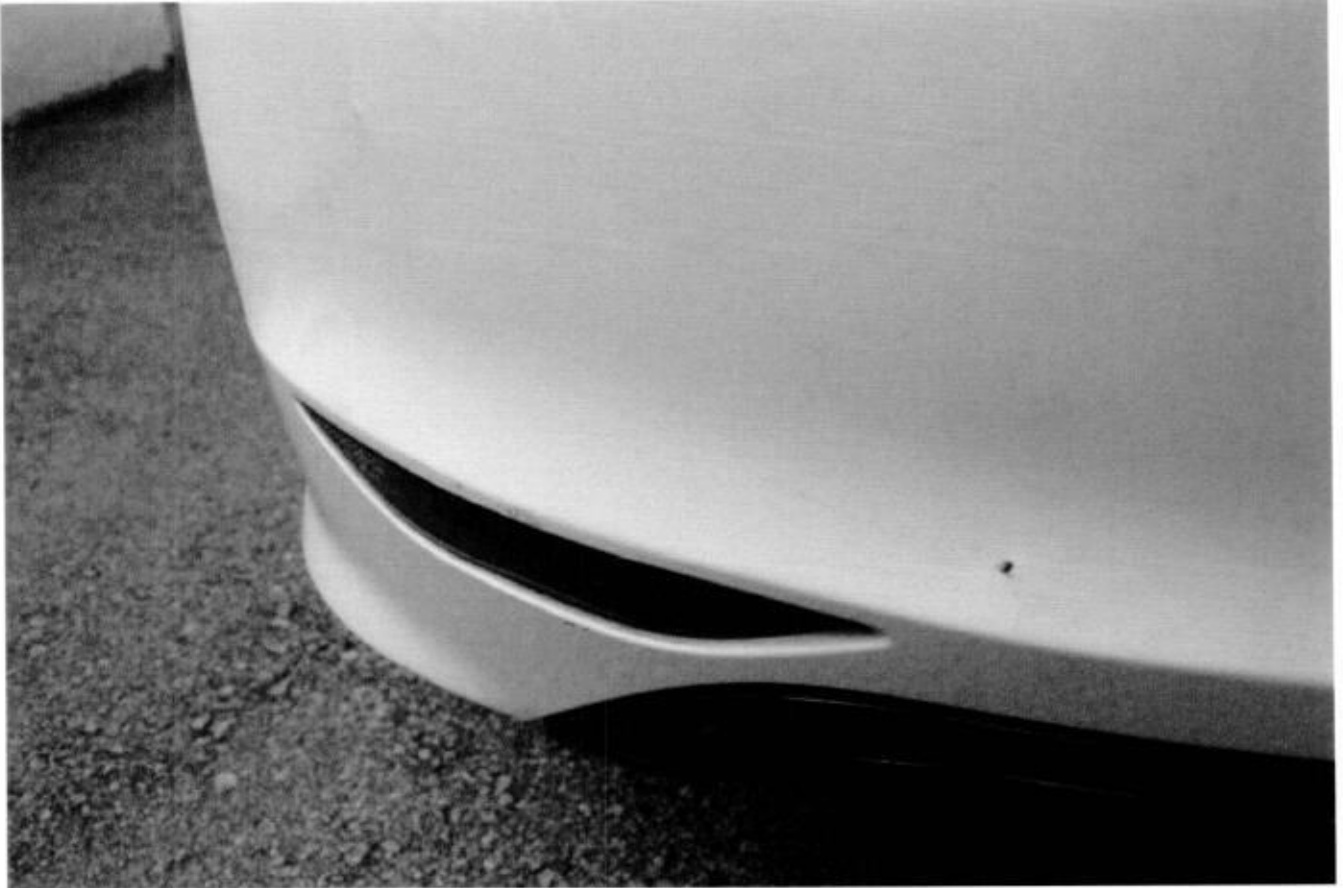
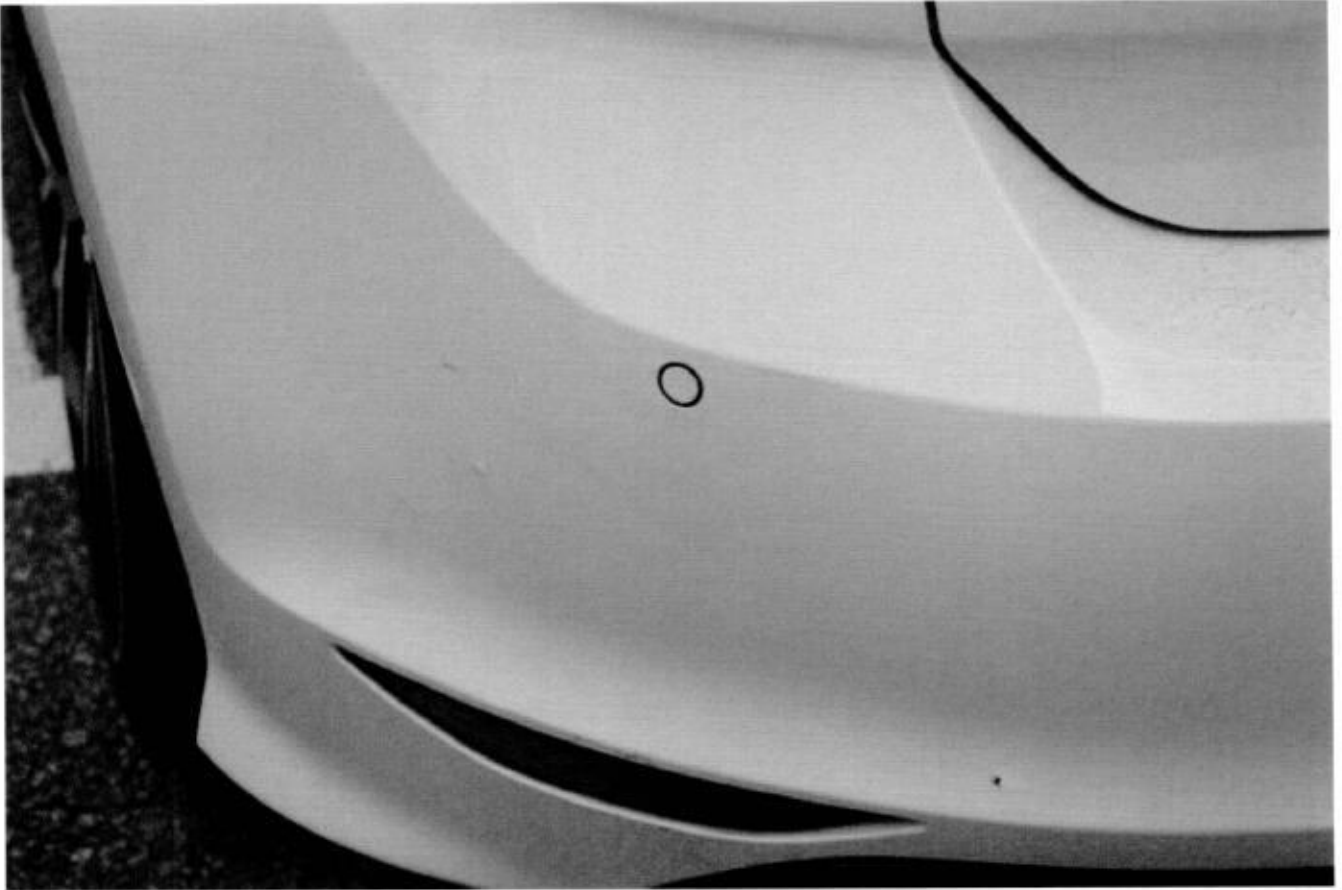
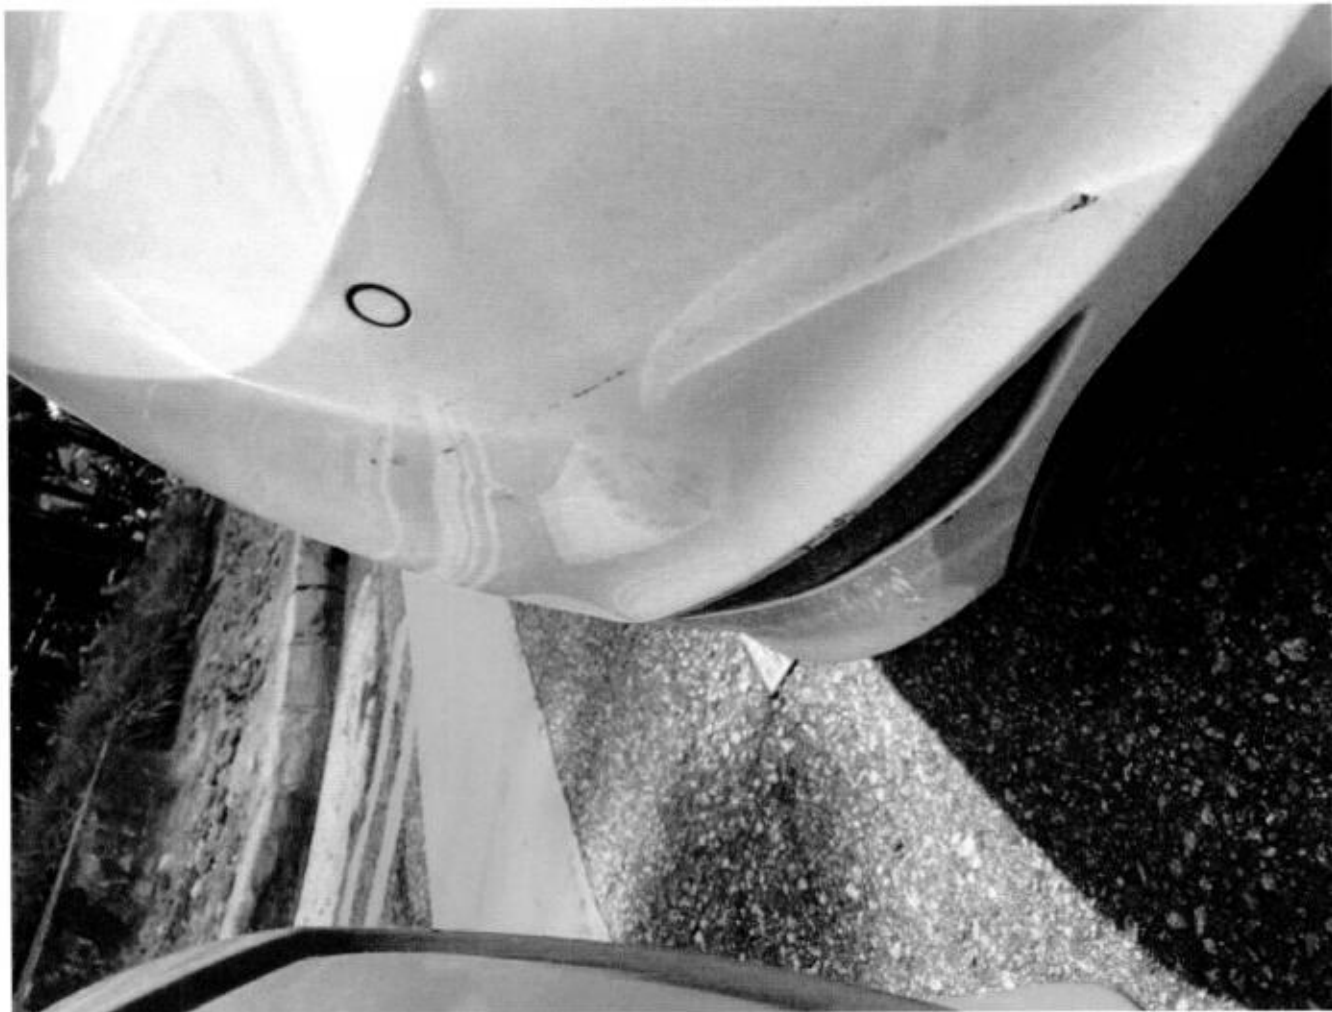
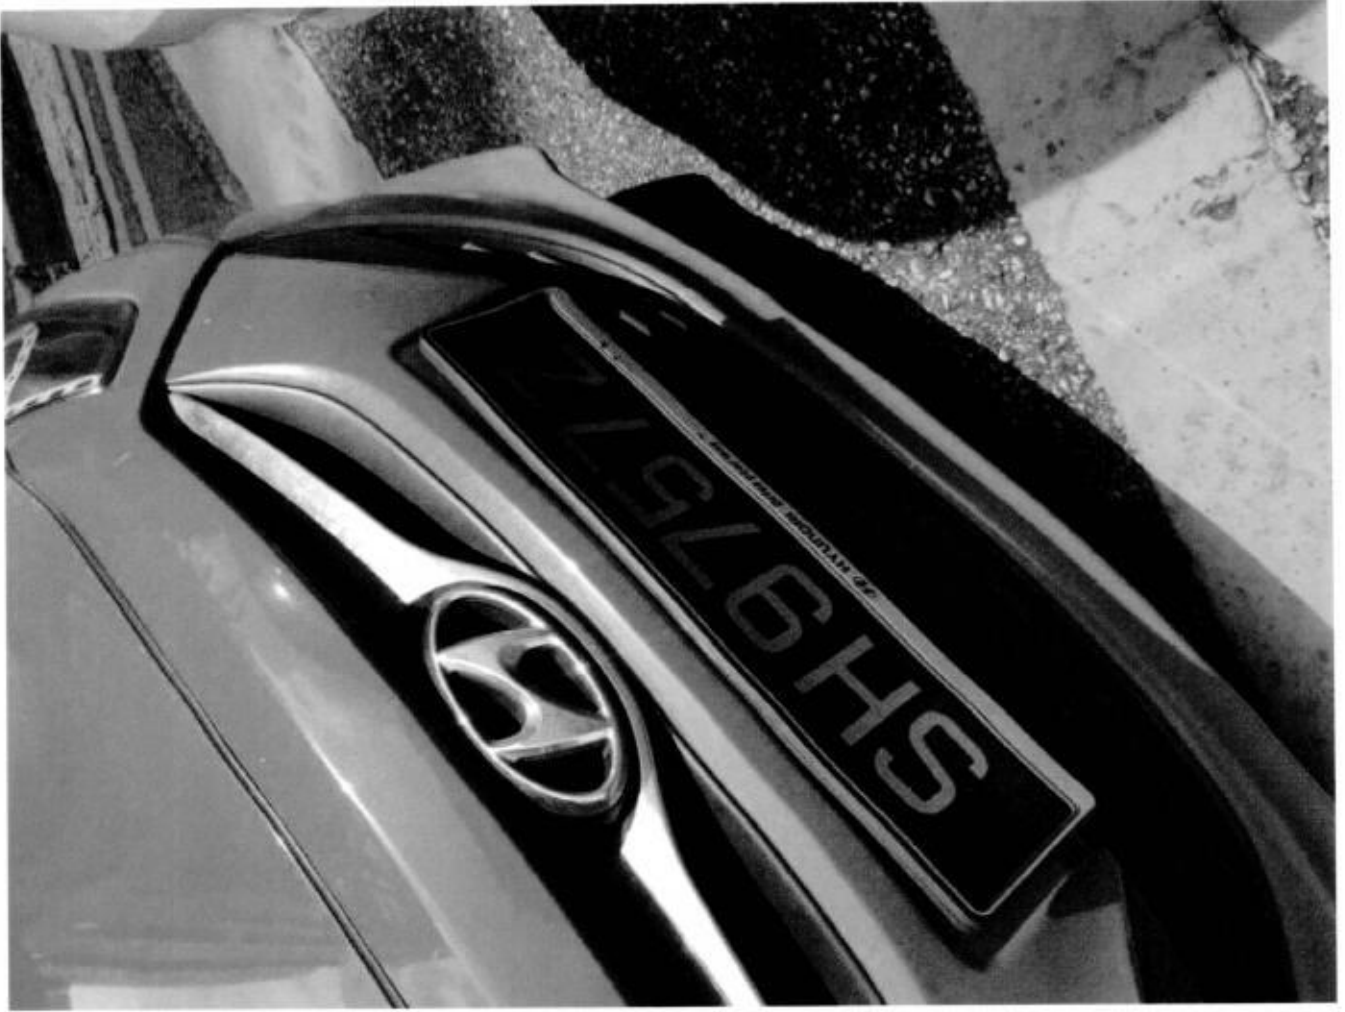
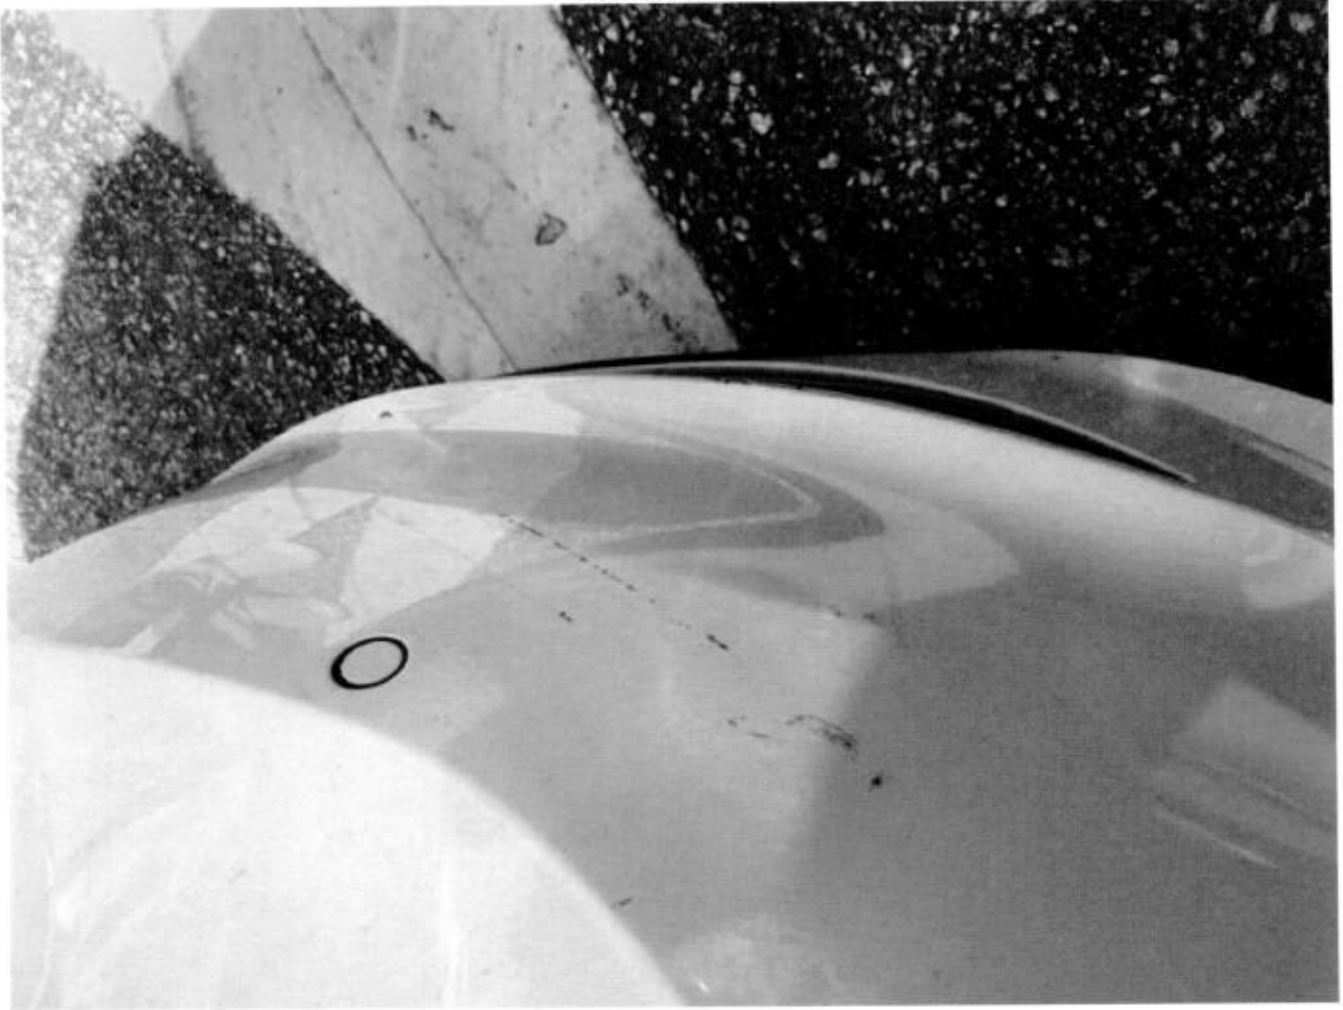
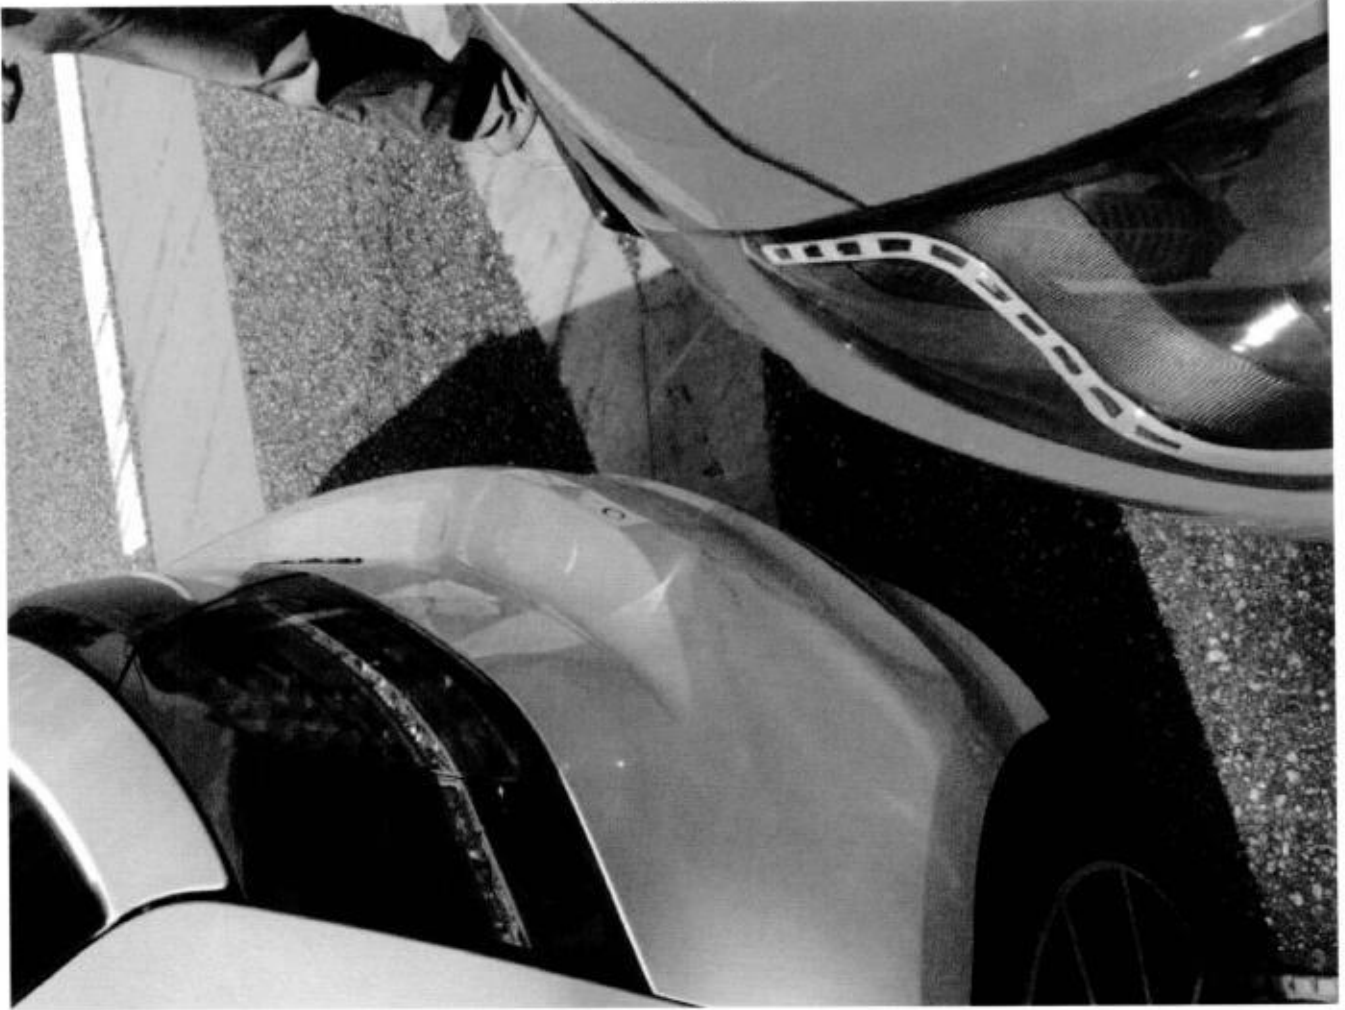
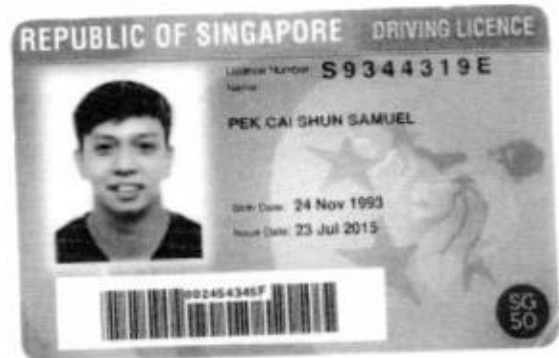
Accident Photo

The vehicle sustained damages at the n/s rear portion.

THE VEHICLE SUSTAINED DAMAGES AT THE N/S REAR PORTION. DAMAGES SEE DETAILS.
--

A) DAMAGES CONSISTENT TO ACCIDENT REPORT. B) THE INSPECTION WAS CONDUCTED ON A "WITHOUT PREJUDICE" BASIS. C) IN ACCORDANCE TO YOUR INSTRUCTIONS, WE HAVE NOT AUTHORISED REPAIRS.
--

Qty	Description of Parts	Condition	Estimate By Workshop (\$)	Our Adjusted (\$)
REPLACEMENT OF PARTS				
1	BUMPER REINFORCEMENT (SN)	SERVICEABLE	725.80	-
1	SENSOR BRACKET (SN)	NECESSARY	14.70	14.70
1	SENSOR BRACKET (SN)	NECESSARY	14.70	14.70
1	SENSOR BRACKET (SN)	NECESSARY	14.70	14.70
1	SENSOR BRACKET (SN)	NECESSARY	14.70	14.70
1	BUMPER BRACKET LH (SN)	SERVICEABLE	36.45	-
1	BUMPER GUIDE LH (SN)	SERVICEABLE	36.45	-
1	REAR BUMPER COVER (SN)	DEFORMED	726.63	726.63
1	DIFFUSER-REAR BUMPER (SN)	SERVICEABLE	311.58	-
1	STRIP (SN)	SERVICEABLE	67.06	-
1	2KADHESIVE (SN)	NECESSARY	103.66	103.66
1	BONDAGENT (SN)	NECESSARY	74.16	74.16
			2,140.59	963.25
LABOUR				
LABOUR.			2,520.00	840.00
SPRAY PAINT.			2,400.00	800.00
PROGRAMMING & CALIBRATION COMPULSORY TO DO AFTER AC.			480.00	480.00
CHECK WIRE HARNESS ECU,S.			280.00	280.00
			5,680.00	2,400.00
GRAND TOTAL			7,820.59	3,363.25
RECOMMENDED COST OF REPAIRS				3,363.25
