S/No	Income Reference	Claimant (Owner / Taxi Company)	Claimant Vehicle No.	Income Vehicle No.	Date of Accident	Estimate	Tentative repair cost
1	MT/0999285-002	COMFORT TRANSPORTATION PTE LTD	SHD 4182R	SLP 4094B	18/06/2018	\$ 3,738.64	\$ 900.00
2	MT/0999426-002	CITYCAB PTE LTD	SHC 276K	SKR 5223R	19/06/2018	\$ 2,686.00	\$ 1,200.00
3	MT/0999510-003	COMFORT TRANSPORTATION PTE LTD	SH 8839C	SHB 8865M	20/6/2018	\$ 1,603.13	\$ 400.00
4	MT/0999812-001	COMFORT TRANSPORTATION PTE LTD	SHC 2368R	GBE 2572C	18/6/2018	\$ 2,420.52	\$ 1,550.00
5	MT/0998569-002	COMFORT TRANSPORTATION PTE LTD	SHD 3594S	SLU 6879P	13/6/2018	\$ 7,568.23	\$ 5,702.63

### 1. Policy Particulars :- THIRD PARTY CLAIM

THE VEHICLE SUSTAINED DAMAGES AT THE O/S BODY.  
DAMAGES SEE DETAILS.

## ADJUSTMENT ON REPAIR COST FOR VEHICLE NO. SHC 276K

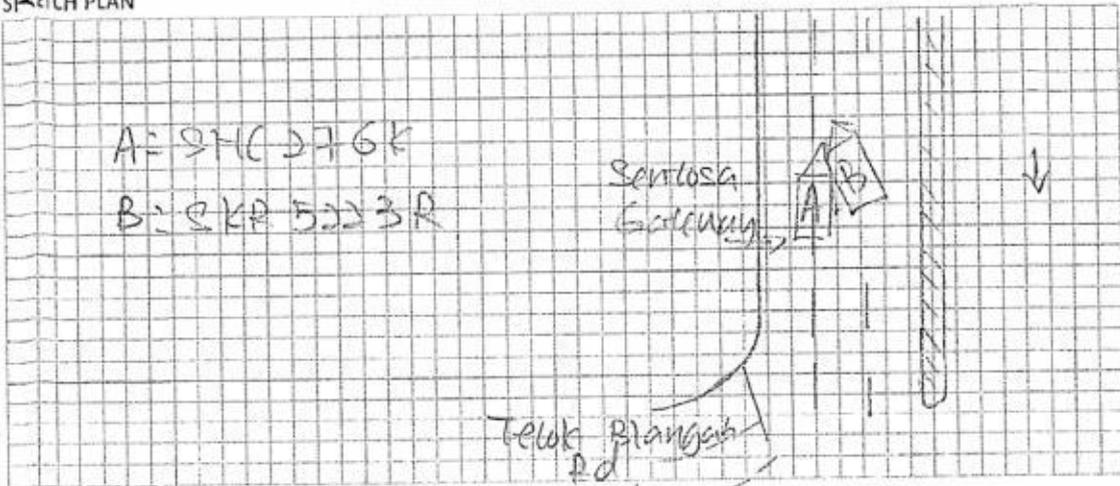
SKETCH PLAN

On 19/6/18. at about 17:50 hrs, I was driving along Sentosa Gateway at speed of 40 km/h.

Out of sudden, a car SKR 5223R cut into my lane in speedy manner. Due to this cause, the car left front portion hit & grazed onto the right front portion of my taxi.

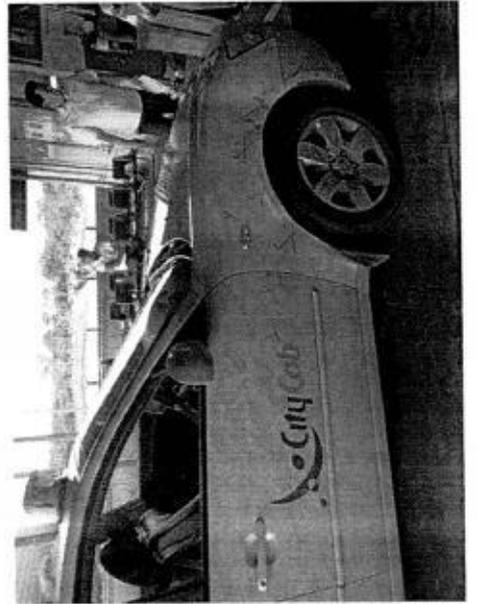
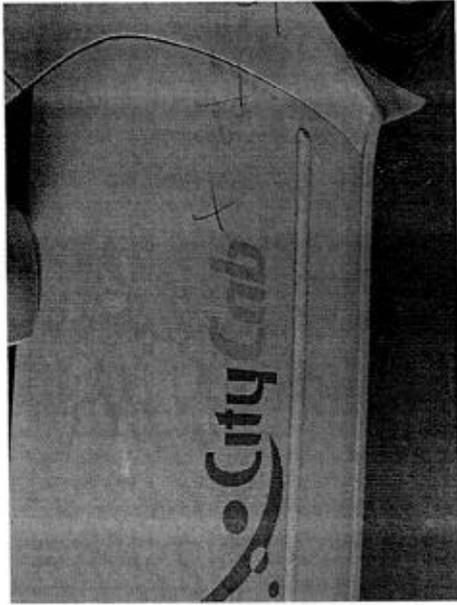
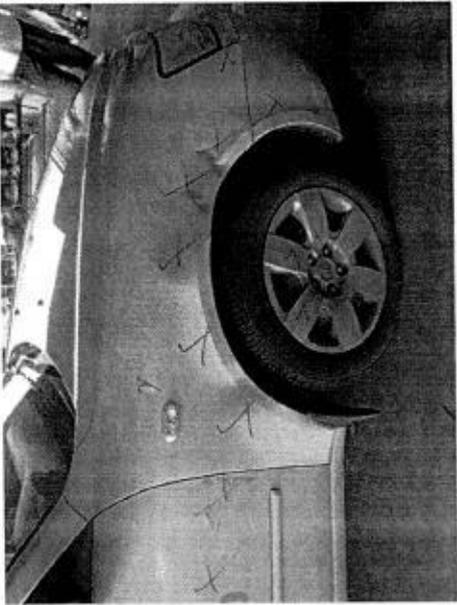
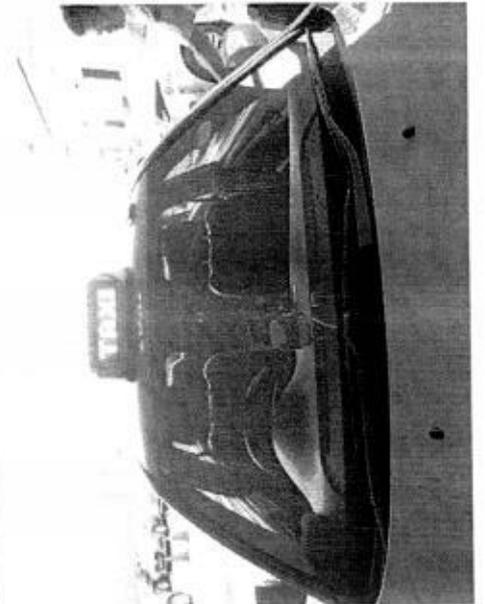
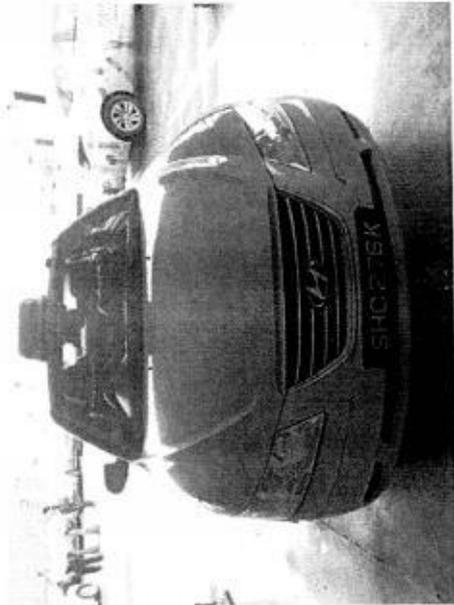
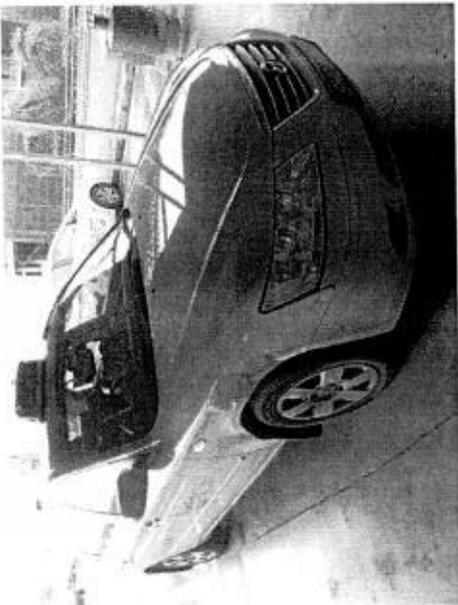
S/NO	LABOR CODE	DESCRIPTION
	NTUC - Taxi	Right Front damage
	LKK/Kadmi -

75.00	75.00
<b>LABOUR</b>				
	PANEL BEATING, INCLUSIVE OF THE REPAIR OF FRONT BUMPER COVER AND FRONT RH DOOR.		560.00	200.00
	SPRAY PAINTING CHARGE.		750.00	600.00
	TUFF KOTE.		50.00	20.00
	FRT WHEEL ALIGNMENT.	NOT NECESSARY	120.00	-
			1,480.00	820.00
<b>GRAND TOTAL</b>			<b>2,686.60</b>	<b>1,485.40</b>
<b>RECOMMENDED COST OF LUMP SUM REPAIRS (TO ITS PRE-ACCIDENT CONDITION) (CONFIRMED)</b>				<b>1,200.00</b>
