REP: CS/MSG18011407/Tlv3/2

## Preliminary Advice

## Point of Impact / General Description of Damages

## VEHICLE DAMAGE INSPECTION REPORT

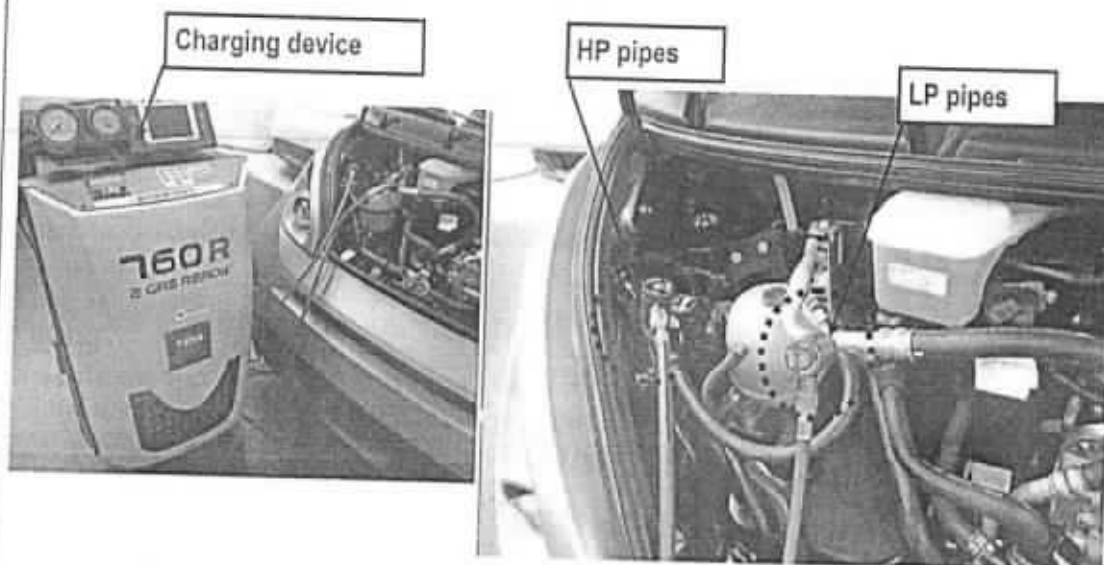
Drain the air-conditioning system in accordance with the charging device recommendations.

**Filling:**Draw off the system to empty it in accordance with the charging device recommendations.  
Fill the system in accordance with the charging device recommendations.*N.B.: Only fill with R1234yf gas (qty. at 350g)*

Disconnect the device on the HP/LP car pipes.

Fit the HP/LP protective car pipe plugs

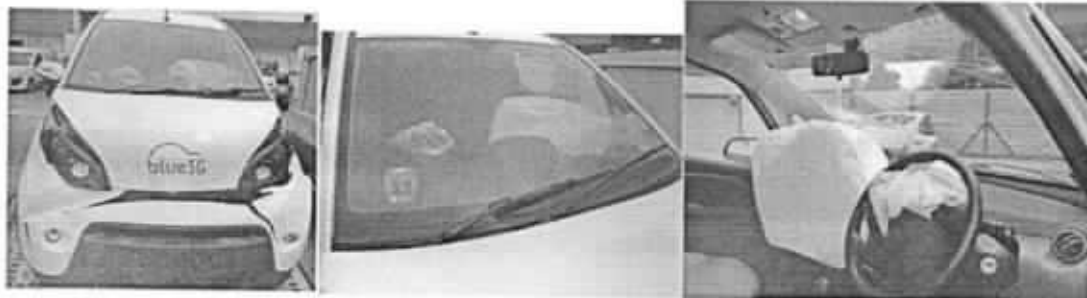
Vehicle No : FV03000-SLU4858M

The vehicle sustained impact / damages front portion and parts claimed are consistent to the accident.

**ACCIDENT EV PICTURES ( AIRBAG ACTIVATED):**

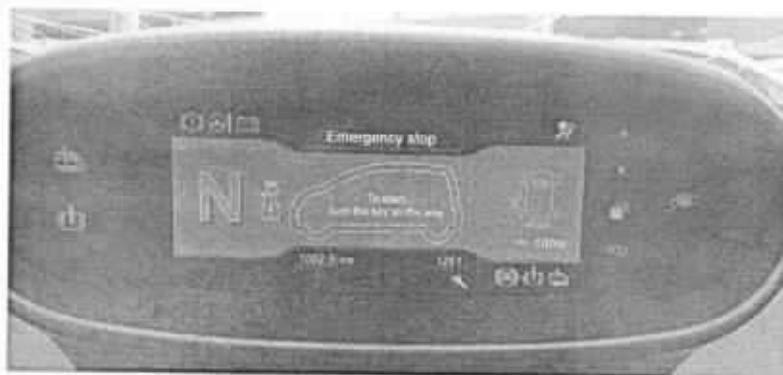
**Step 1: Emergency activated alarm**

**I. Procedure of diagnosis with result or reason of replacement:**
