ESTIMATE TO REPAIR VALKSWAGEN JETTA 1.4 TSI - SKG6174A

VEHICLE DAMAGE INSPECTION REPORT

Handling Insurer:	China Taiping Insurance (Singapore) Pte. Ltd.	Policy No:	DMCVSN3017411803		
Claimant Vehicle No :	SKG6174A	Insured Vehicle No :	GQ424M		
Date of Loss:	18/06/2018	Nature of Claim:	TP	Claim No:	SNM18D03018C02

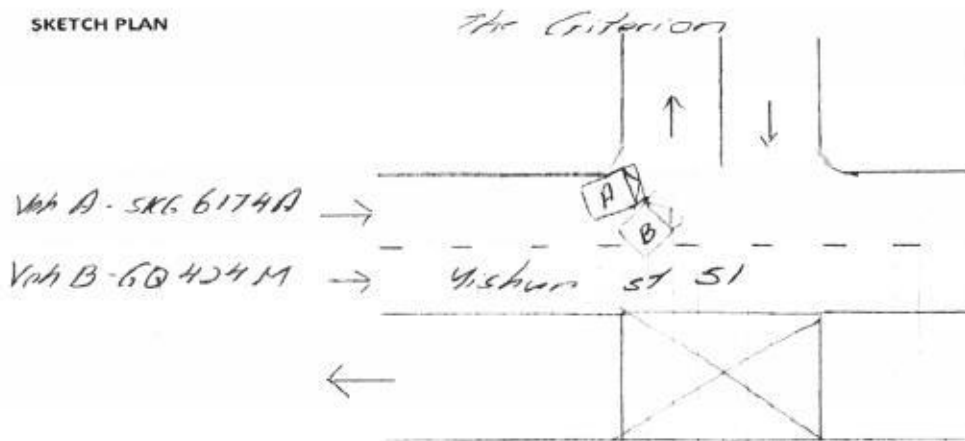
SKETCH PLAN

On 18/6/18 at about 1020hrs, while entering Ronda Criterion at 19 Yishun St 51, I am ~~at the~~ queuing at the owner entry lane. Mr Lee Boon Yew was turning in from the visitor lane and cut into my lane ^{because he} wanted to cut the queue from entering from the visitor lane. Therefore he bang into my vehicle SKG 6174A Right side of my front vehicle.

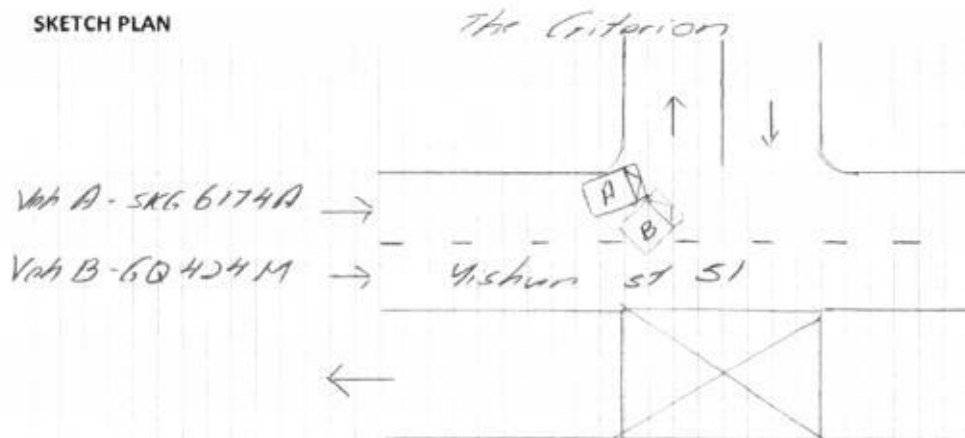
SKETCH PLAN

On 18/6/18 at about 1020hrs, while entering Cenda Criterion at 19 Yishun St S1, I am ~~at the~~ queuing at the owner entry lane. Mr Lee Boon Yew was turning in from the visitor lane and cut into my lane ^{because he} ~~and~~ wanted to cut the queue from entering from the Visitor lane. Therefore he bang into my vehicle SKG 6174A Right side of my front vehicle.
