## Preliminary Advice

| Make | : BMW 640i | Est. Duration of Repair | : 6.00 |

The vehicle sustained impact / damages rear o/s portion and parts claimed are consistent to the accident.

## VEHICLE DAMAGE INSPECTION REPORT

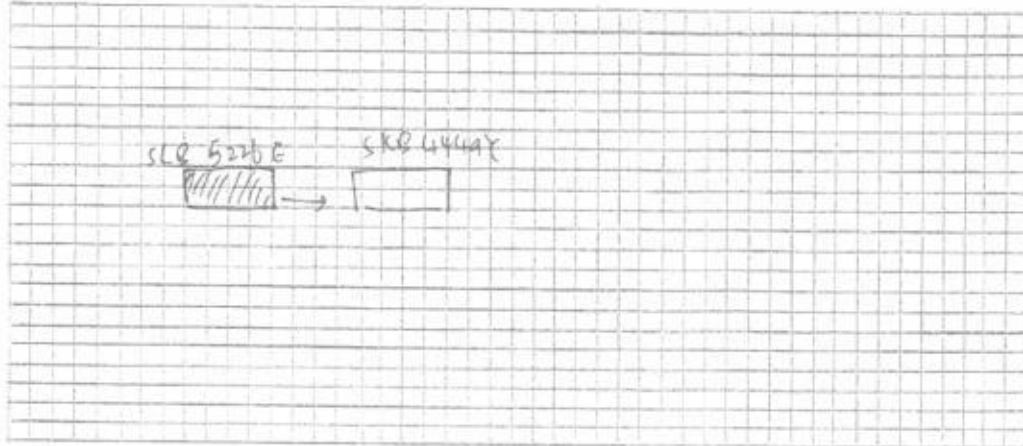
## SKETCH PLAN

On 18/6/18 around 11.25am, I was driving along Marymount Road towards the junction of Ang Mo Kio Ave 1. I was driving on the middle lane of the Road (3 lane Road). The front vehicle slowed down as a ~~bus~~ vehicle was filtering to the slow lane. I slowed down too and was hit at the behind by vehicle SLB 5226 E. It was drizzling at the time of the accident. I am claiming against Rivermen Auto Services Pte Ltd at 10 Ang Mo Kio Industrial Park 2A #04-07/16 Ark Autopoint. Under Policy no A 28386328 MTR. (MS16)
