YP 7032G

ACCIDENT INVOLVING YP7032G & SHD3174X ON 16.06.2018

ESTIMATE REPORT 1st QUOTATION

VEHICLE DAMAGE INSPECTION REPORT

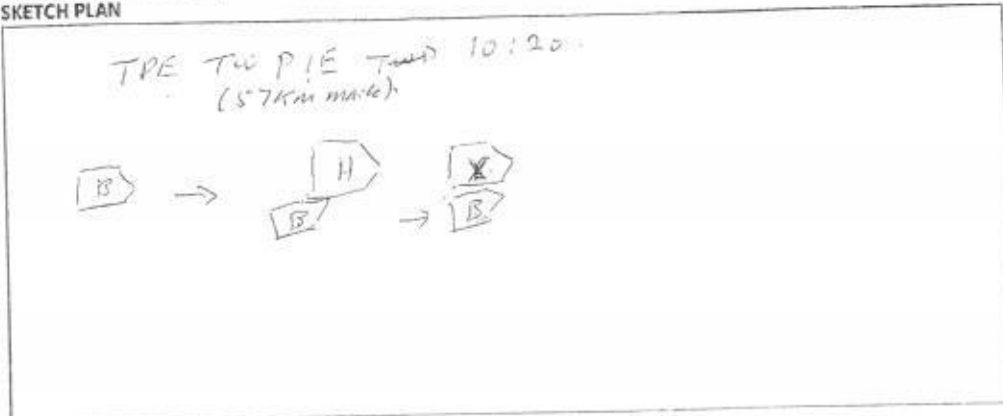
SKETCH PLAN

Accident happened at PLE TPE toward PLE.
 There was a vehicle breakdown (veh. 'X') on TPE.
 My vehicle was providing 'safety cover' for the
 breakdown vehicle. Suddenly veh. taxi No 870 3174 X
 hit on to the right rear ^{side} portion of my vehicle.
