To: Lompac Insurance Bhd 300 Beach Road #17-04/07 The Concourse Singapore 199555	From: LKK Auto Consultants Pte Ltd 51 Ubi Ave 1 #01-25 Paya Ubi Industrial Park Singapore 408933
Attn: Ong Li Li	Date: 27 Jun 2018
<u>Preliminary Advice</u>

Vehicle No	: SGY9819G	Accident Date	: 25/06/2018
Make	: TOYOTA WISH	Policy No.	: Z17VP05015221
Assignment Date	: 26/06/2018	Excess	: S\$0.00
Date of Inspection	: 26/06/2018	Est. Duration of Repair	: 6.00
Inspection At	: WOON MENG MOTOR PTE LTD (BUKIT BATOK) 50 BUKIT BATOK STREET 23,, #01-06 MIDVIEW BUILDING SINGAPORE 659578

VEHICLE DAMAGE INSPECTION REPORT

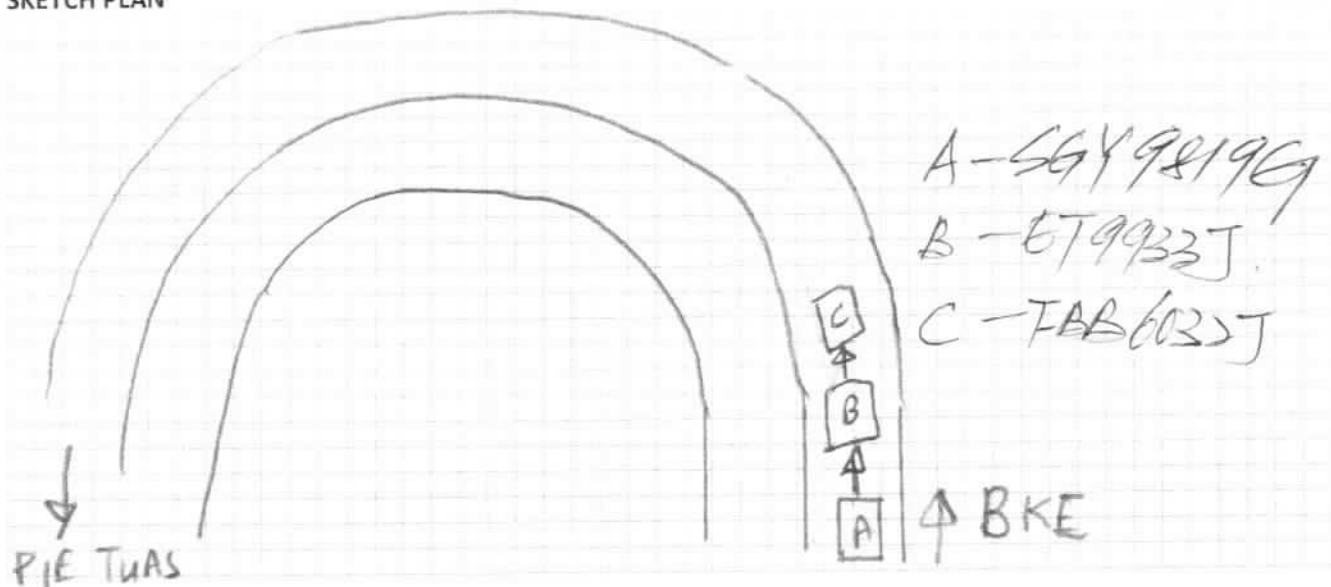
SKETCH PLAN

At around 0900hrs to 0930hrs, I was driving from BKE towards PIE Tuas. Because it was raining, the road is slippery. Biker 'C' skidded and fell at the bend. Car 'B' immediately emergency brake and could have hit biker C. I also emergency brake, but my car hit car 'B' rear. My car front was damaged by the hard metal of car 'B' mercedes car. The rear of mercedes car B was only slight dent and a bit crack only. Car 'B' mercedes car could have hit biker C. Car B driver said there is some scratches in front. Both of us confirmed there was no injury. We helped Biker 'C' to get up from his fall and assisted his bike to the shoulder. Car 'B' rear was slightly dented and no injury of the car B driver and his passenger. I took some pictures of the slight dented rear of car B and there are no damages on other parts of his car apart some chipped off and no injuries from car 'B' and biker 'C' who fell off on his own and biker was also not injured and all of us drive & ride off from the scene. No traffic report made as no injury. Car B has no major damage except rear slight dent and chipped off.
