## VEHICLE DAMAGE INSPECTION REPORT

Our File No: CS/CTI18011573/KSD3Q2

Reg No: **SKG7695G**

Make &amp; Model: BMW X5, 3.0 (A)

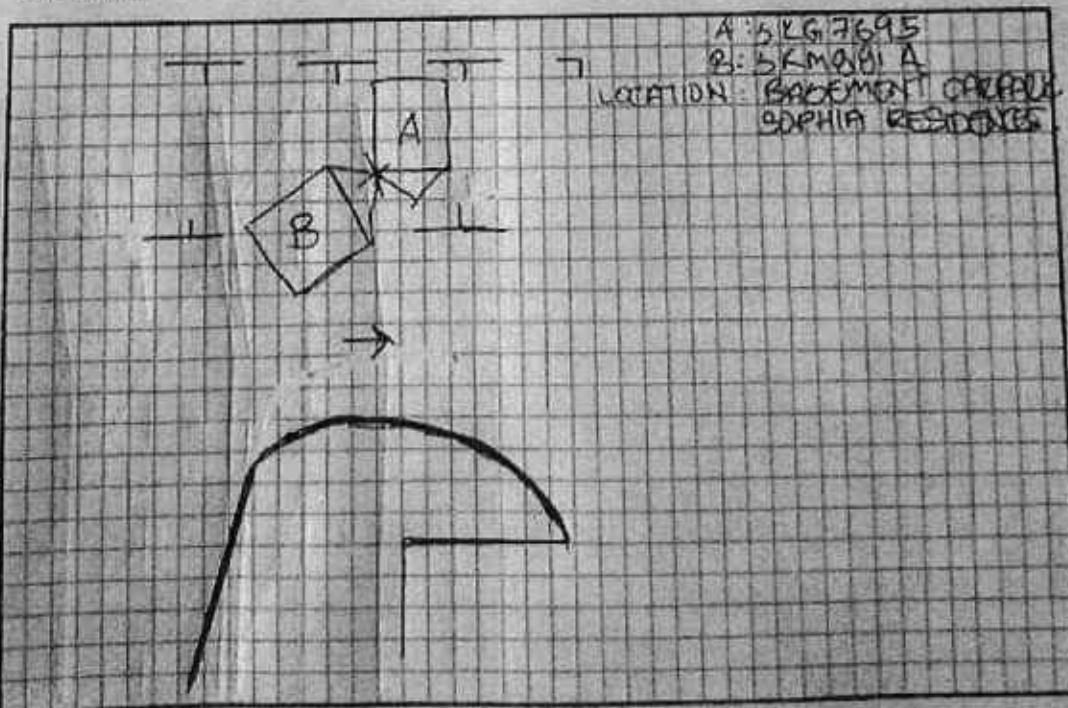
### Sketch Plan

My vehicle was parked in the carpark lot within my residences. Vehicle B had drove into the carpark and while making a turn, the front portion of vehicle B had collided onto the front right portion of my vehicle. The impact had left the axis of my front tyres to be shifted a certain angle after the collision. No injuries were involved.
