PRELIMINARY ADVICE OF VEHICLE NO. RU 4105G .

RE: CMTD1802447/GPL - SUV(LKK)/ GBD4866Y & RU4105G ACC ON 07/06/2018

ADJUSTMENT ON REPAIR COST FOR VEHICLE NO. RU 4105G

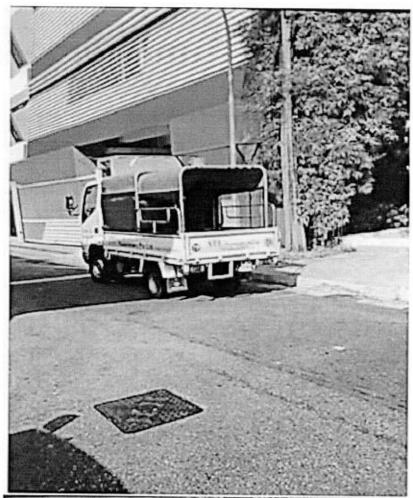
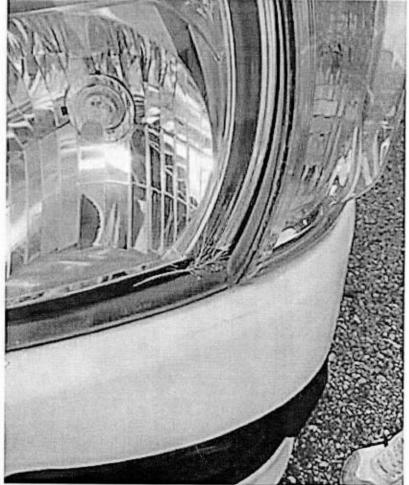
A ADDITE TURNSPORT BASE
	LOADING LUNCOADING BAY
hinds:	8
Hill	
ESCRIBE CIRCUMS	TANCES OF THE ACCIDENT
WHIE	REVERSING I ACCIDENTARY HIT THE FROM
HEADLAM	O (LEFT), THERE WAS A SUIHT CANCE. WIN
	OF OTHER VEHALLE

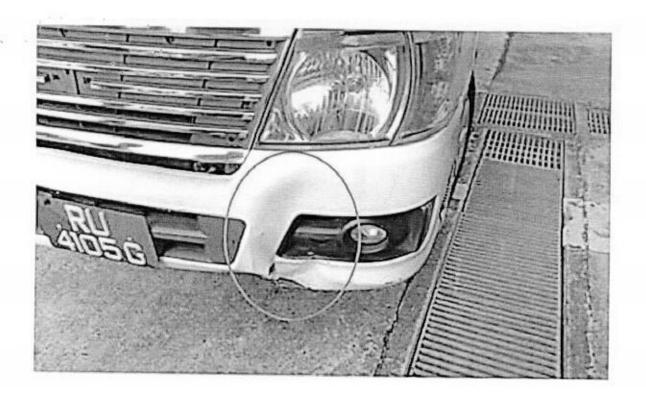
Our driver mentioned that he only hit the left front headlamp of RU4105G.

While we note that your client's damage may have previous damage at the front lower bumper area which is not related to the accident.

Damage are to be verified by independent surveyor :
